# Insensitivity of the North Branch Root River, Milwaukee County, Wisconsin: Implications for Restoration

Michael D. Harvey, PhD, P.G., Robert A. Mussetter, PhD, P.E., Stuart C. Trabant, PE, (Tetra Tech, Inc.), David Fowler (Milwaukee Metropolitan Sewerage District)

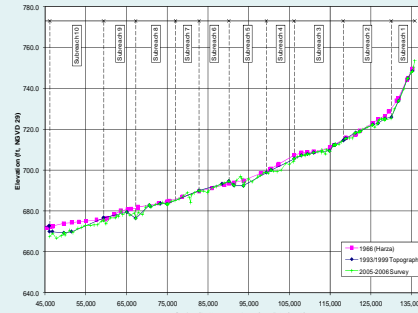
Figure 3. Comparative thalweg profiles for the North Branch Root River.

**Vertical Stability:** Comparative thalweg data indicate that there has been little bed degradation since 1966 except in SR 1 (due to downstream channelization), SR 4 (due to removal of LWD jams) and SR 10 (due to downstream channelization) (Figure 3). Vertical stability is due to consolidated tills in the bed of NBRR (Figure 4).

#### Bed Stabilization: Approx. 7 feet of additional degradation in SR 1

- Three constructed-riffle grade-control structures

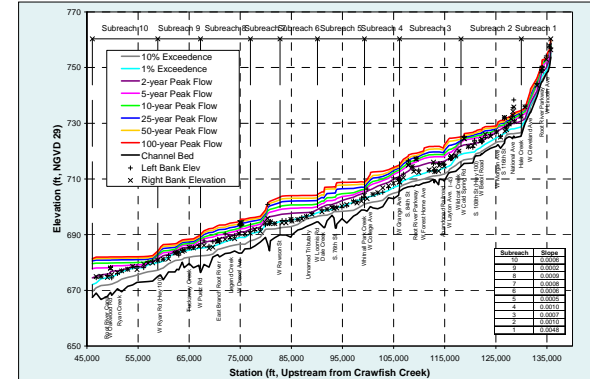
Figure 7. Hydraulic and bed and bank profiles of the NBRR.

**Hydraulic Capacity:** HEC-RAS modeling was used to identify the channel capacity along the NBRR (Figure 7). Where the NBRR was channelized but not bermed (SR 4-10), the channel capacity is about the 1% exceedence flow which is equal to the pre-development 2-yr RI peak flow. Where the channel was bermed (SR 2-3), the capacity is equal to the present 2-yr peak flow. Channel capacity varies from the 5- to the 100-yr RI peak flow in SR 1 that has incised and is bounded by historic terraces.

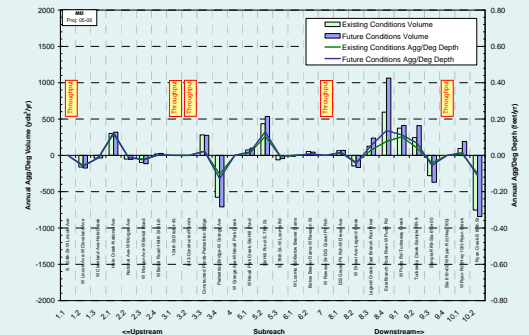
Figure 8. Annual volume of aggradation or degradation under existing and future (2020) hydrologic conditions and corresponding change in bed elevation along NBRR.

**Sediment Transport:** Reach-averaged hydraulics from the HEC-RAS model and bed material gradations for the individual subreaches were used to conduct a sediment continuity analysis of the NBRR for existing and future conditions. Where the median size ( $D_{50}$ ) of the bed material was less than 4 mm, the Yang (1972) equation was used and where the  $D_{50}$  exceeded 4mm the Wilcock and Crowe (2003) equation was used (Figure 8). Degradation is predicted in SR 1, SR 9, SR 10 and in SR 3 downstream of historic sand-and-gravel mining pits. Aggradation is predicted downstream of the major tributaries in SR 2, SR 5, and SR 9 where the coarser bed material load delivered by the steeper tributaries is not readily transported by the NBRR. The increased future condition flows generally increase local aggradation in SR 5 and 9 and also increase degradation in SR 3, 9 and 10.
