# Urban Stream Restoration

## Pheasant Branch Creek, Middleton, WI

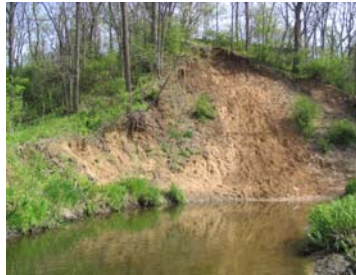
Severe erosion is common in Pheasant Branch Creek. This slope located between Park Street and Century Avenue eroded approximately 25 feet over the five year period between 2000 and 2005.

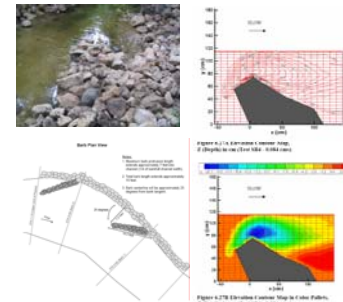
Stream barsbs can create areas of slow-moving backwater that induce near-bank depositional features and accelerate mid-channel flows that promote scour pool development. As a result, these structures enhance beneficial habitat for fish, amphibians, reptiles, and aquatic insects. The rootwads and barsbs built were all seeded with native species endemic to southern Wisconsin with deep extensive rooting systems.

Flow deflection techniques were also used to move the thalweg away from eroding banks toward the center of the channel; creating variable flows across the channel cross section.

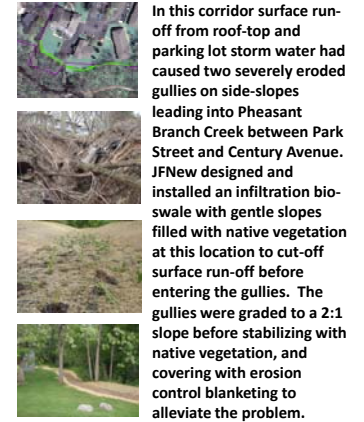
In this corridor surface run-off from roof-top and parking lot storm water had caused two severely eroded gullies on side-slopes leading into Pheasant Branch Creek between Park Street and Century Avenue. JFNew designed and installed an infiltration biowale with gentle slopes filled with native vegetation at this location to cut-off surface run-off before entering the gullies. The gullies were graded to a 2:1 slope before stabilizing with native vegetation, and covering with erosion control blanketing to alleviate the problem.

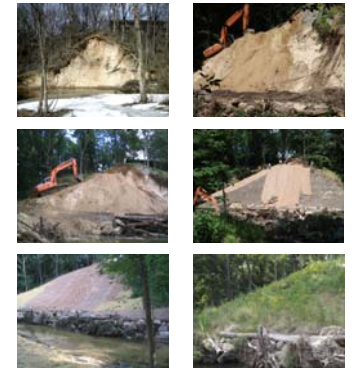
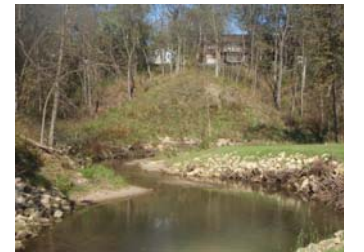
The stability and fertility of streambanks consisting of primarily sands throughout this reach was problematic. Many sites were graded to a more stable angle of repose and then covered with top soil to provide a better growing medium before planted with native vegetation.
