Effects of the Vernon Springs Dam Modification on Fishes in the Turkey River, Iowa.

Greg Gelwicks, Greg Simmons, and Megan Thul
Iowa DNR Fisheries Research

Vernon Springs Dam Modification

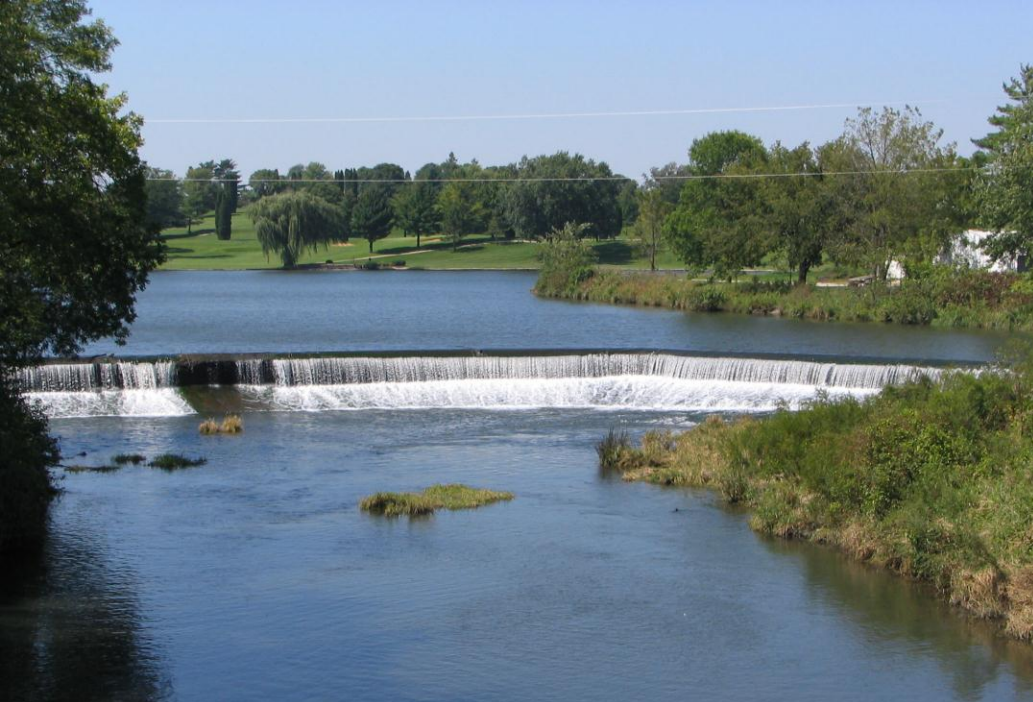
VERNON SPRINGS DAM TURKEY RIVER CRESCO, IOWA

250 feet long
8 feet high

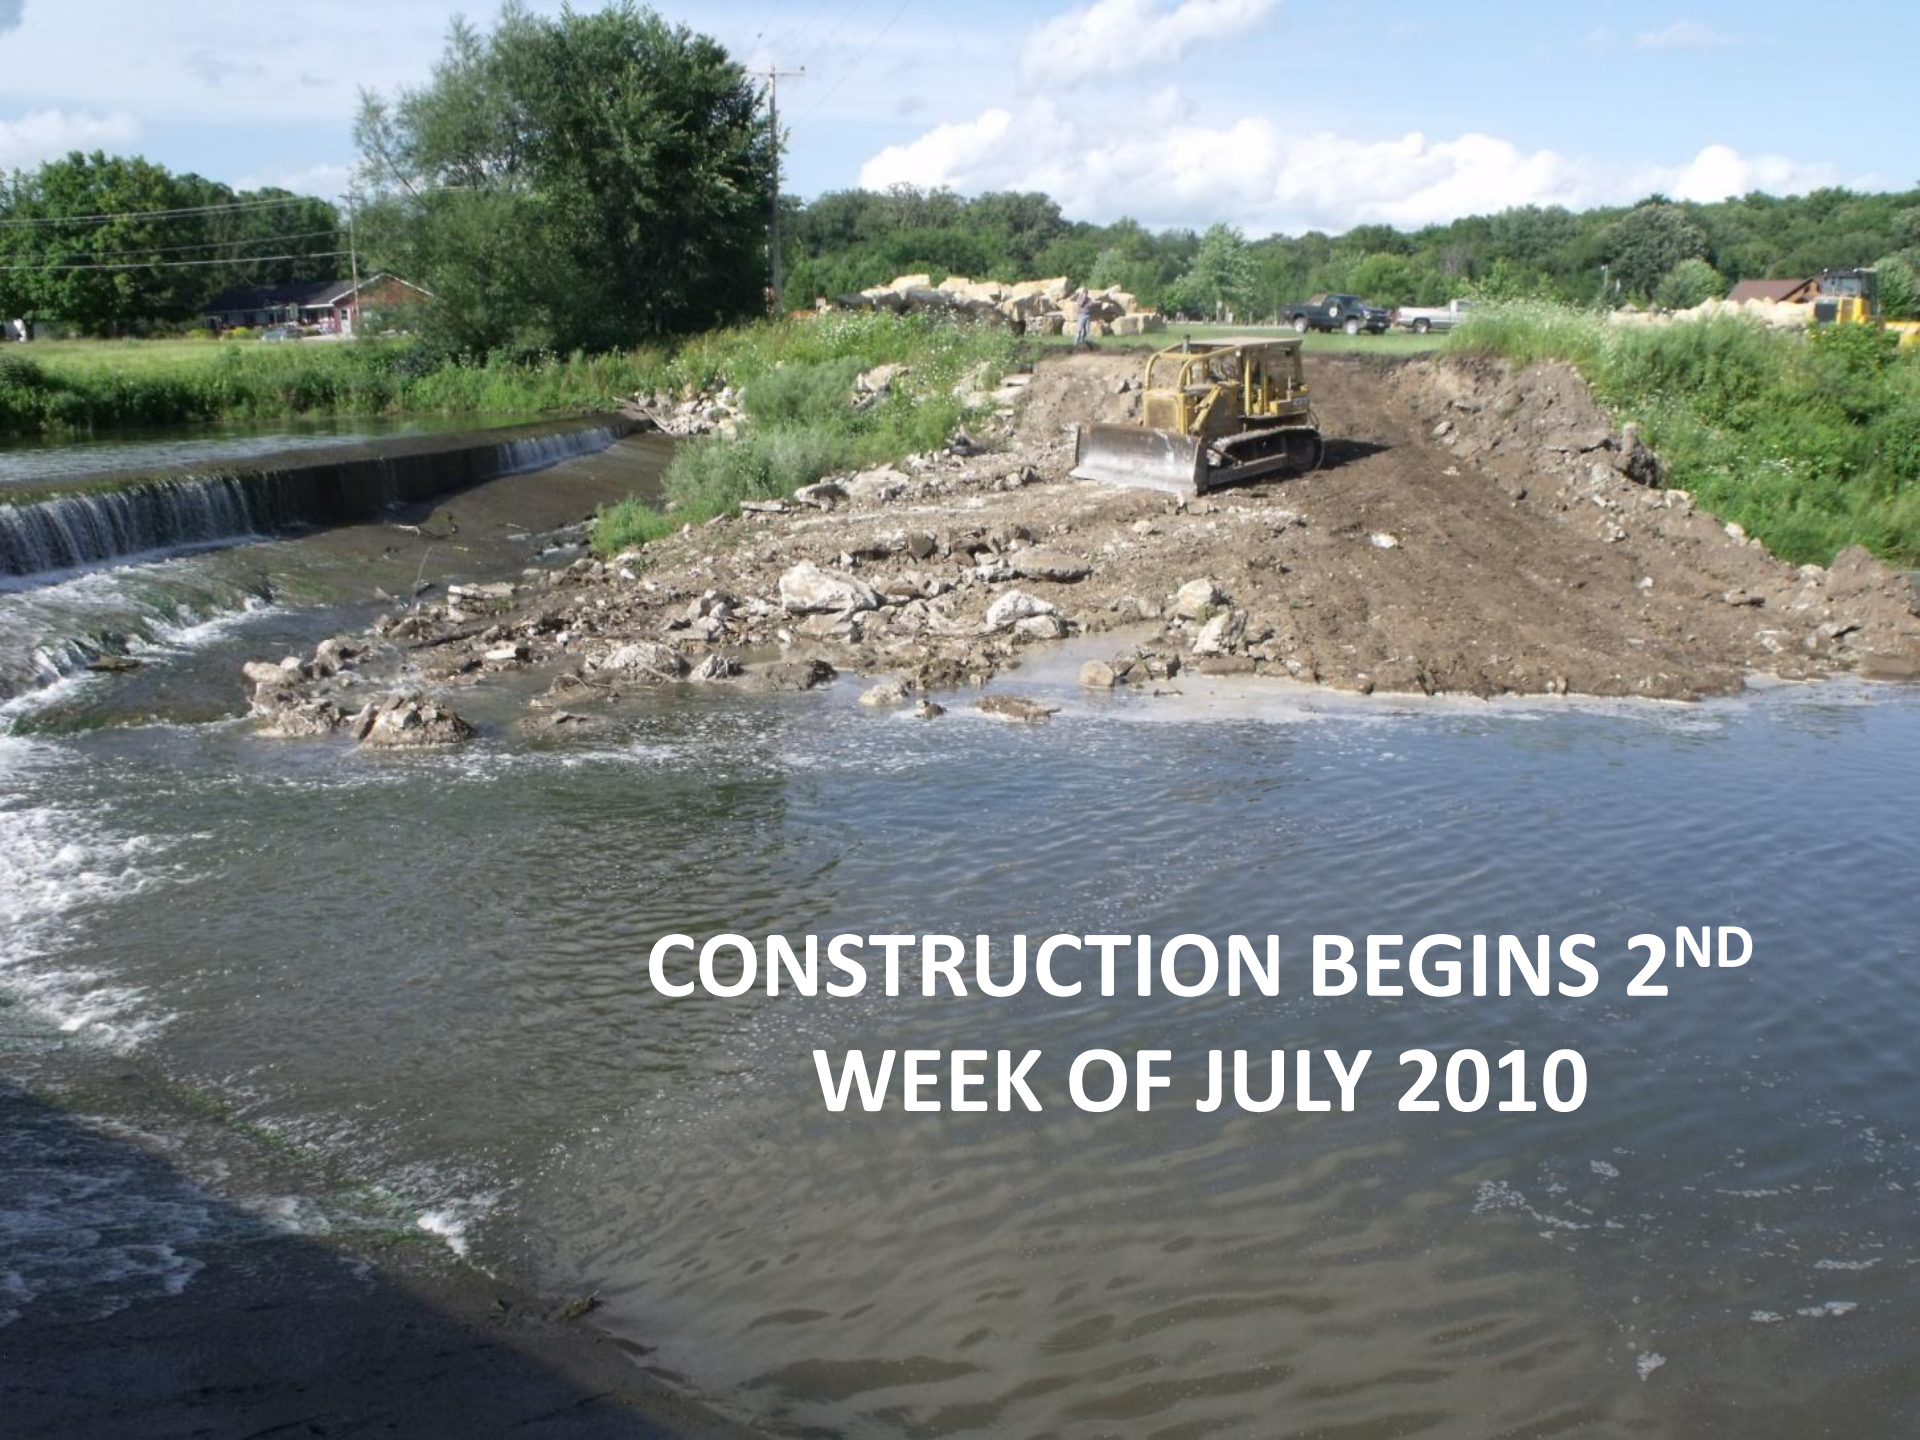
**CONSTRUCTION BEGINS 2ND
WEEK OF JULY 2010**

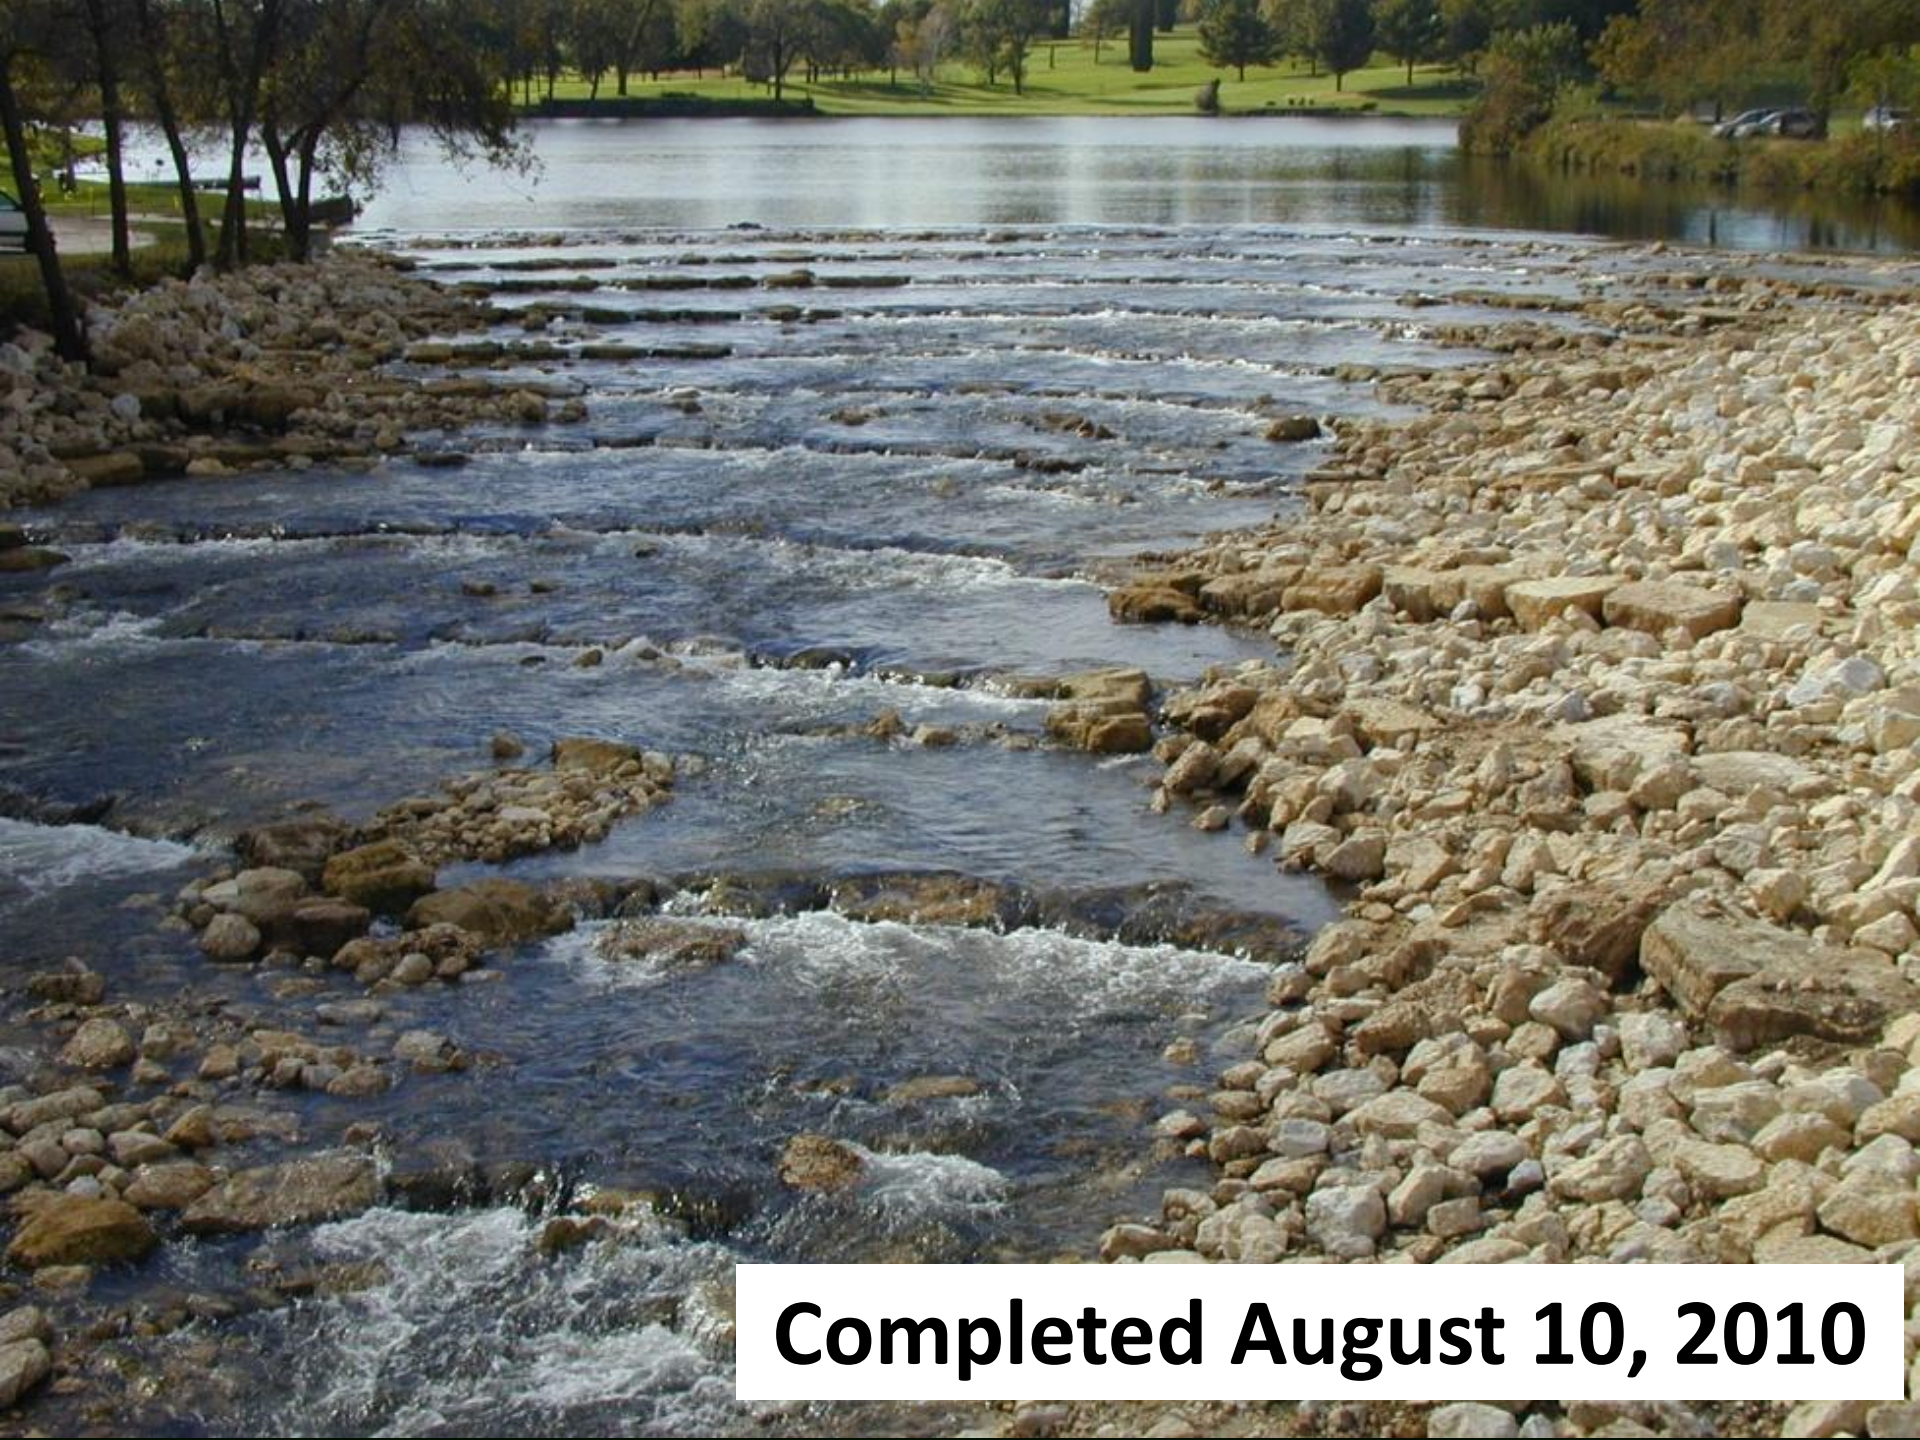
Completed August 10, 2010

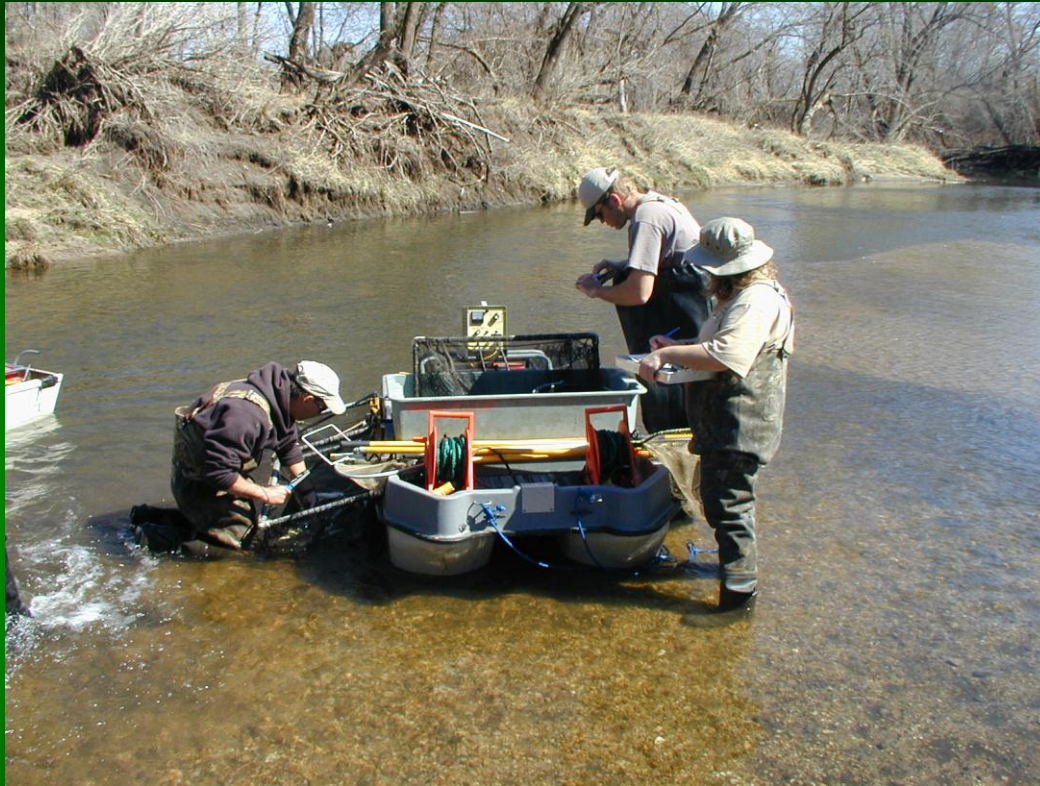
Fish Marking

Fish were marked downstream of the dam in 2008, 2009, and 2010

Pelvic fin clips – most fish

Third and fourth dorsal spine – Walleye and Centrarchids
