Knickpoint Migration in Western Iowa Streams

John Thomas – Hungry Canyons Alliance

Upper Midwest Stream Restoration Symposium
– February 2014

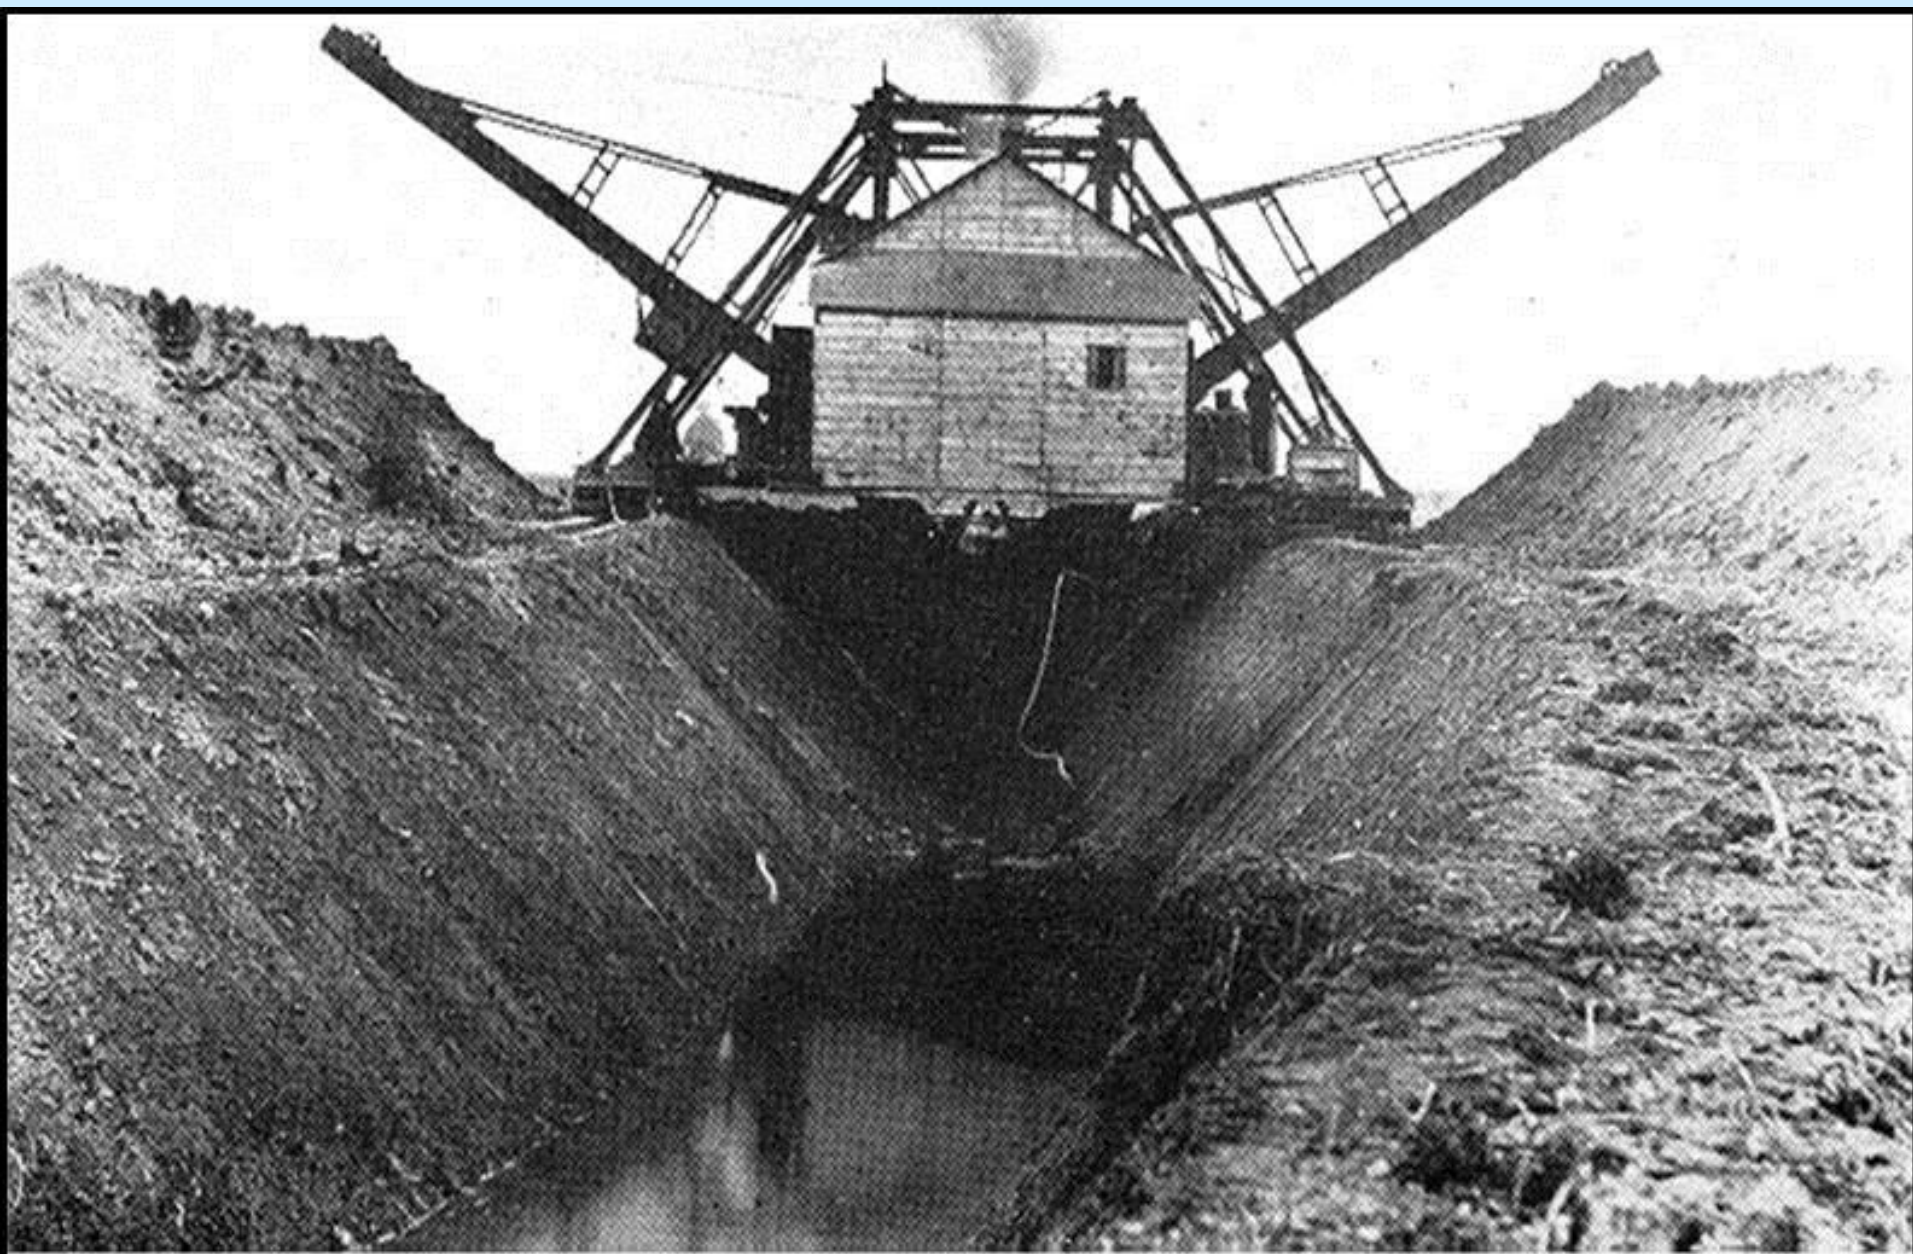
Excavating a large ditch using steam power, circa 1910.

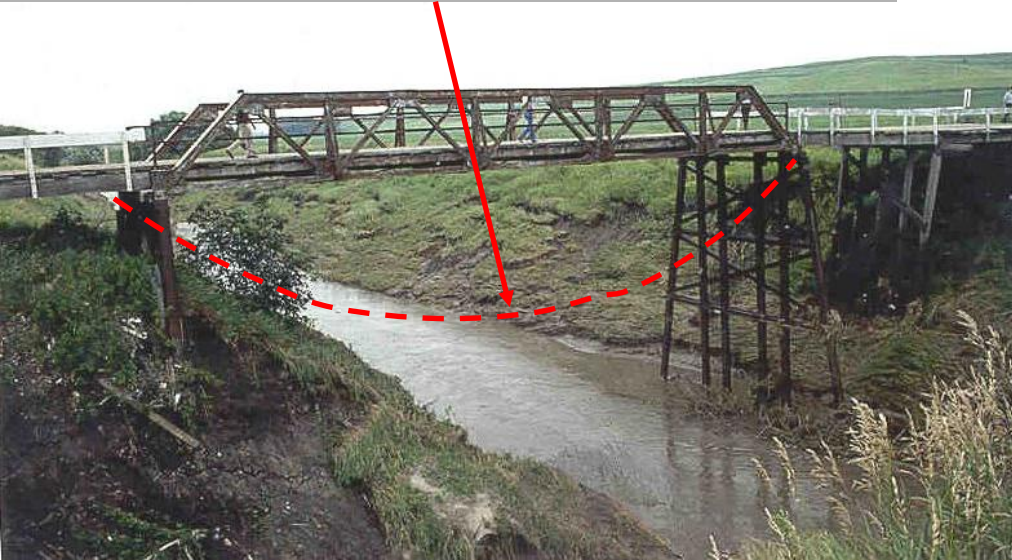
Consequences of knickpoint passage

Approx. old channel cross section

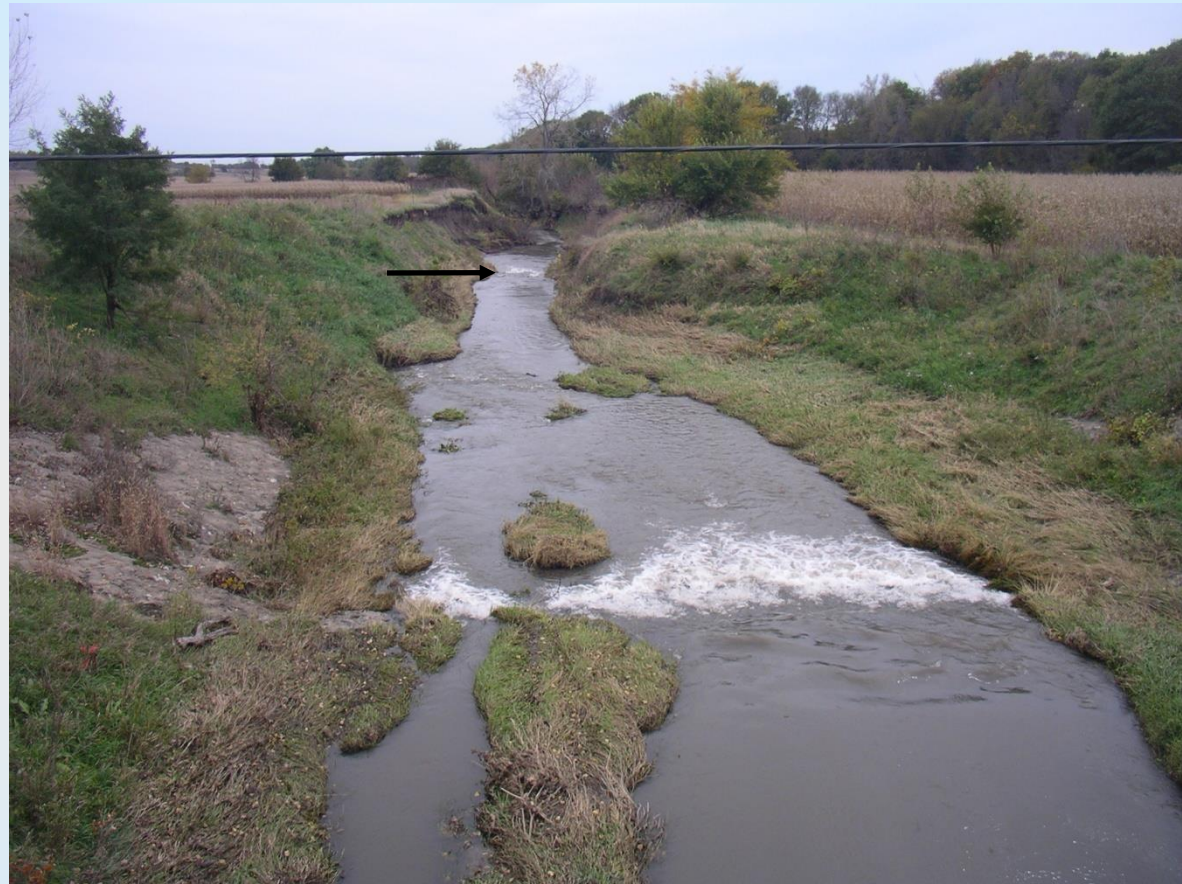
Knickpoint Study Site

Mud Creek DA – 97.5 km²

Rural agricultural landscape

Channel 4-5 m deep

Baseflow - knickpoint - 5 m wide and average flow depth 10 cm

Knickpoint DA – 85.5 km²

Weir and bridge upstream

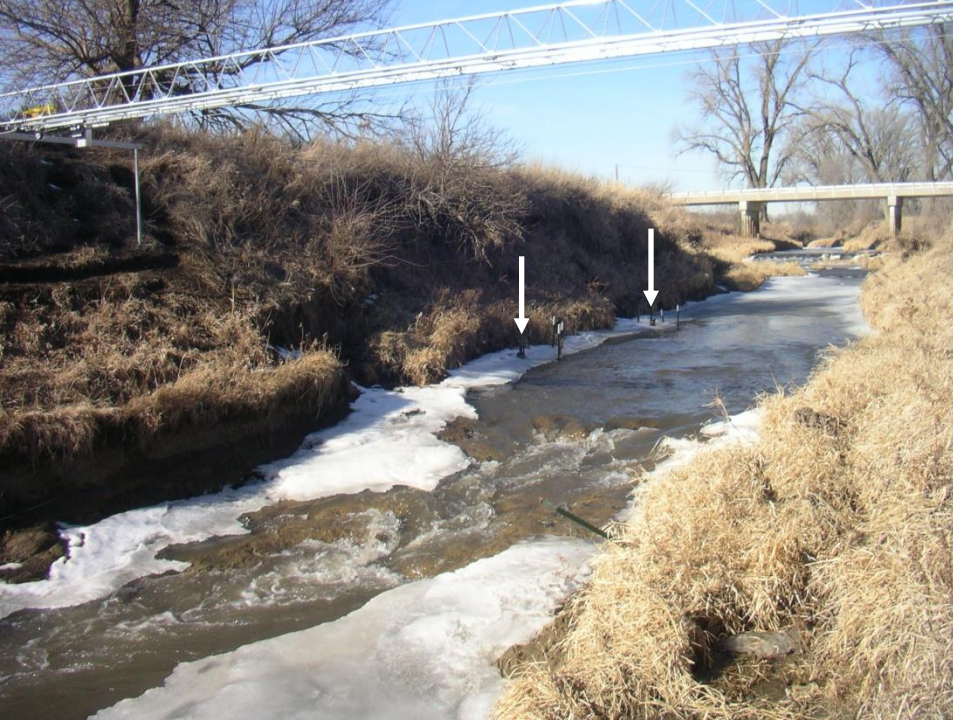
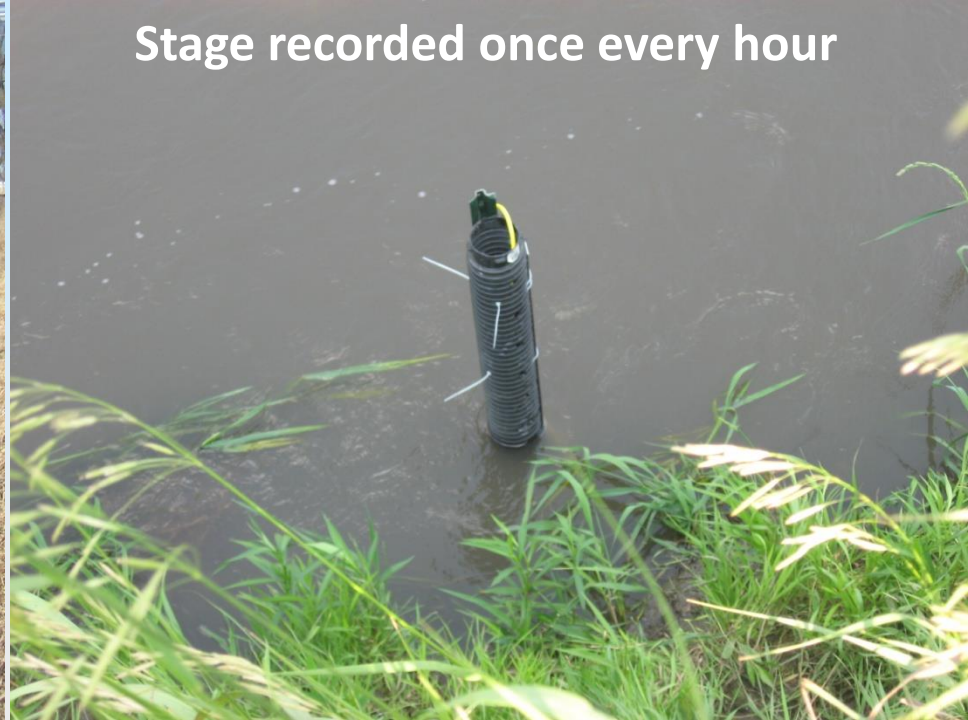
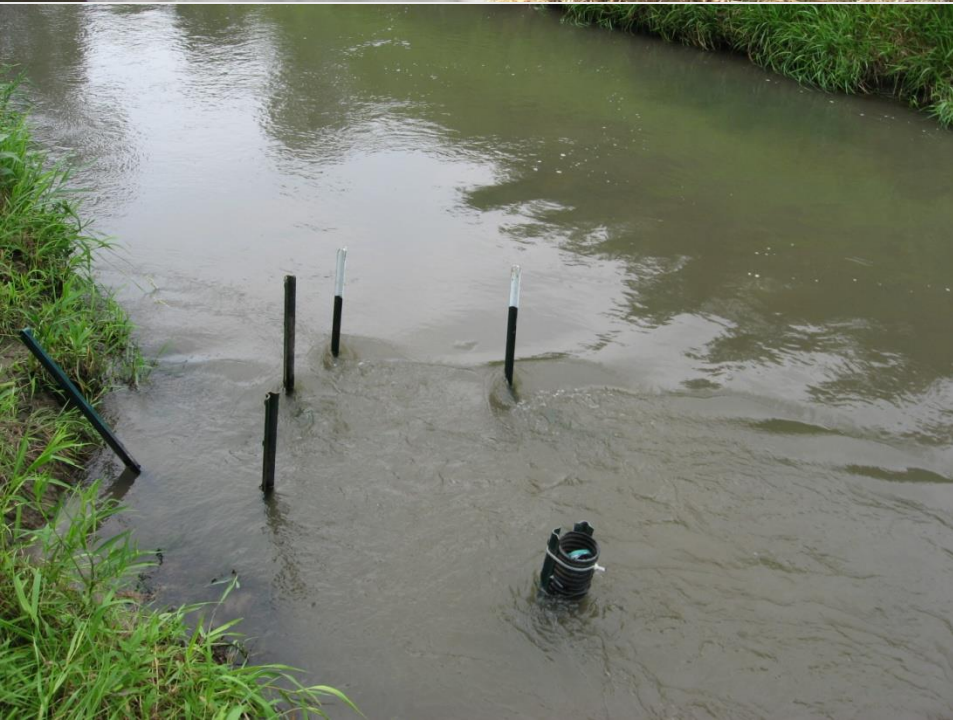
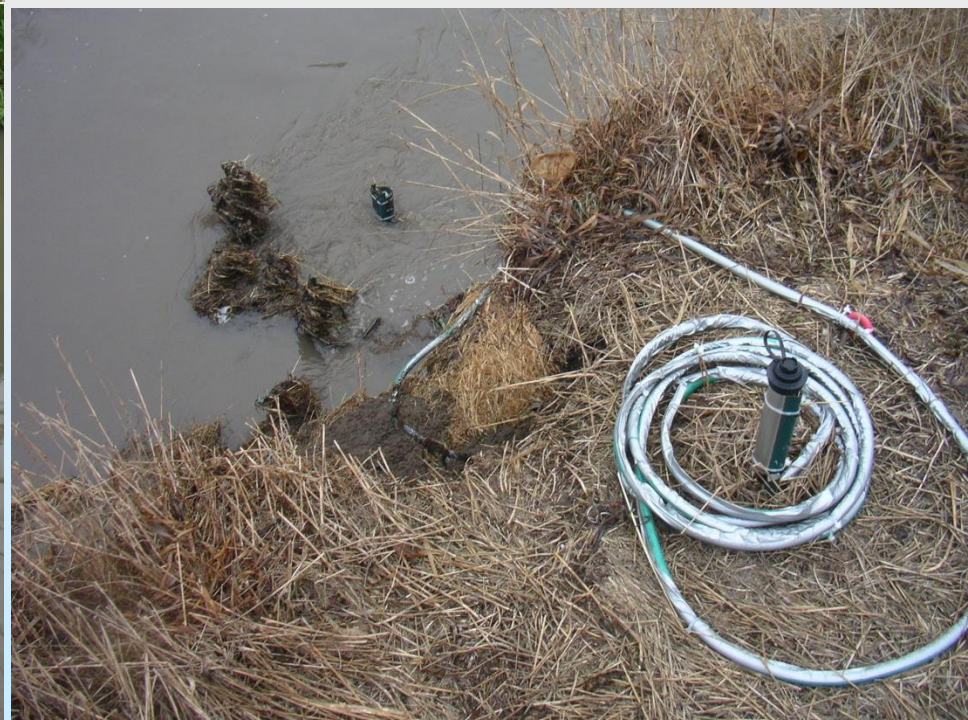
Stage recorded once every hour

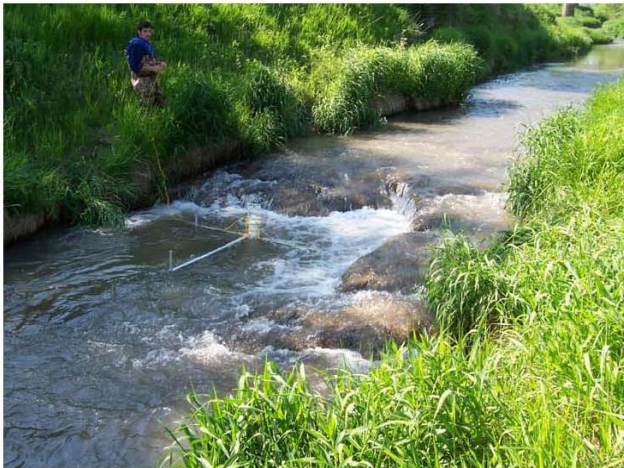
**Knickpoint on
May 21, 2006**

- 2006 knickpoint
 - 0.7 m drop from knickpoint lip to scour hole base
 - Another 0.6 m drop in elevation underwater 6 m downstream
- 2007 knickpoint
 - retreated 1.8 m
 - scour hole had expanded in width and depth
- Linear channels upstream from the knickpoint lip
 - Possibly caused by passage of past knickpoints leaving a scar on channel bed

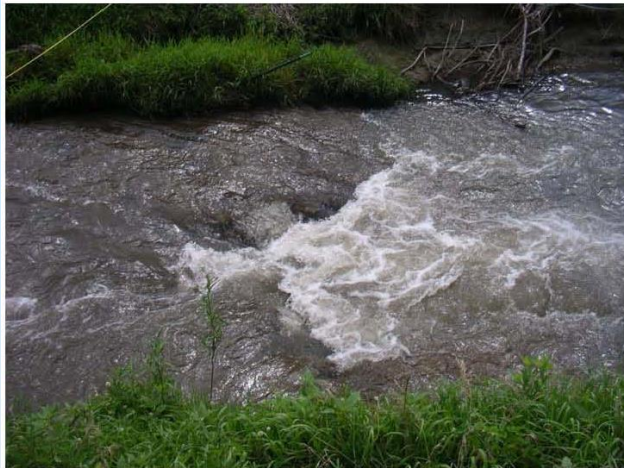
**Knickpoint on
July 23, 2008**

- 2008 knickpoint
 - Finger-like projection extended upstream, funneling majority of water going over knickpoint
- 2008 knickpoint
 - Retreated 3.6 m between February 11 and March 3, 2009 along path of finger-like projection
 - Deep narrow channel bypassed knickpoint ledge sediment on either side and scour hole created US
 - Only baseflow during this period

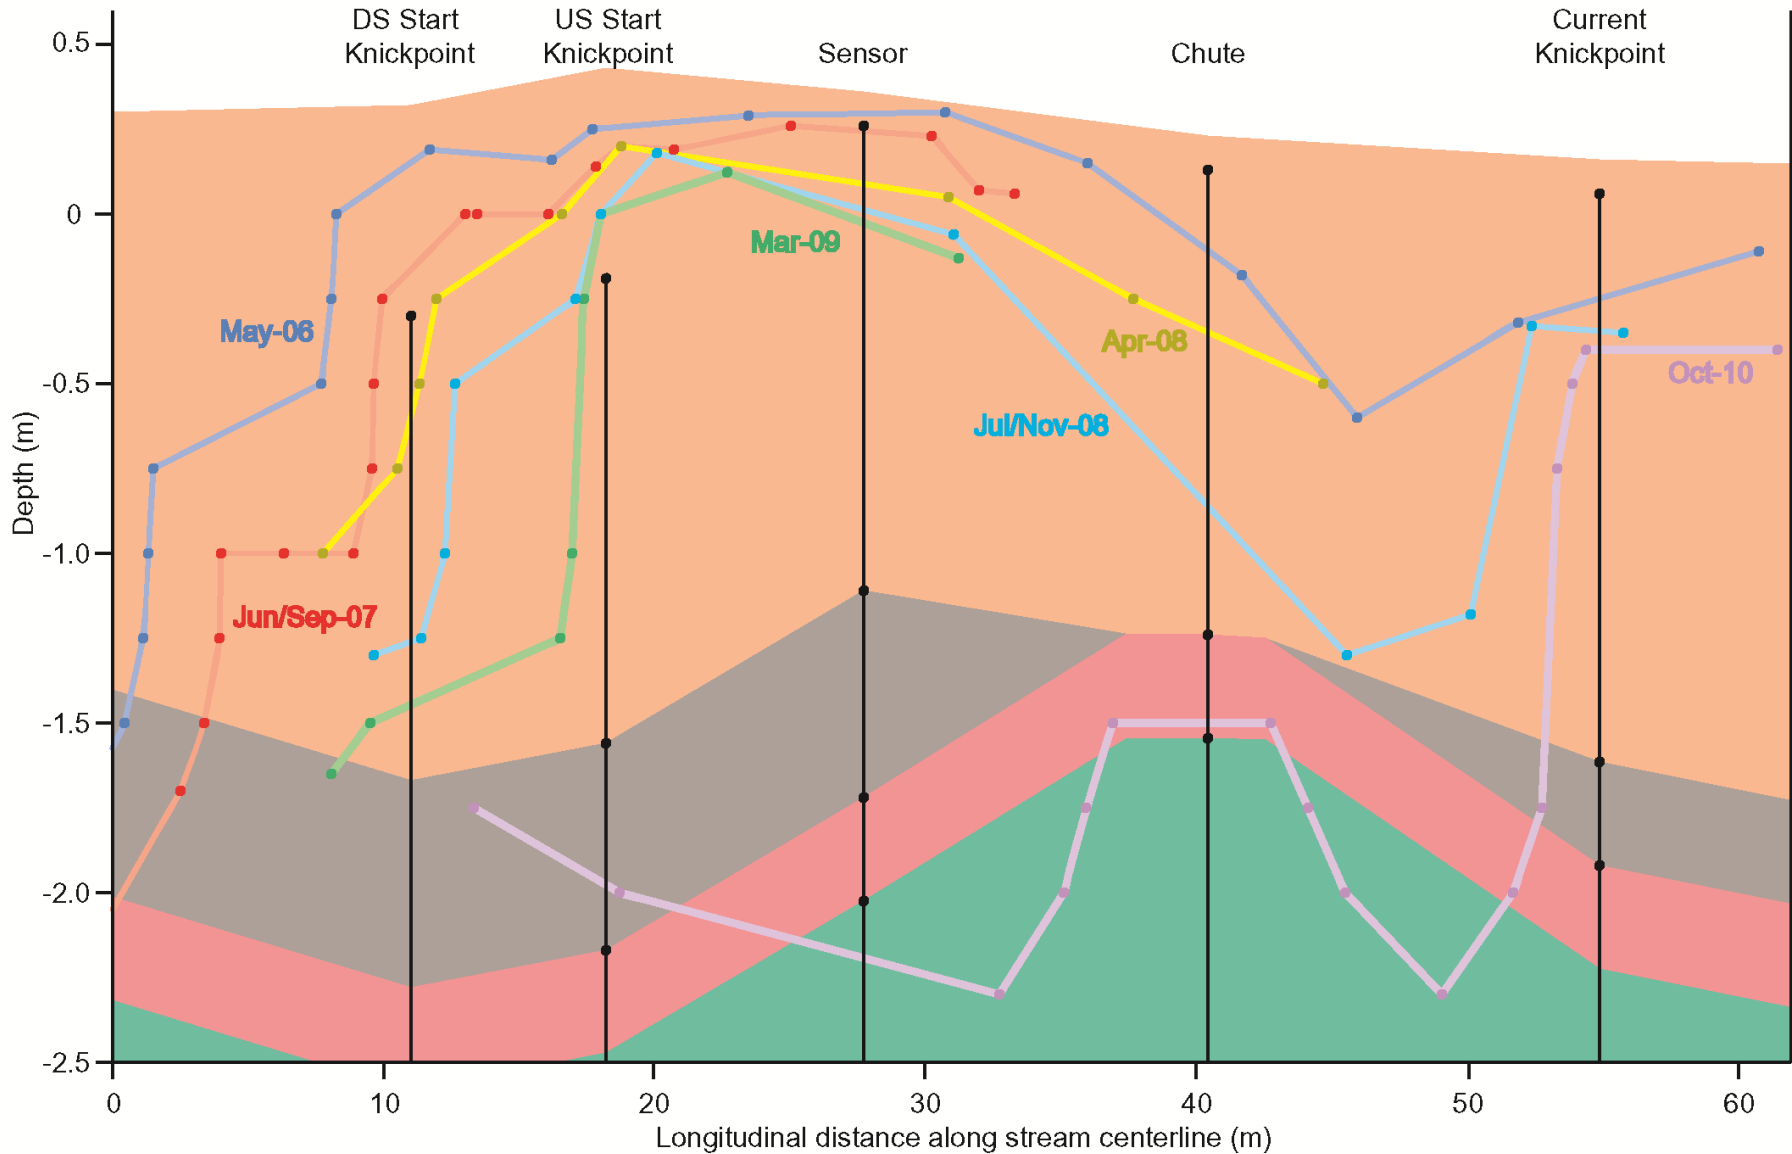
Channel Bed Erodibility/Lithology and Knickpoint Profiles

= Silt Loam
 = Loam
 = Sand
 = Sandy Loam

- Between April and August 2010 knickpoint retreated 30.5 m
 - No significant snowmelt or rain events
 - Another example of little change in driving stresses (flow) but had rapid retreat
- Look closer at stratigraphy
 - Boreholes into streambed
 - Stratigraphic diagram shown later extrapolates stratigraphy using these boreholes, deep boreholes on banks, and photographs

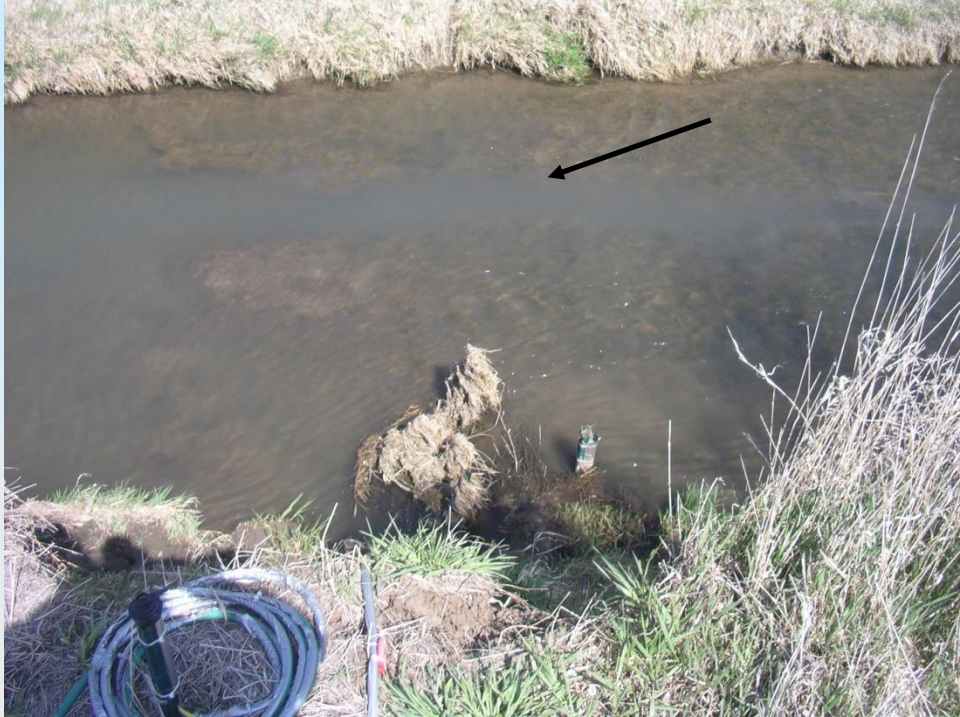
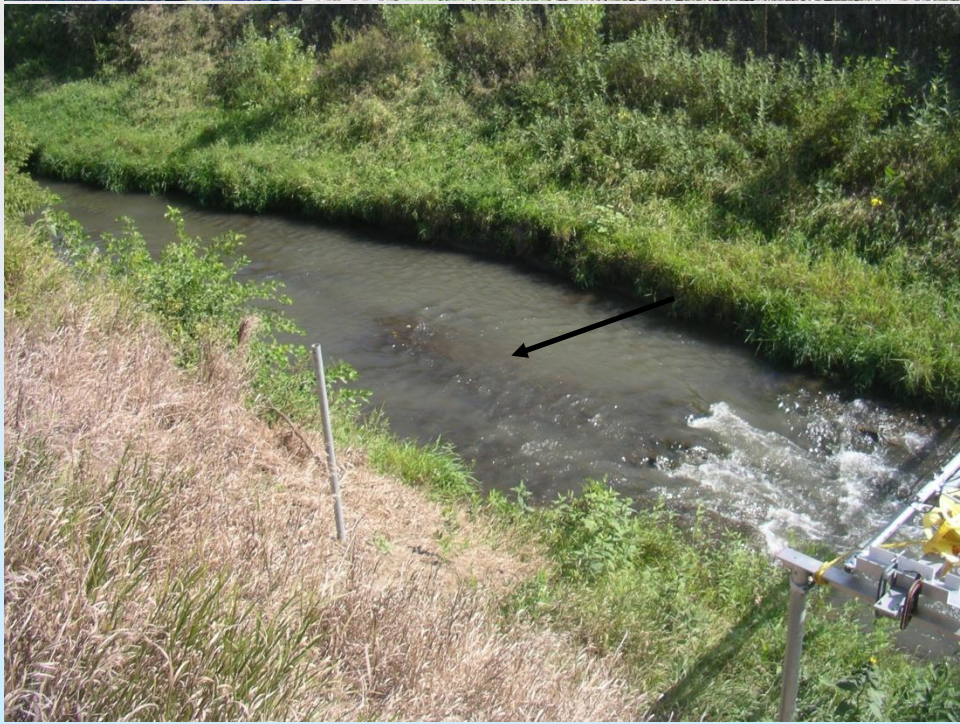
Erosional Topography

- Caused by presence and propagation of multiple knickpoints in series
 - Current streambed and knickpoint surface is scar of passage of past knickpoints
- rapid knickpoint migration – little channel bed scour – become exposed ledges through which future knickpoints migrate
- slow knickpoint migration – high channel bed scour and deep, large scour holes – remain pools between future knickpoints

- Presence and propagation of multiple knickpoints in series cause erosional topography
 - Current knickpoint is bed scar of past knickpoints
- Other factors in knickpoint erosion
 - Not direct causes of knickpoint retreat
 - Abrasive scour of krotovina potholes may be areas of weakness through which knickpoint advances
 - Areas of unfocused flow exposed to weathering may become more erodible and probable area of focused flow in future
 - Formation of ice over knickpoint
 - Pipe-like flow under the ice – fluvial erosion of surface
 - Plucking and removal of large sediment blocks

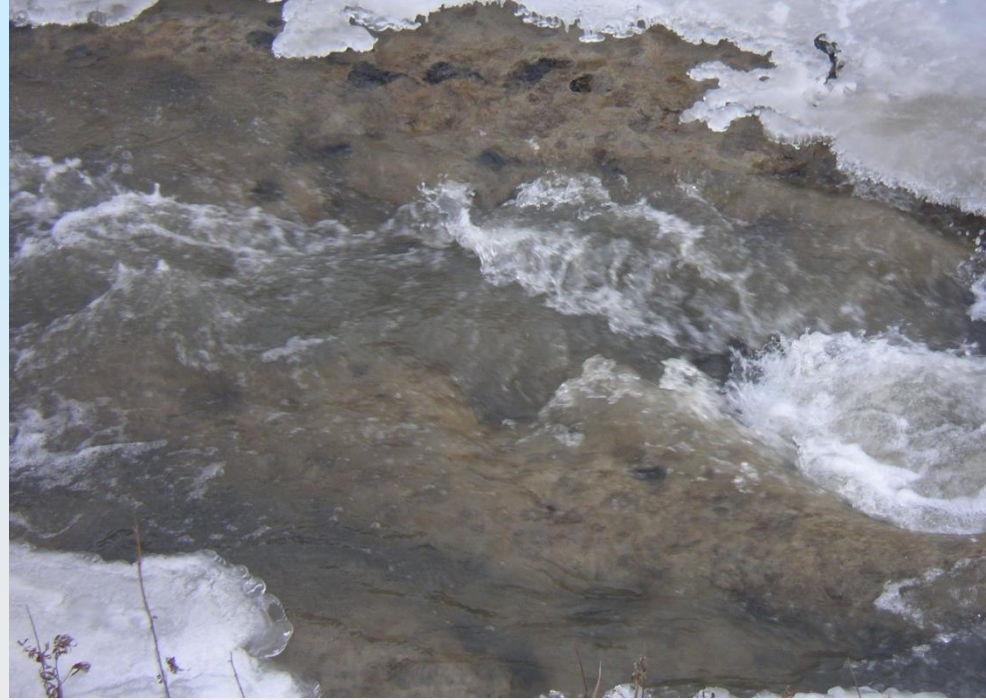
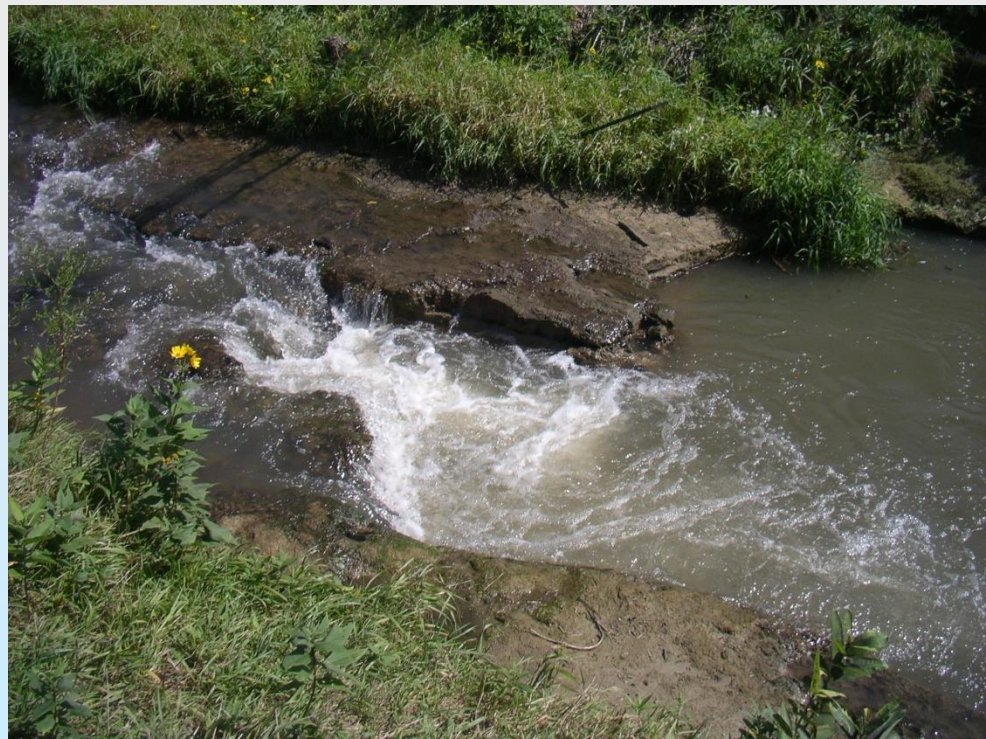
Other Factors in Knickpoint Migration

- Abrasive scour of krotovina potholes may be areas of weakness through which knickpoint advances
- Areas of unfocused flow exposed to weathering may become more erodible and probable area of focused flow in future
- Pipe-flow during ice-over conditions and plucking

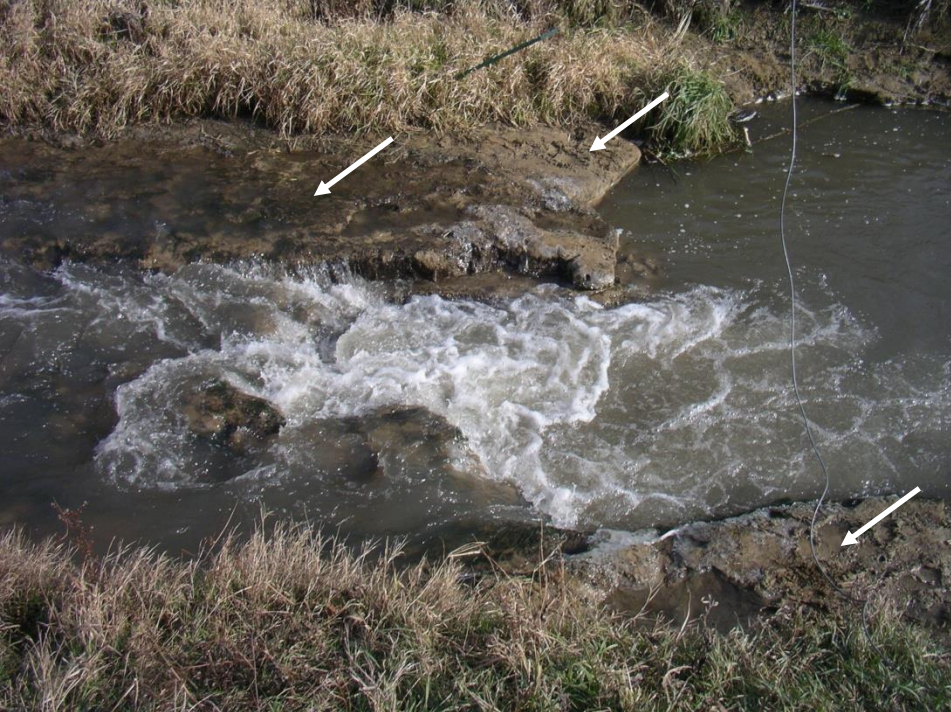
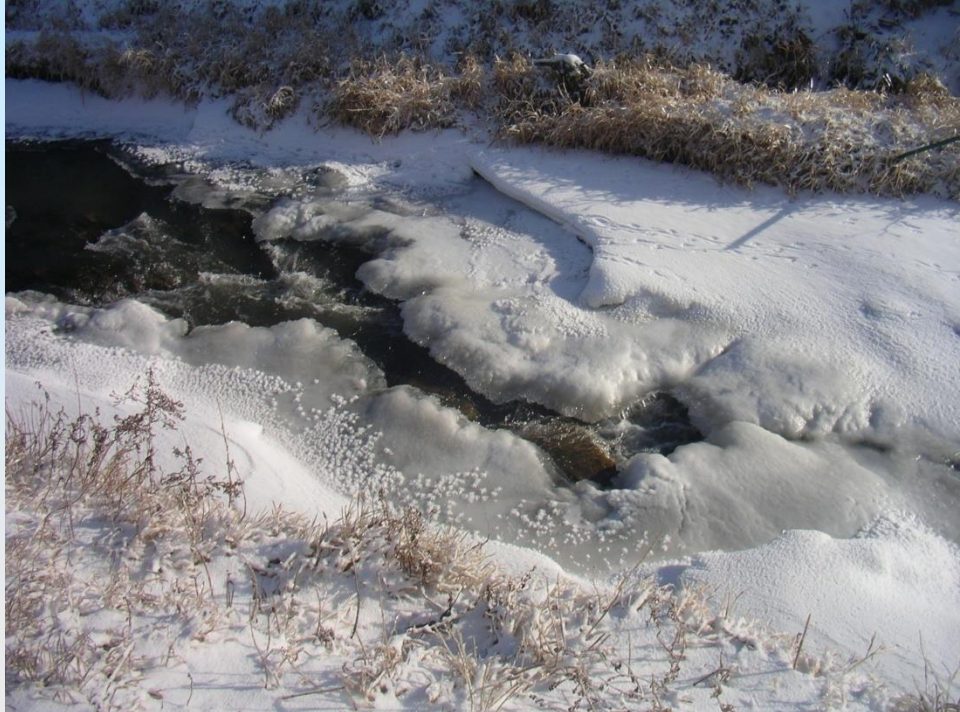
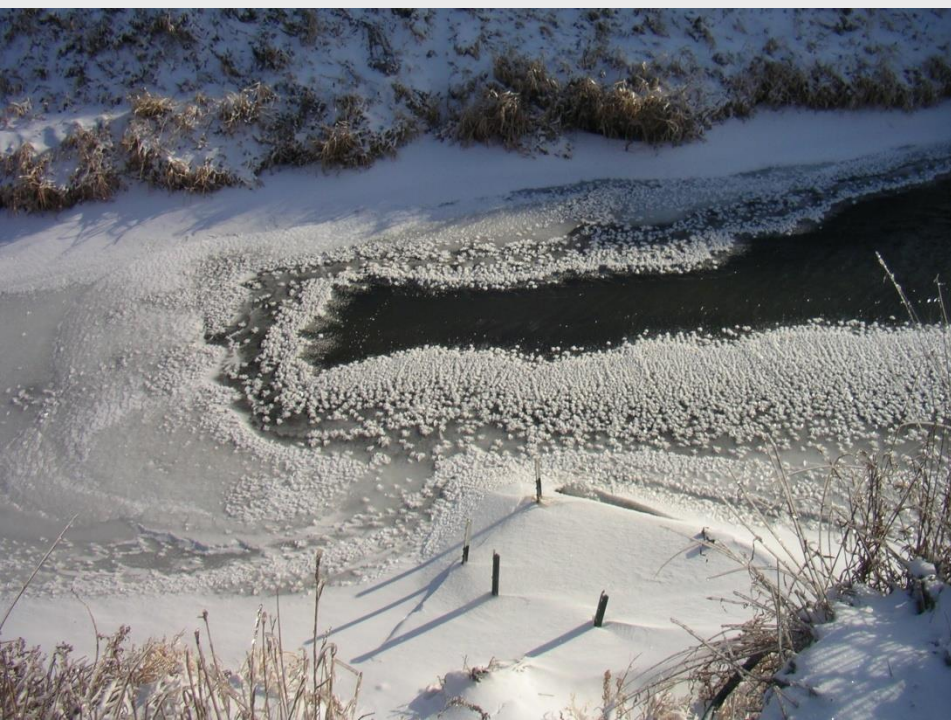
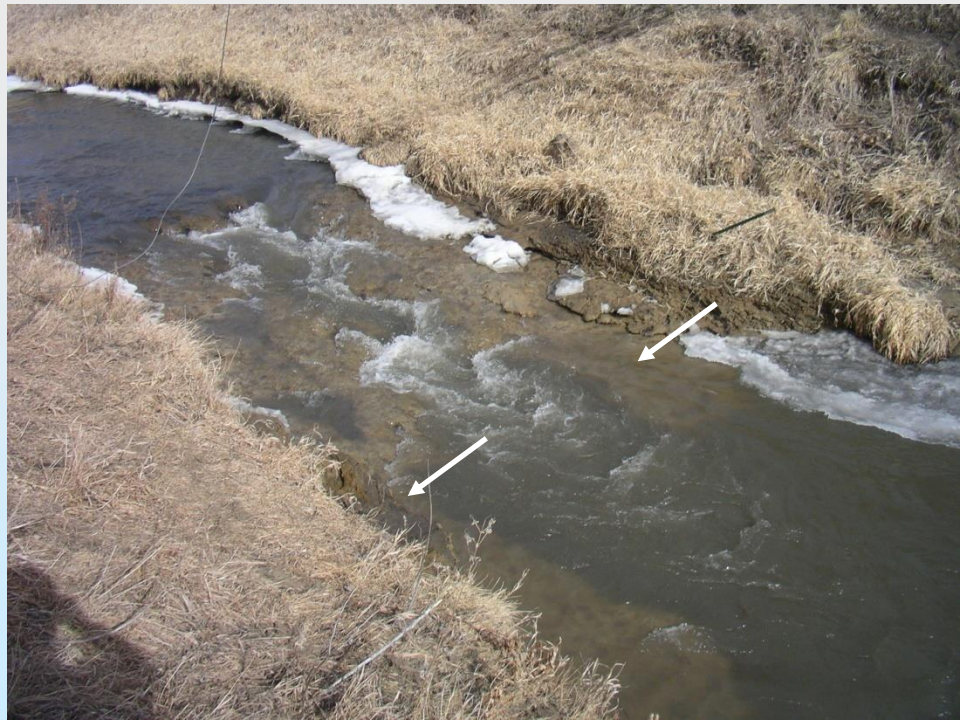
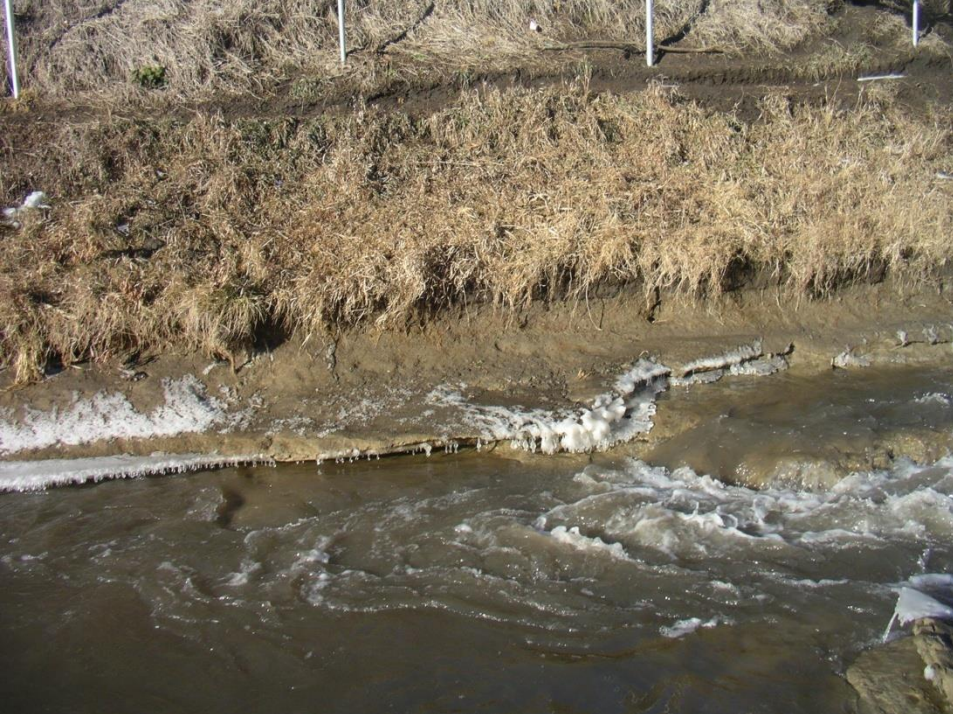
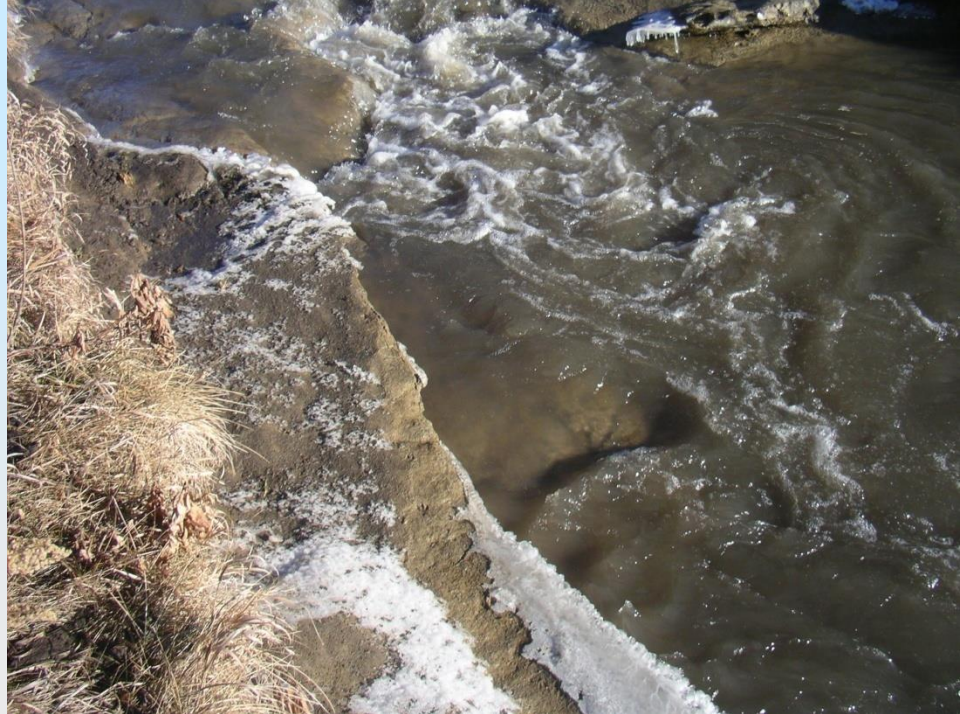
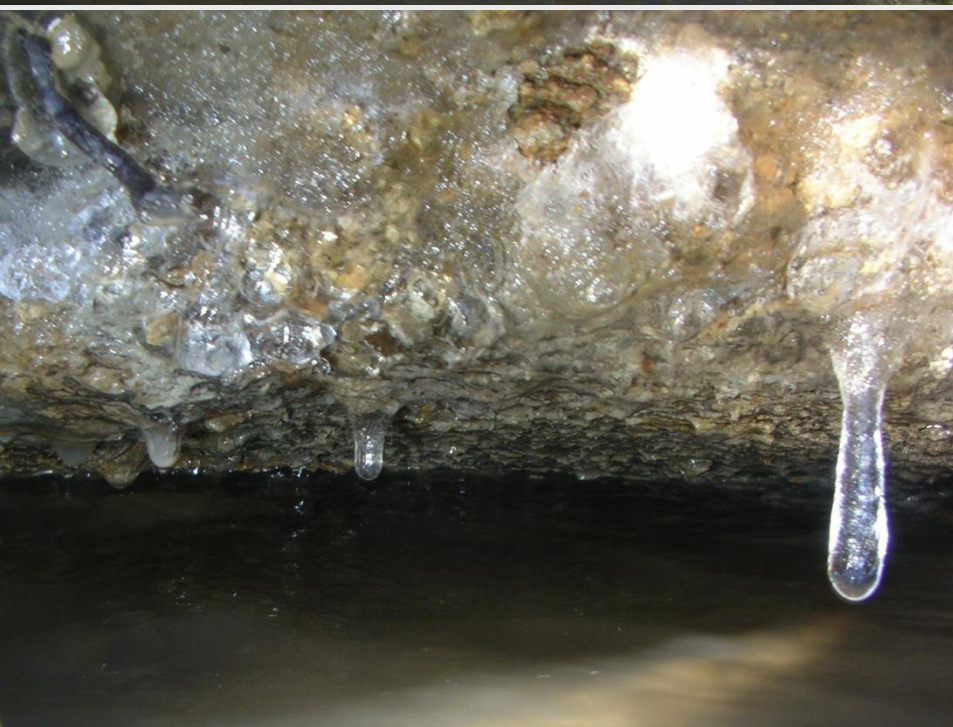
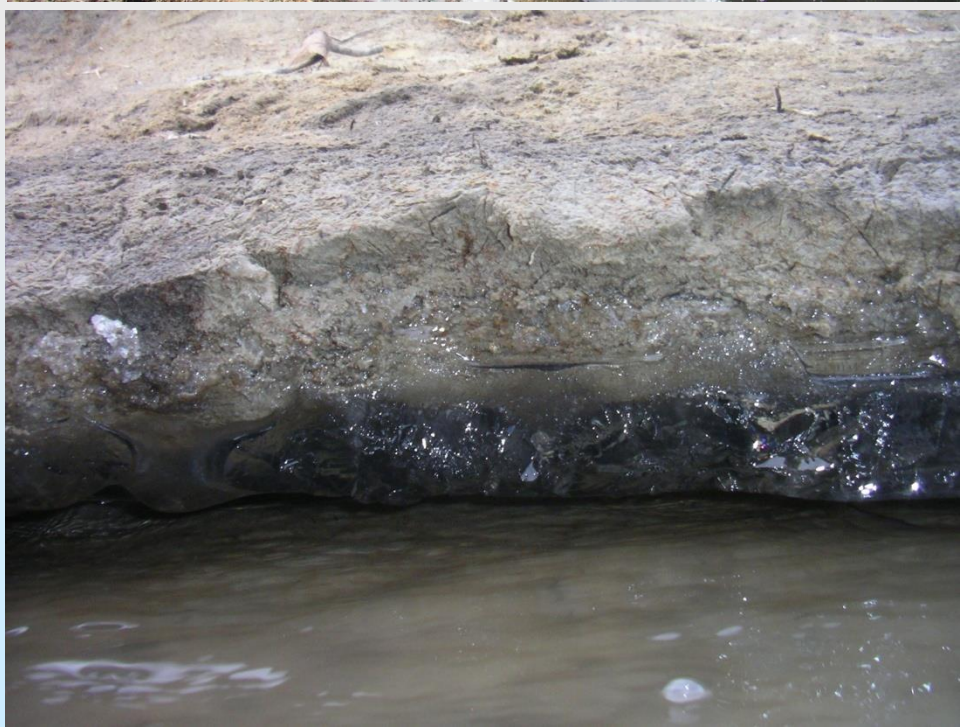
- Ice froze to knickpoint bed surface during extended cold spell
- Large snow melt event
 - Temperatures warmed more than 40°F in one day

- Several large blocks of sediment plucked and moved due to buoyancy of ice
- Segregation ice observed on detached block
- Block likely plucked along similar segregation ice layer
