STREAMBANK STABILIZATION OF A CONSTRICTED CHANNEL USING STORMWATER WETLANDS

Michael J. Malon

Resource Conservationist, Jo Daviess County Soil and Water Conservation District, Elizabeth, Illinois

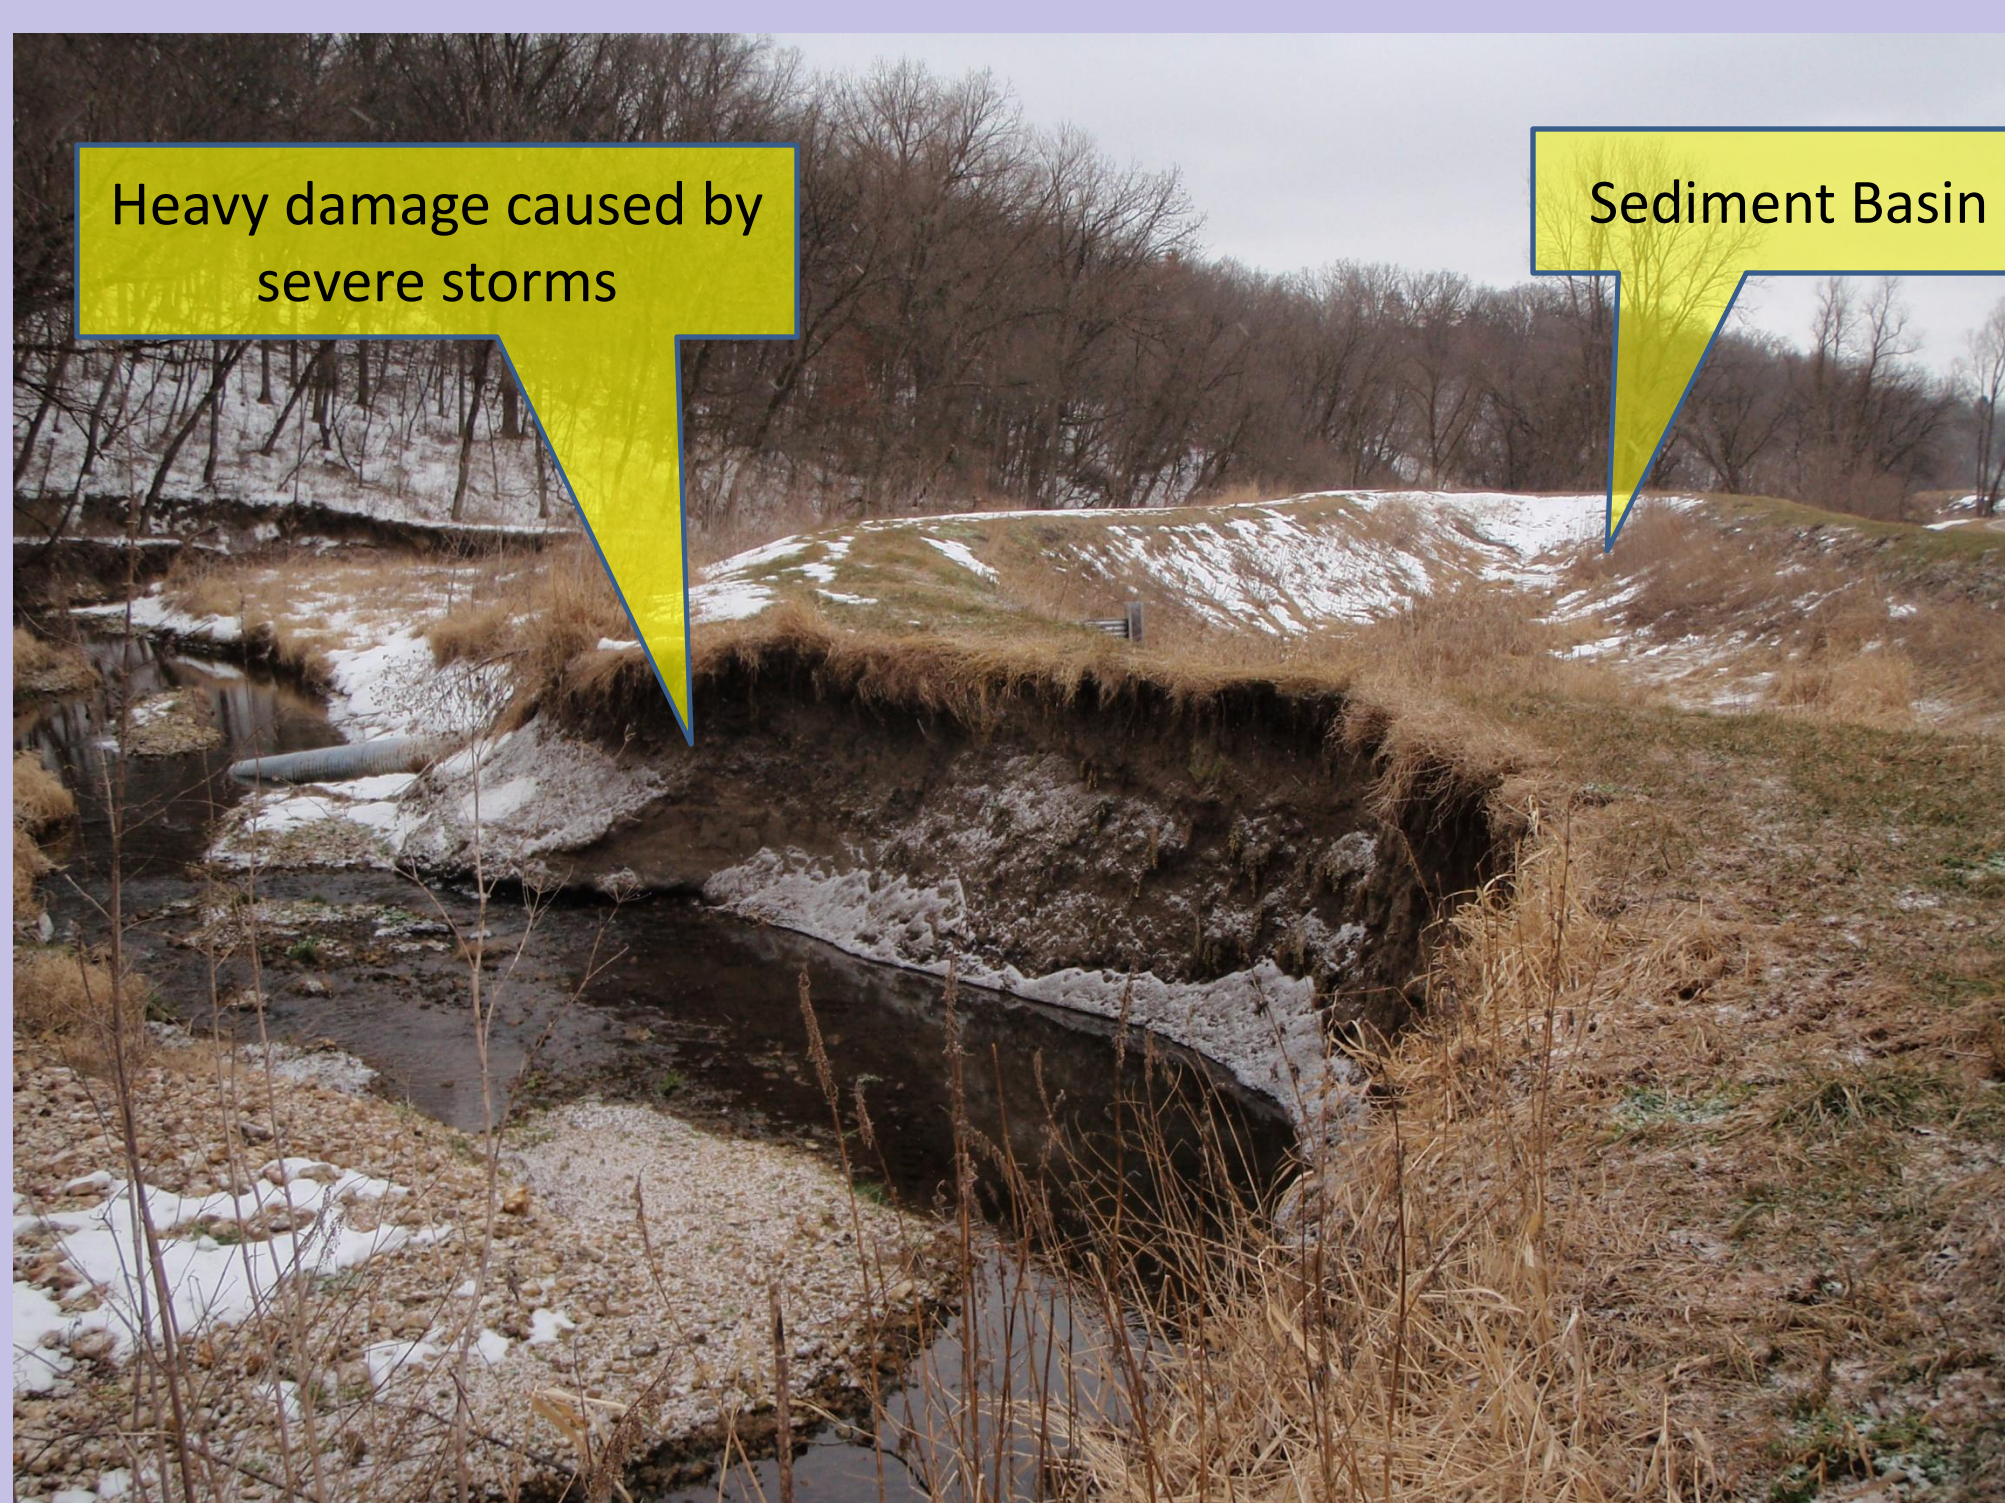
Looking downstream showing stream bank erosion and damage to water and sediment basin infrastructure.

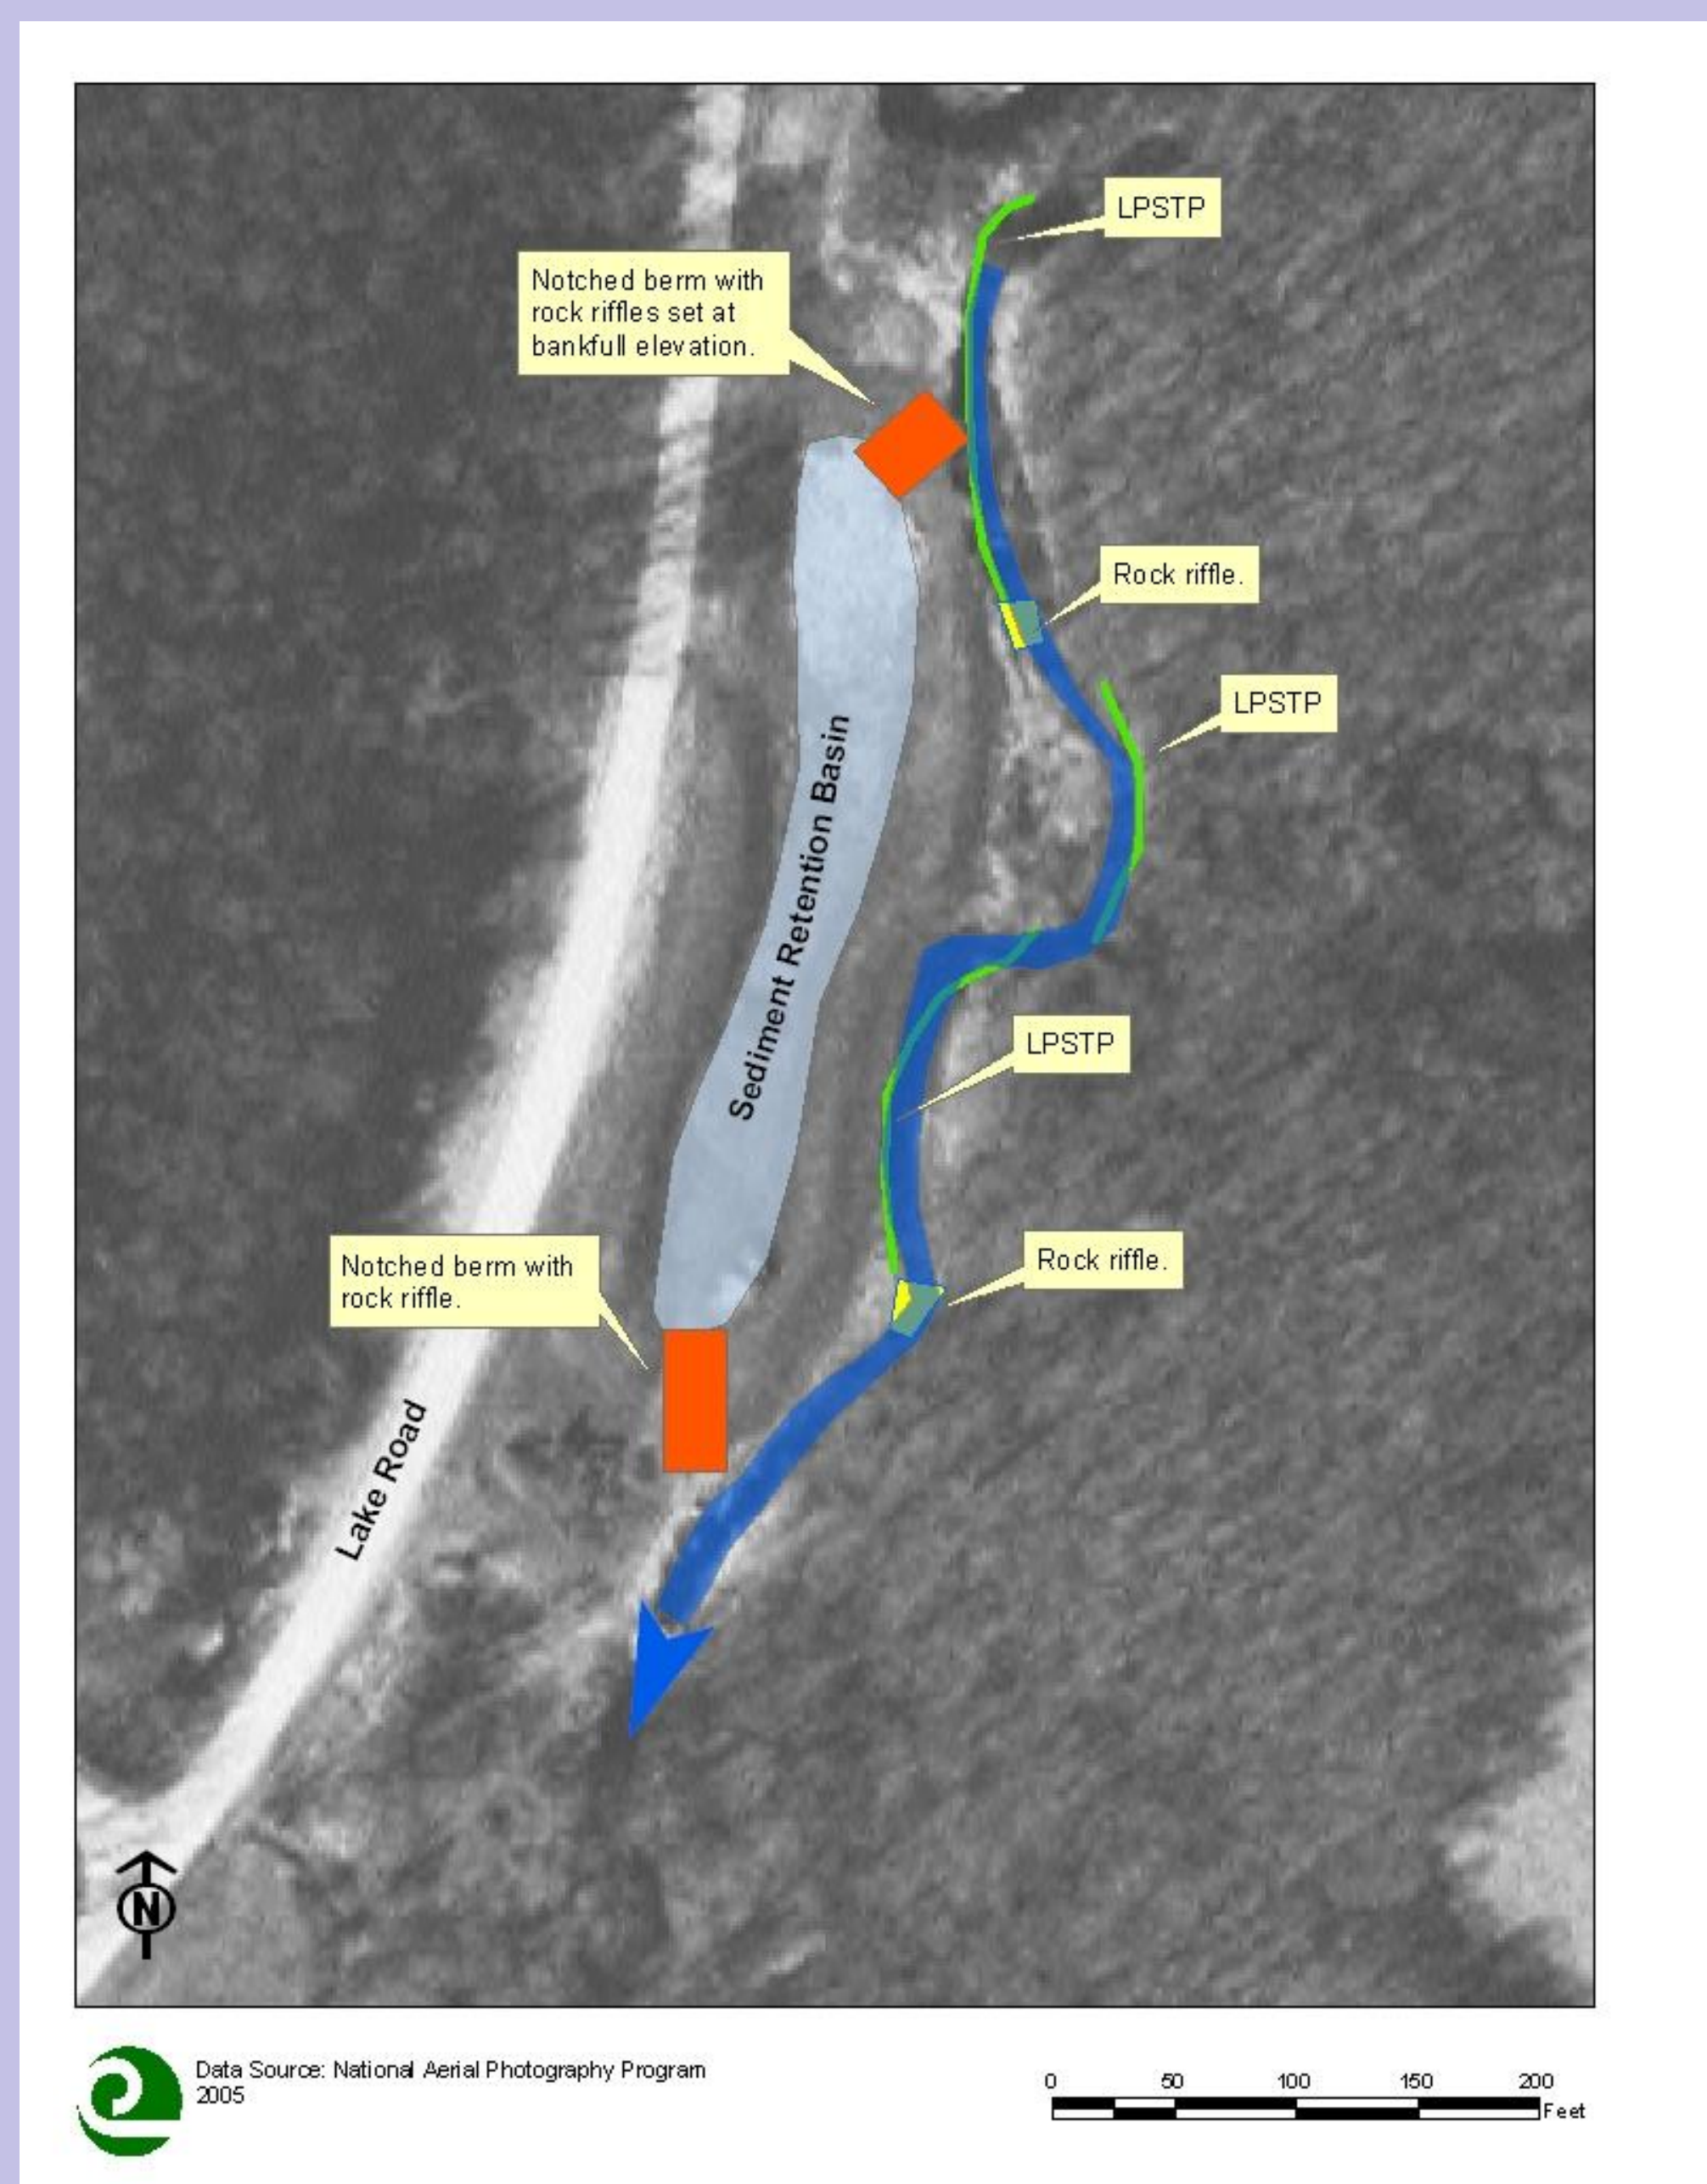
Plan Map

- The basin was converted to a wetland area to relieve out of bank flow and capture sediment and nutrients.
- The berm forming the basin walls was notched at the North and South ends. The entrance notch at the North end was set with a low grade at the bankfull elevation of the stream and protected with RR-5 rock.
- The downstream end was opened and stabilized with a rock-riffle terminating at the elevation of the adjacent stream.
- During out of bank flows this reconstructed wetland offers 17,500 cubic feet of storage and 1.2 minutes of residence time.
- Grade control was implemented in the stream channel with two rock riffles to help connect the stream with the small floodplain where it existed.
- Longitudinal peaked stone toe protection (LPSTP) was used on eroded corners. The stream channel was moved on one severe corner to reduce radius of curvature.

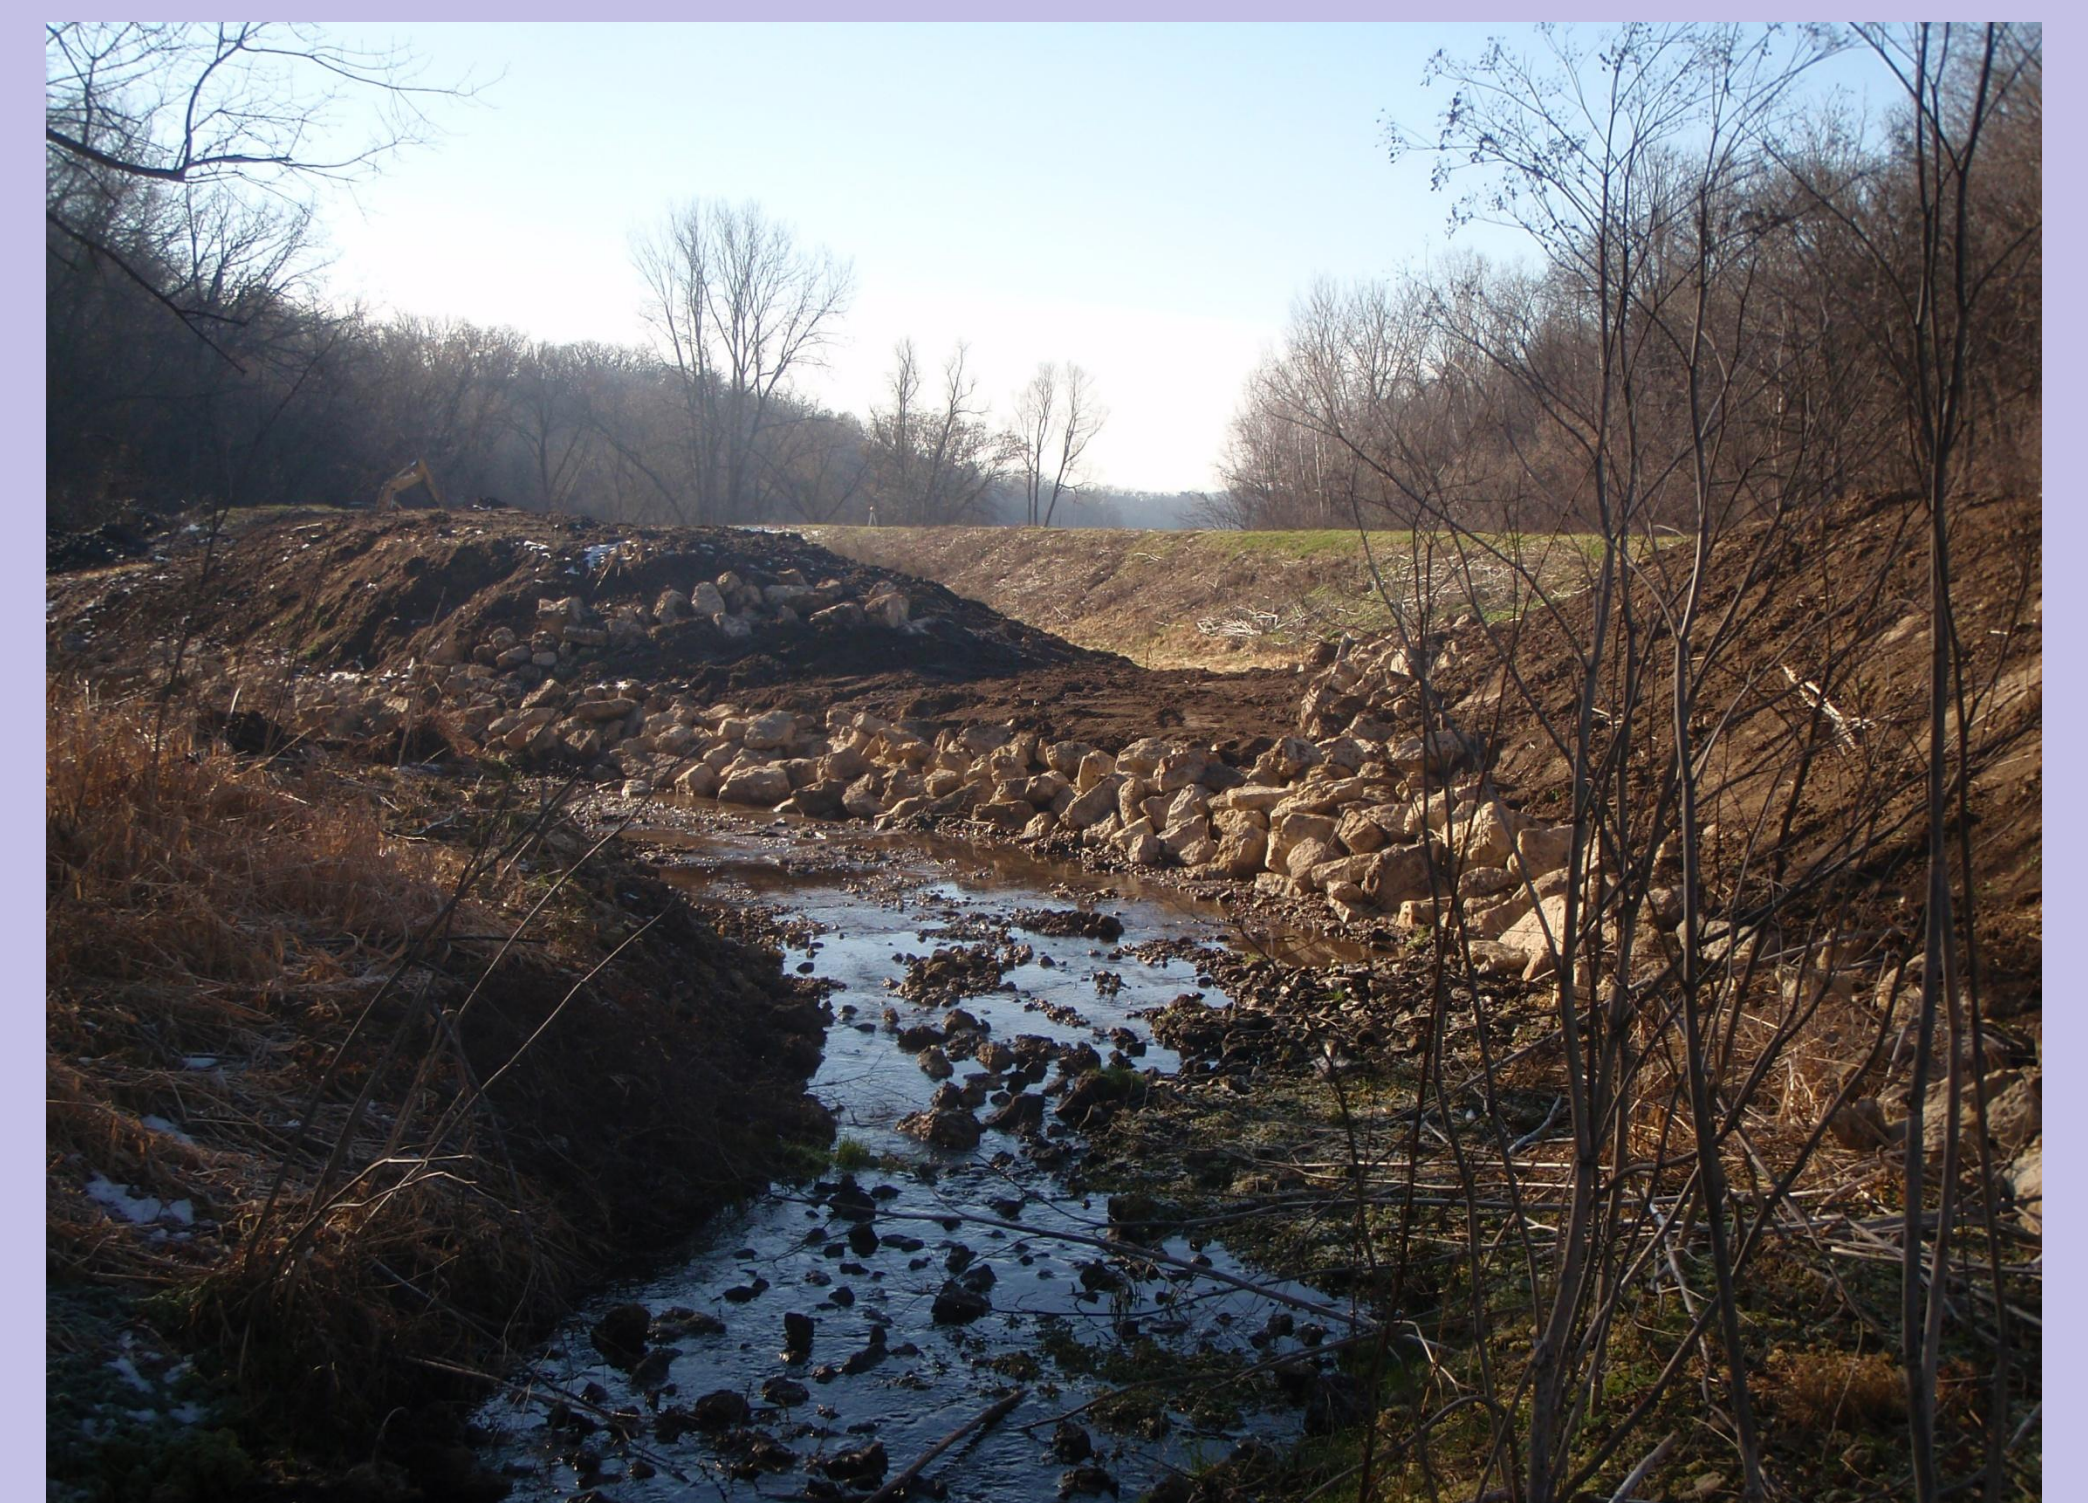
LPSTP and inlet to wetland.

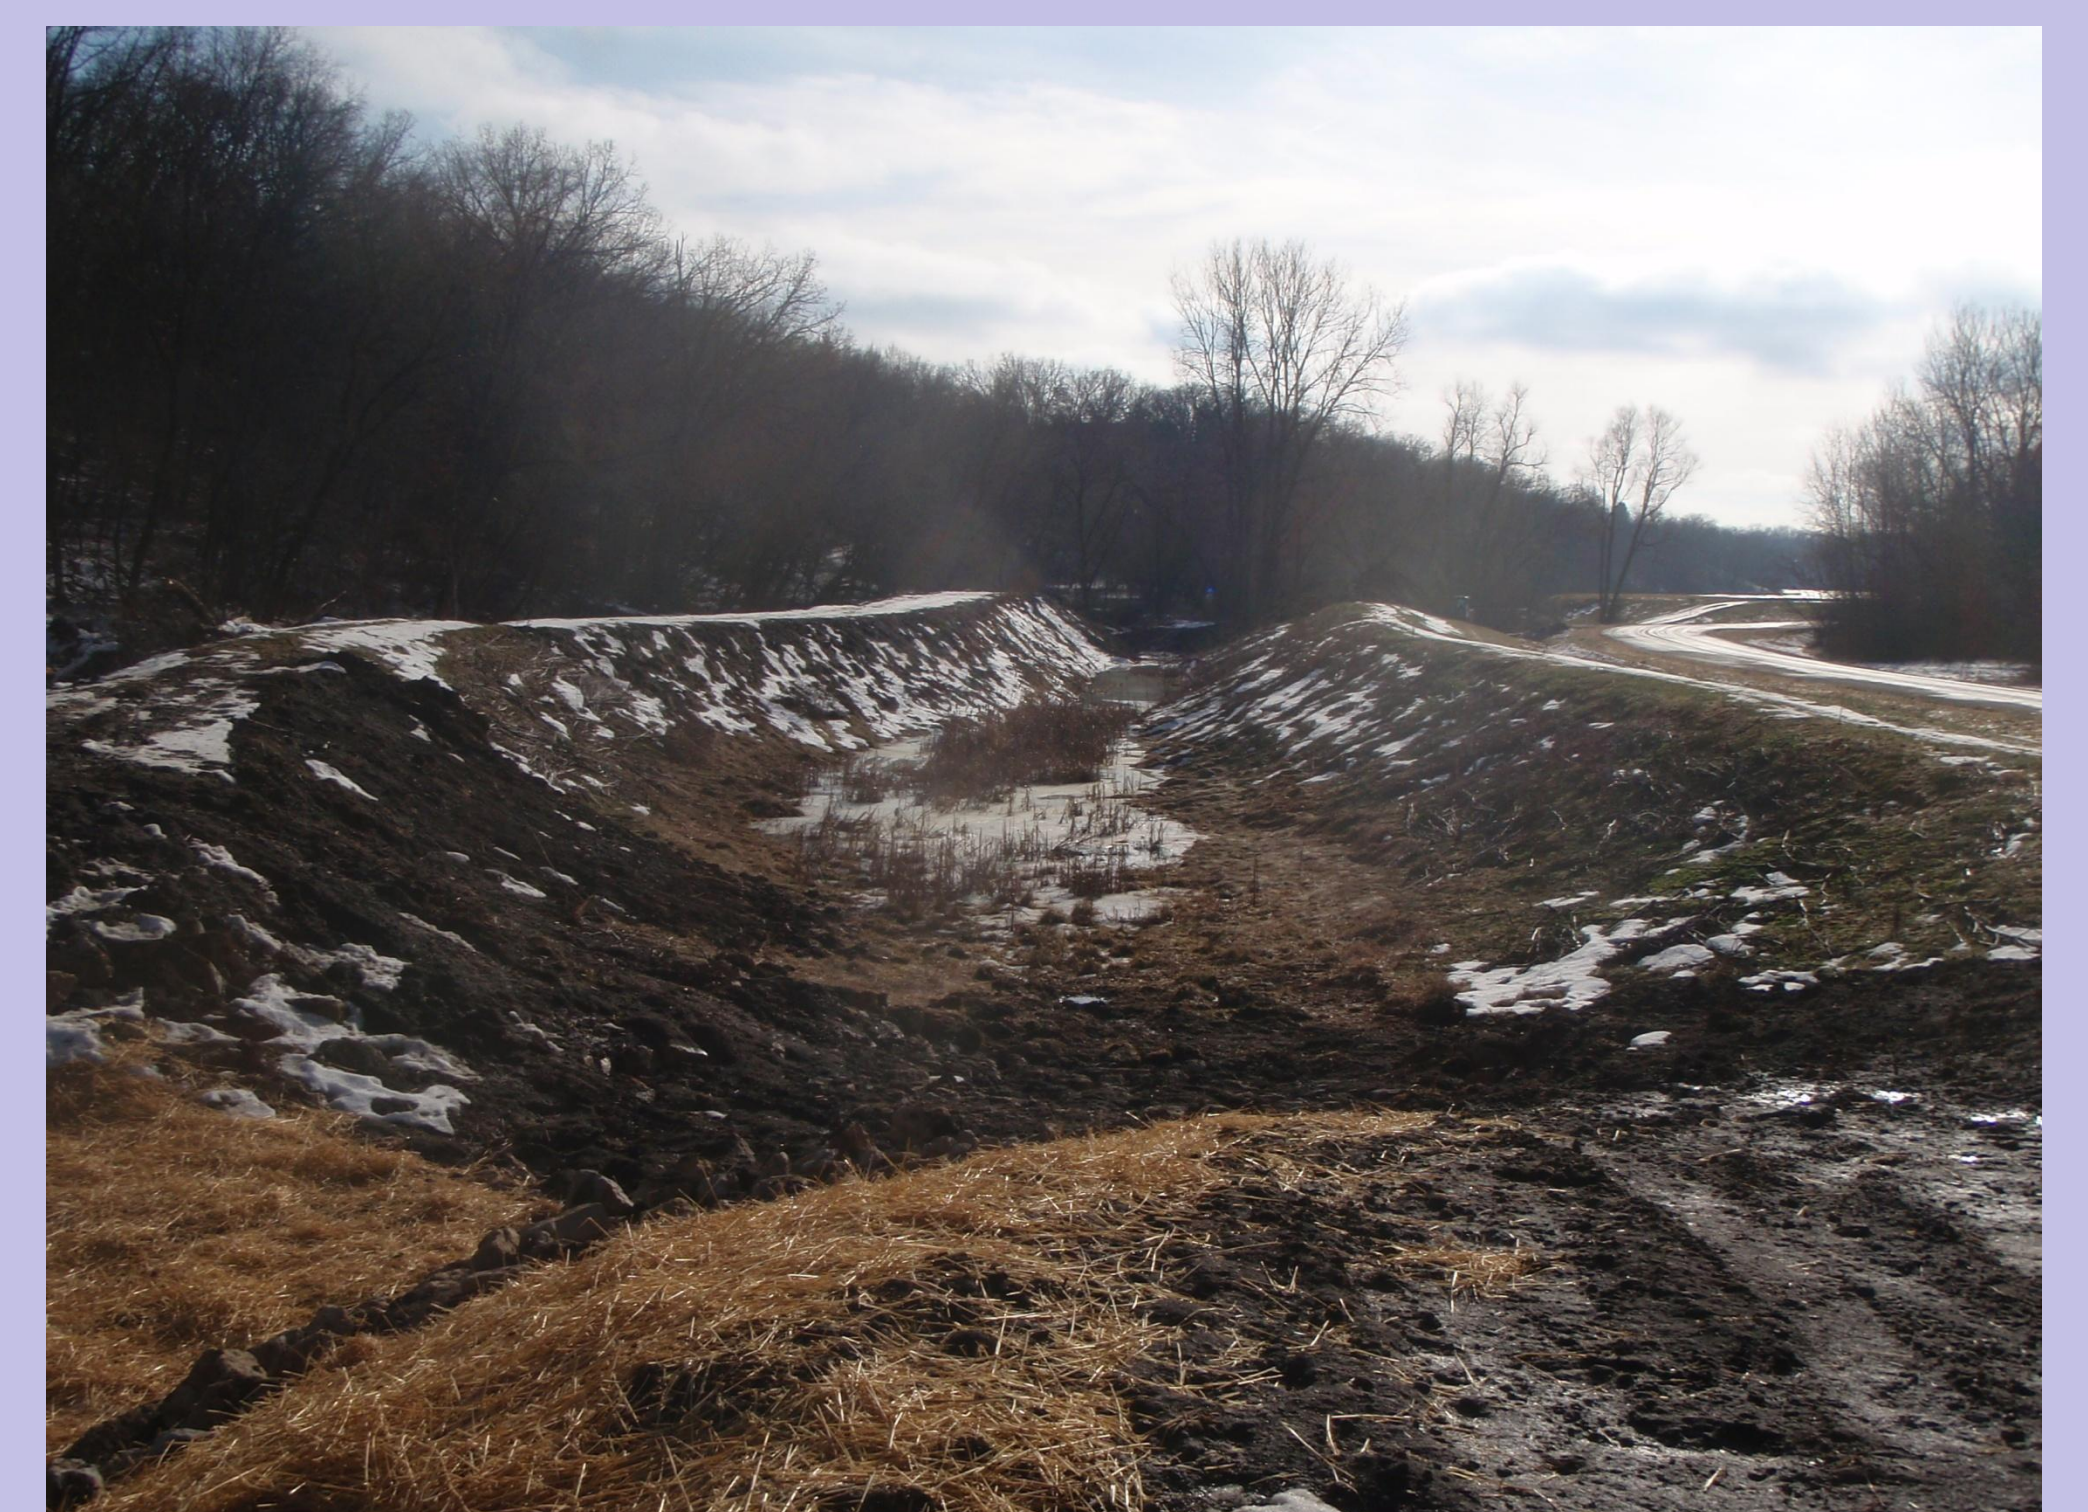
New wetland structure looking downstream.

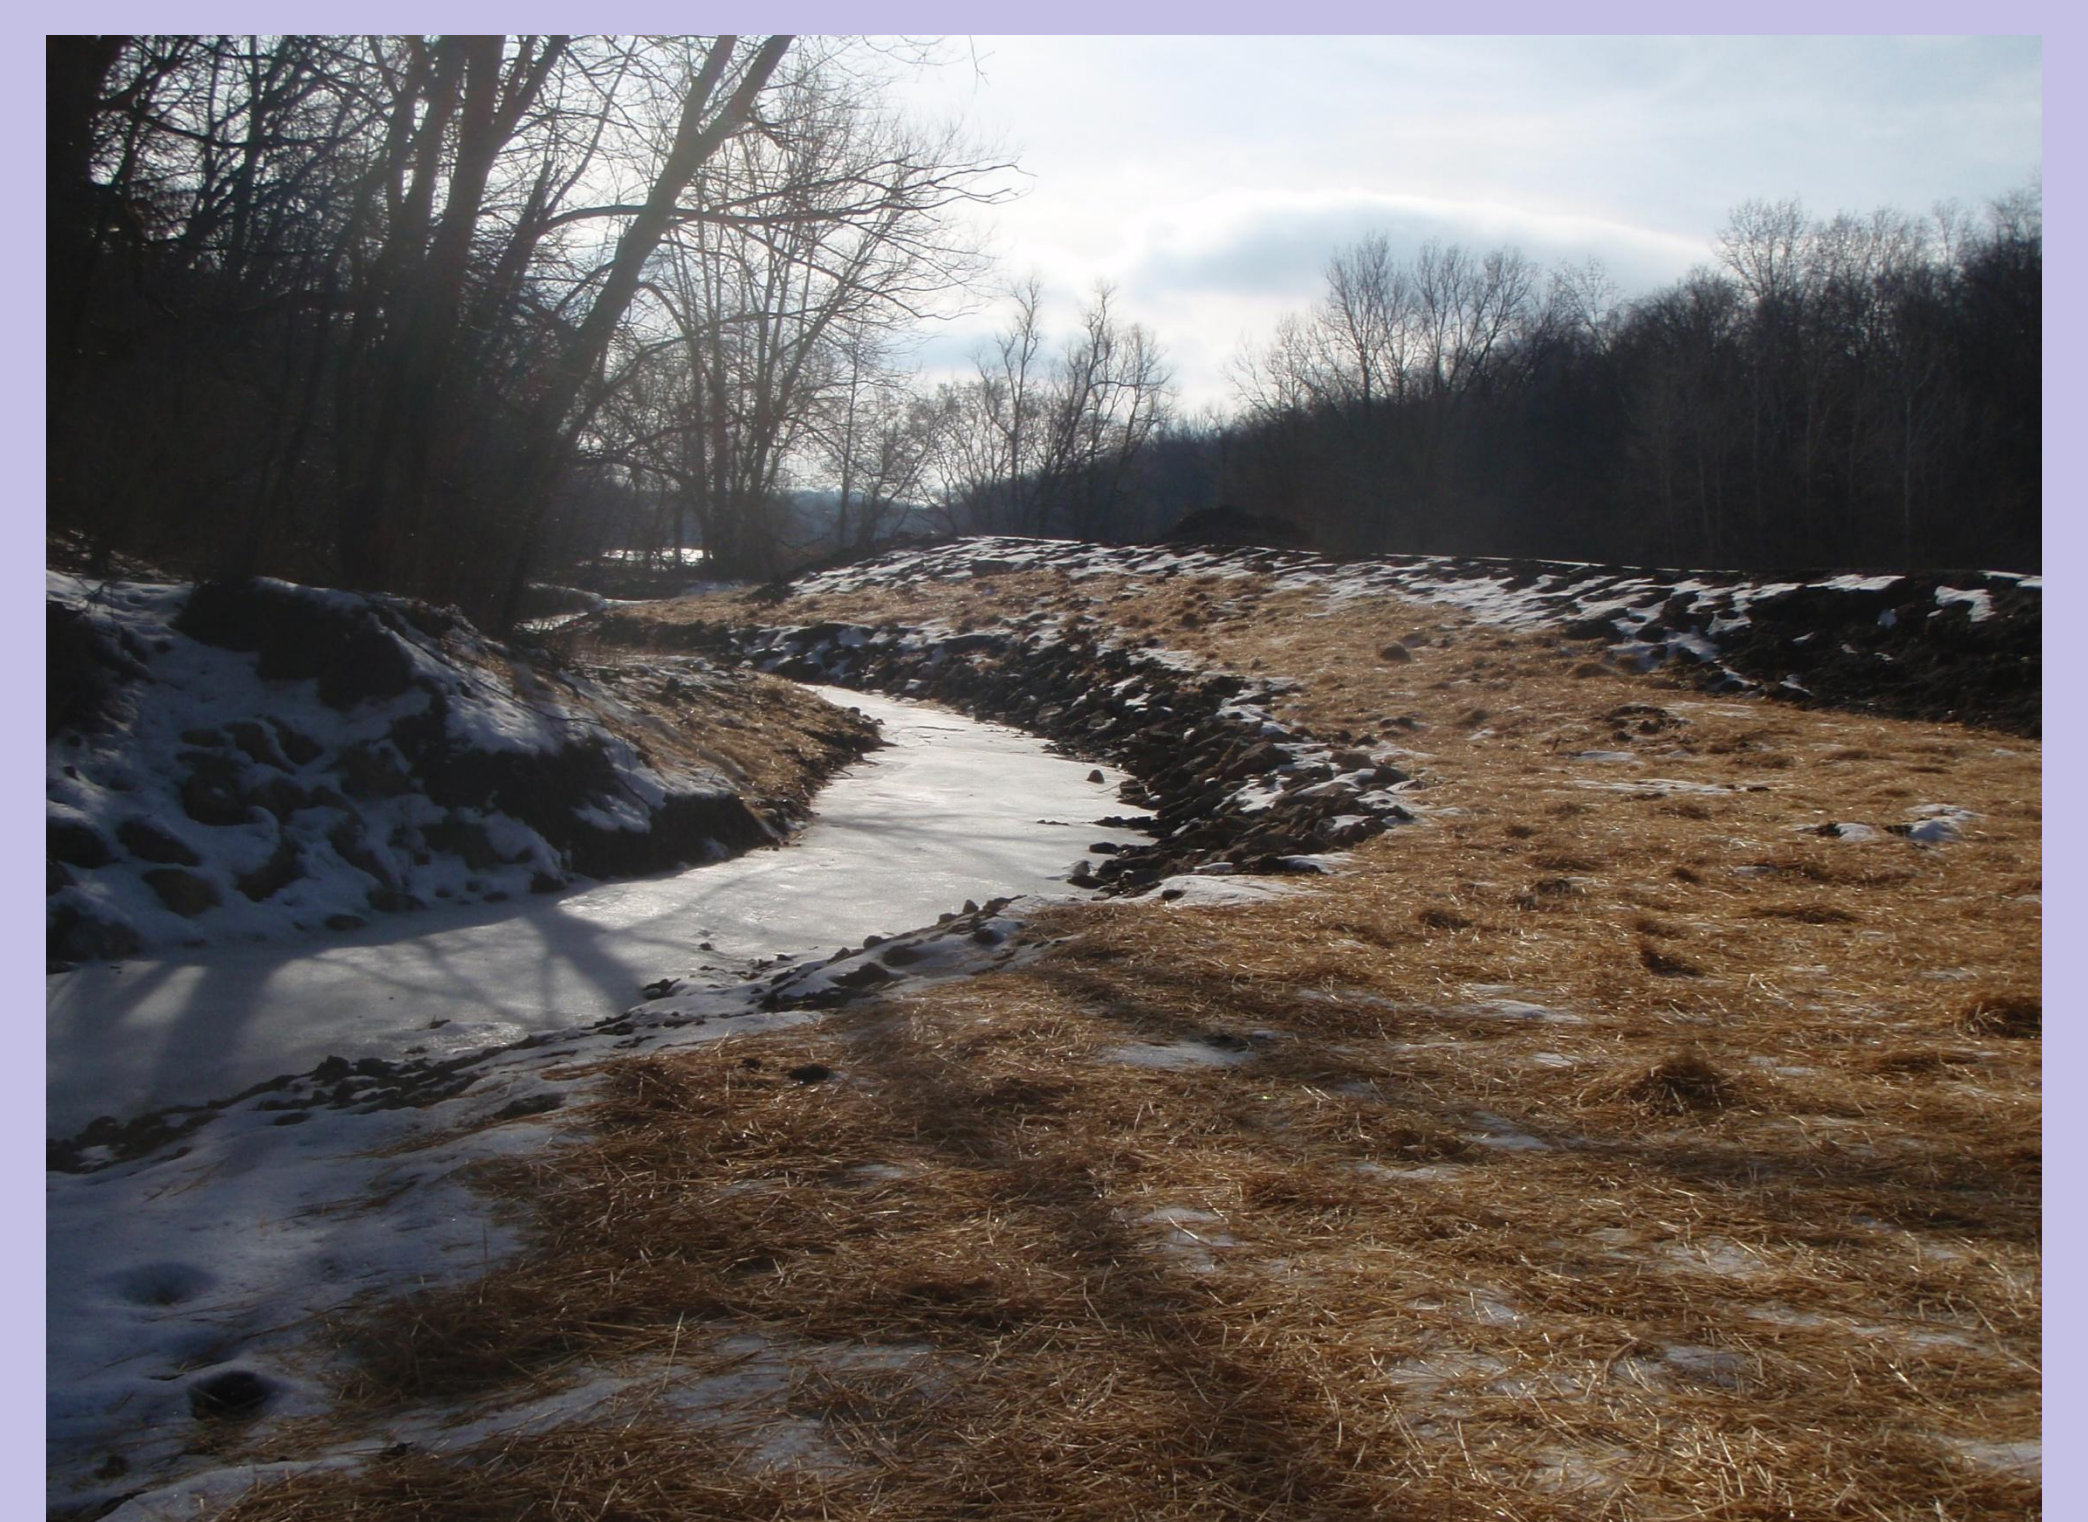
New corner alignment with LPSTP.

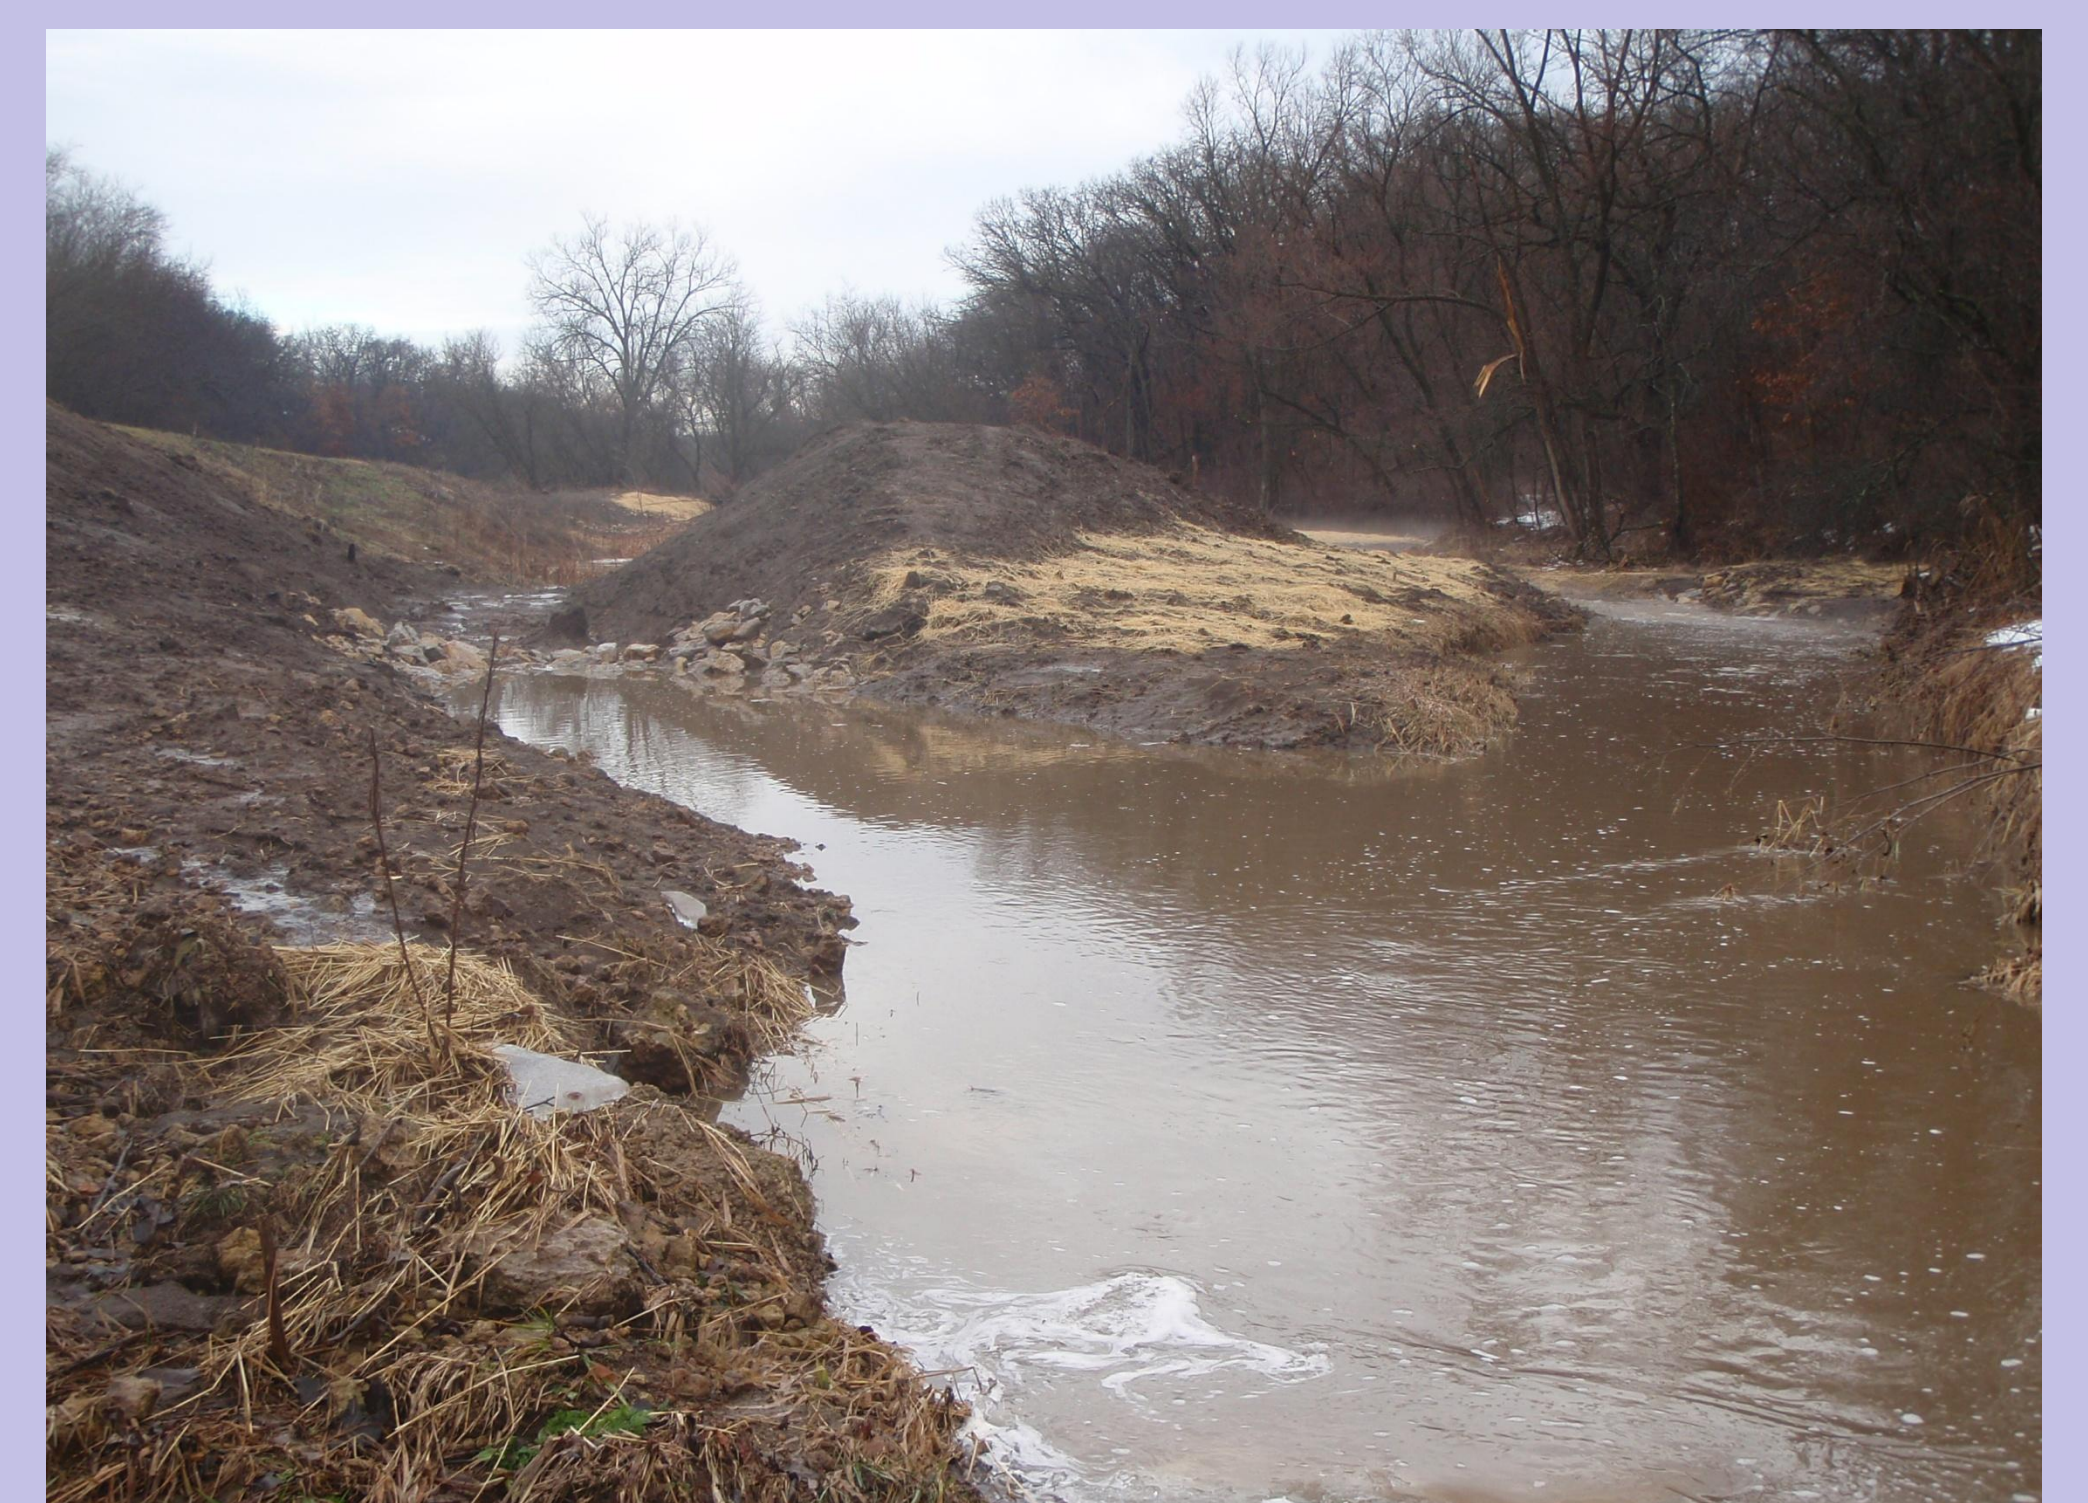
Convergence of wetland with stream under storm flow.
