**Natural Channel Design in a Legal Ditch System:
Restoration of Lawndale Creek**

Luther Aadland, Ph.D.

Minnesota Department of Natural Resources

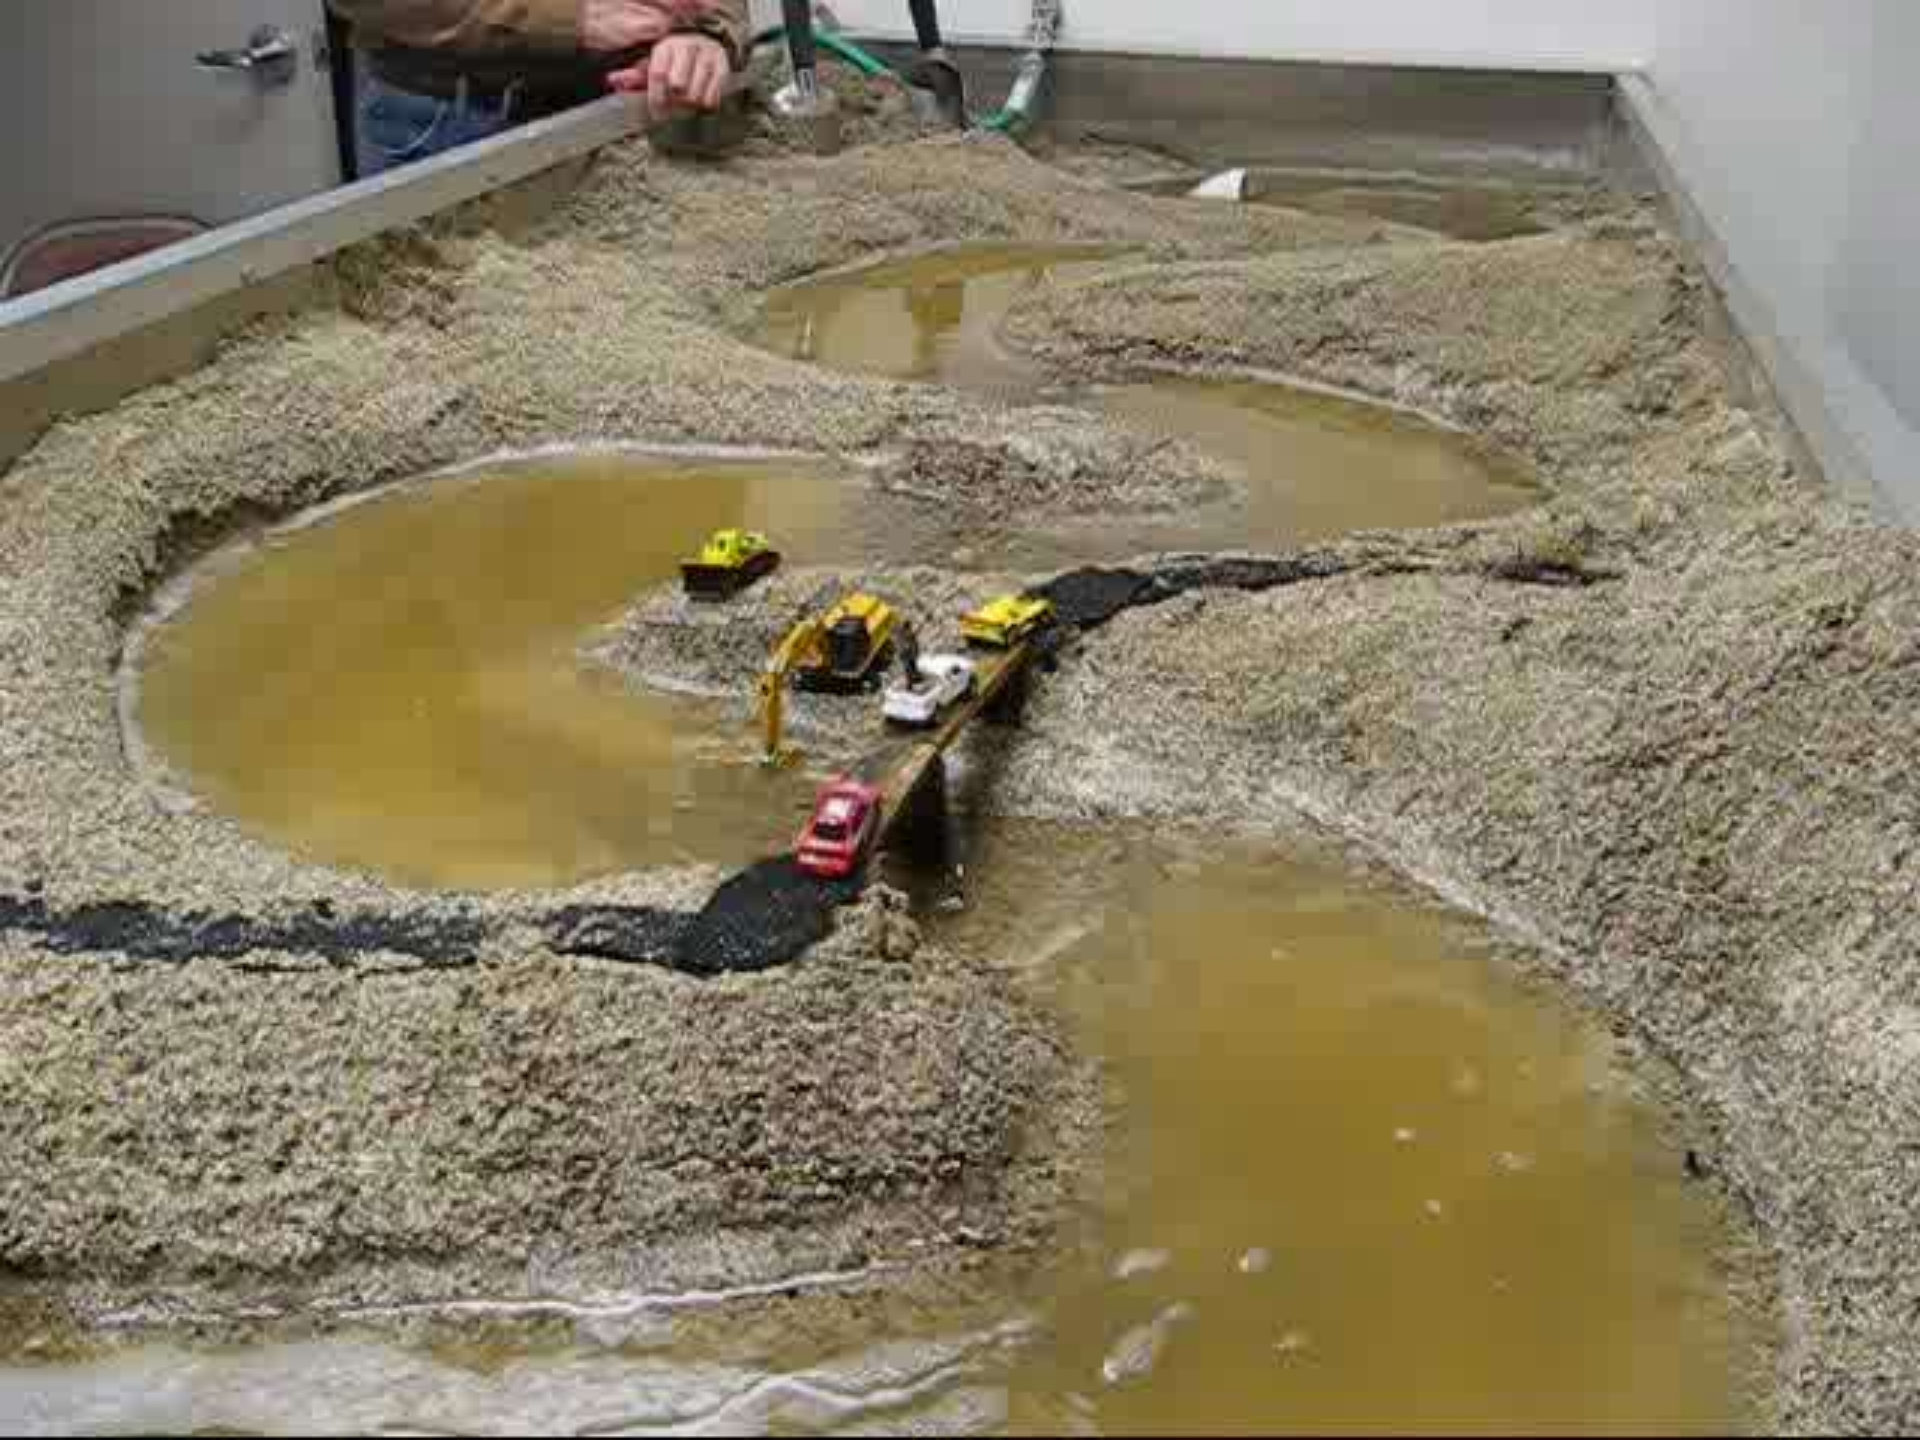
South Branch Buffalo River

An aerial photograph showing a straightened river channel, identified as the South Branch Buffalo River. The river is a narrow, light-colored strip running diagonally from the bottom left towards the top right. It is flanked by green fields on the left and a dark, possibly forested or agricultural area on the right. A dirt road runs parallel to the river on the right side, with several vehicles visible. A yellow excavator is positioned near the riverbank on the right side. The overall scene illustrates the result of channelization or 'channel improvement' in a rural setting.

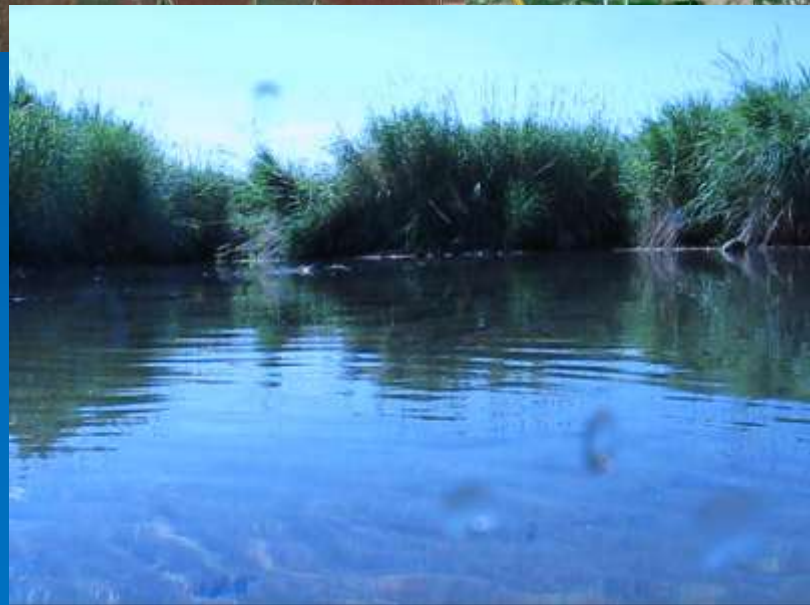
State Ditch 40 was dug in the 1890s

County Ditch 14 was dug in 1960 and carried all base flow and most flood flow due to channel incision

The Atherton became a WMA in 1960

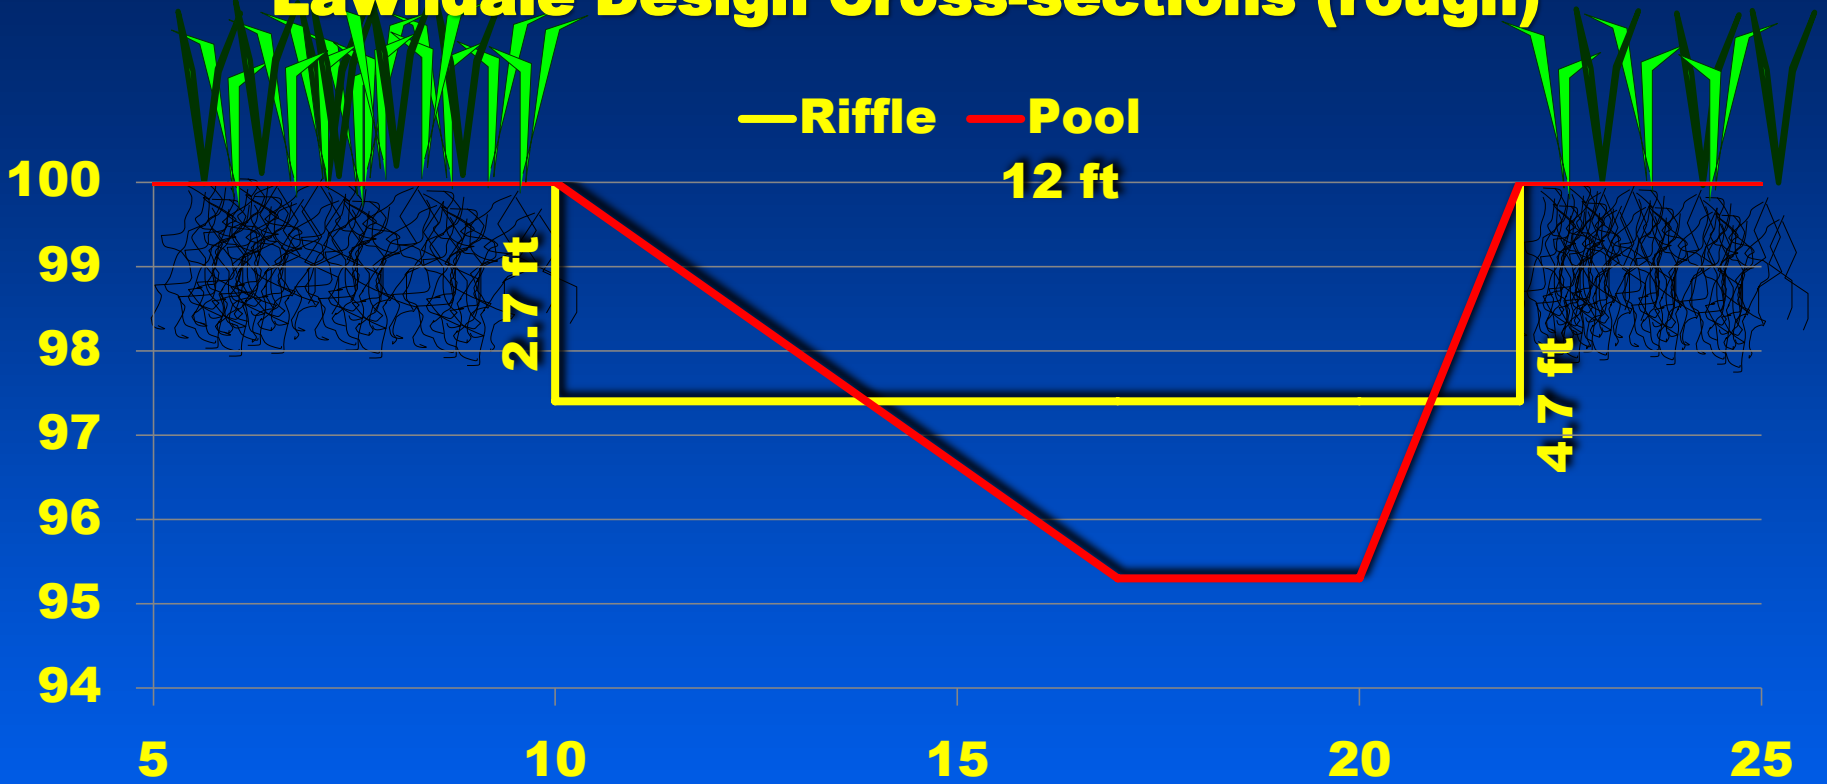
Lawndale Design Cross-sections (rough)

Upper Reference Reach (2.6 miles)
Drainage Area = 7 mi²
Bankfull Width 6 - 10 ft
"E5" channel
Slope = 0.2%
Mannings N = .056 (backcalculated)
Bankfull discharge = 9 - 20 cfs
Tau = 0.7 kg/m²

Bankfull discharge = 50 cfs
Bankfull shear stress = 0.8 kg/m²

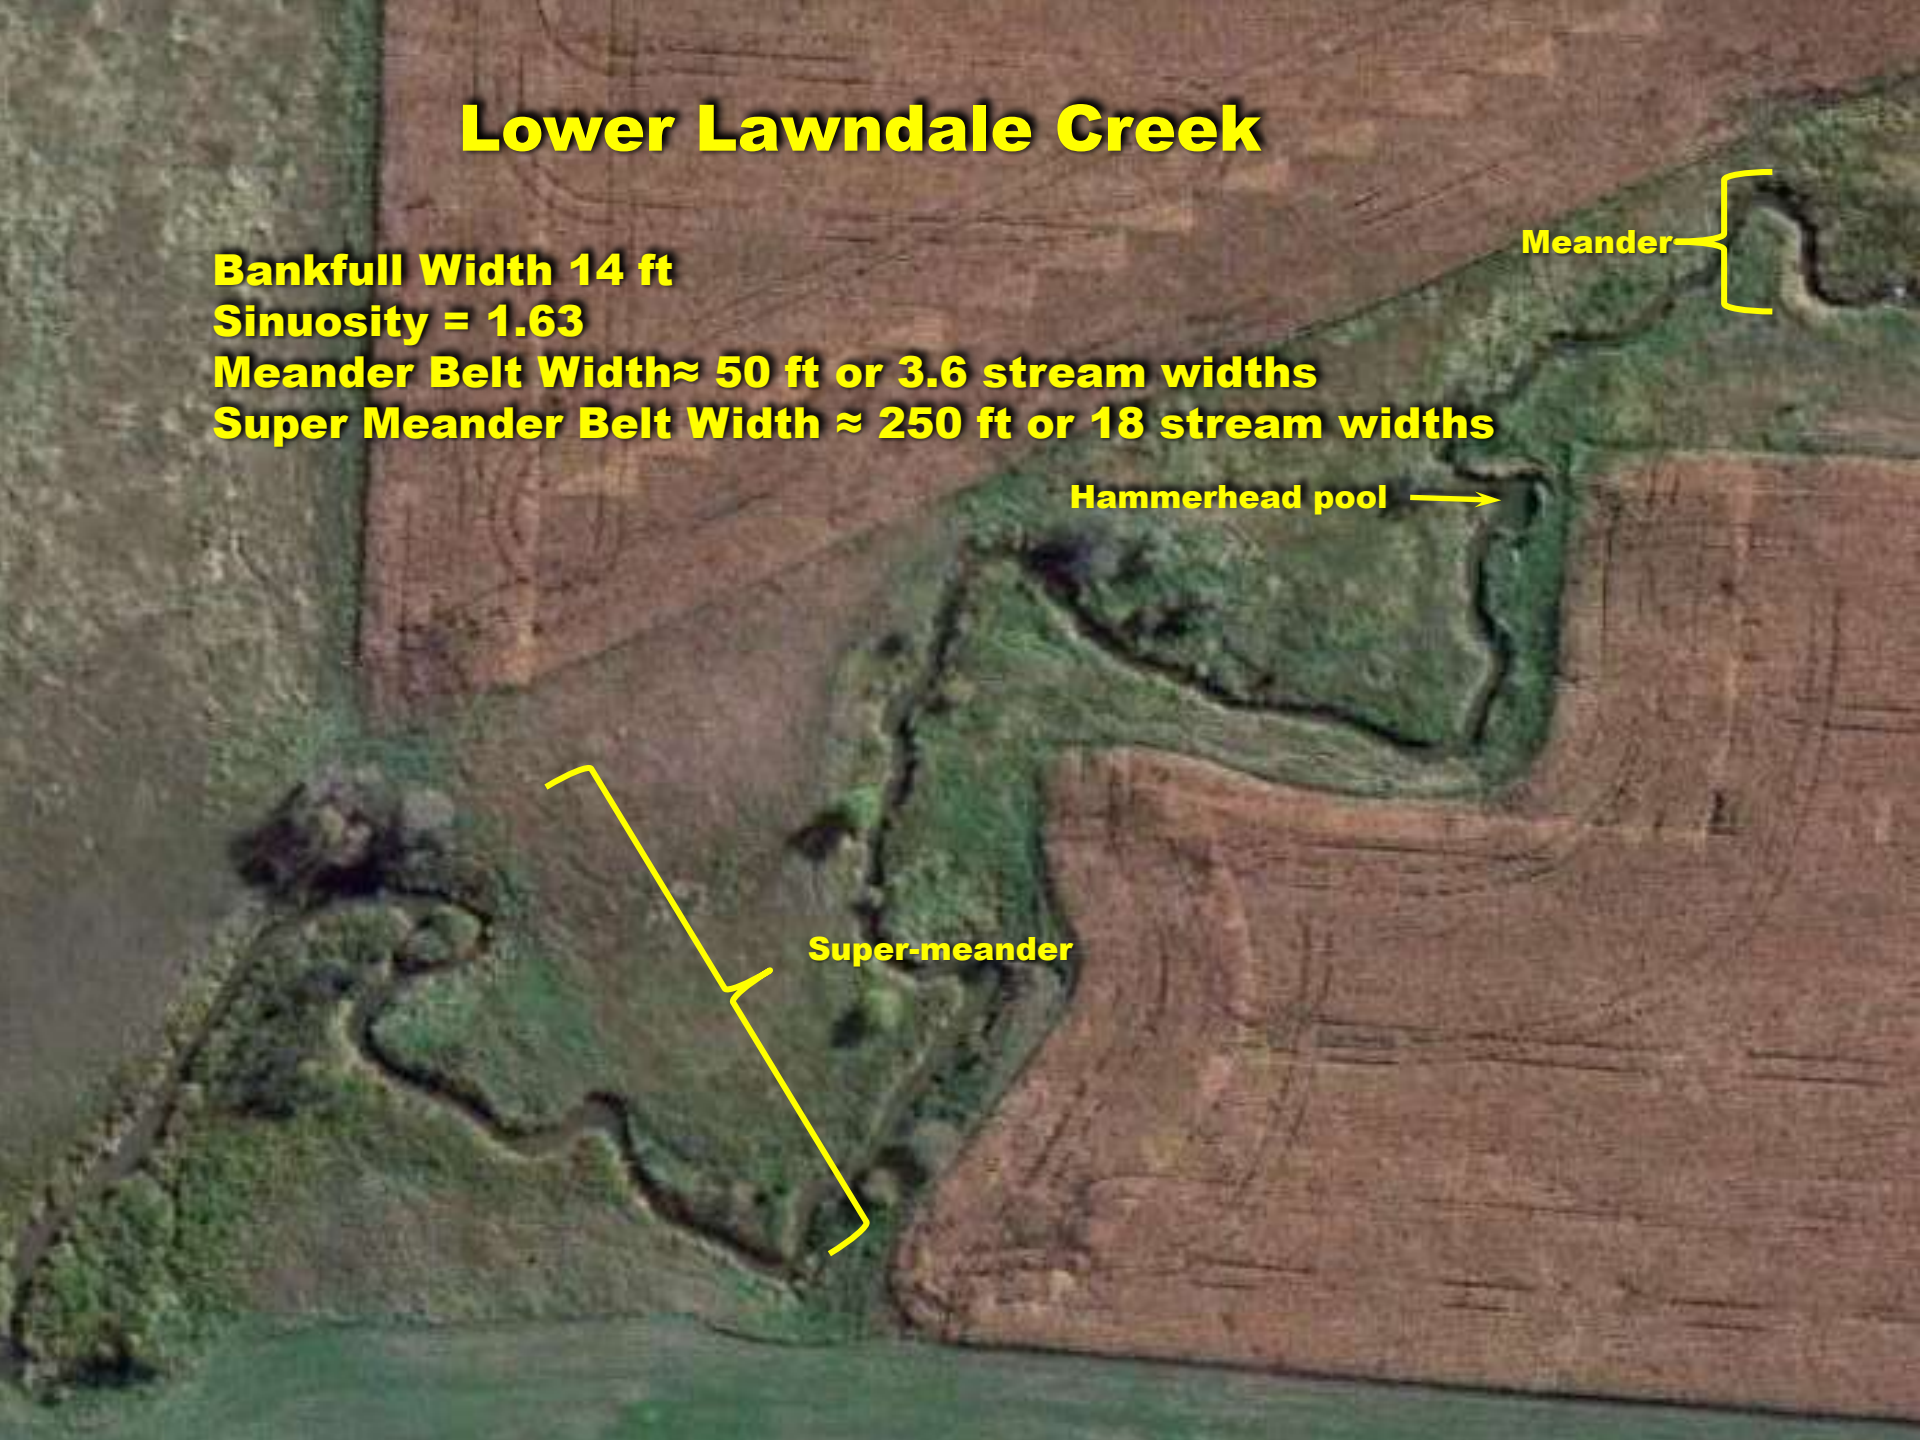
Meander

Super-meander

Hammerhead pool

Upper Lawndale Creek

Bankfull Width \approx 10 ft

Sinuosity = 3.35

Meander Belt Width \approx 50 ft or 5 stream widths

Super Meander Belt Width \approx 250 ft or 25 stream widths

Radii of curvature 1.2 – 2.5 (those <1.5 often result in formation of hammerhead pools)

Lower Lawndale Creek

Bankfull Width 14 ft

Sinuosity = 1.63

Meander Belt Width \approx 50 ft or 3.6 stream widths

Super Meander Belt Width \approx 250 ft or 18 stream widths

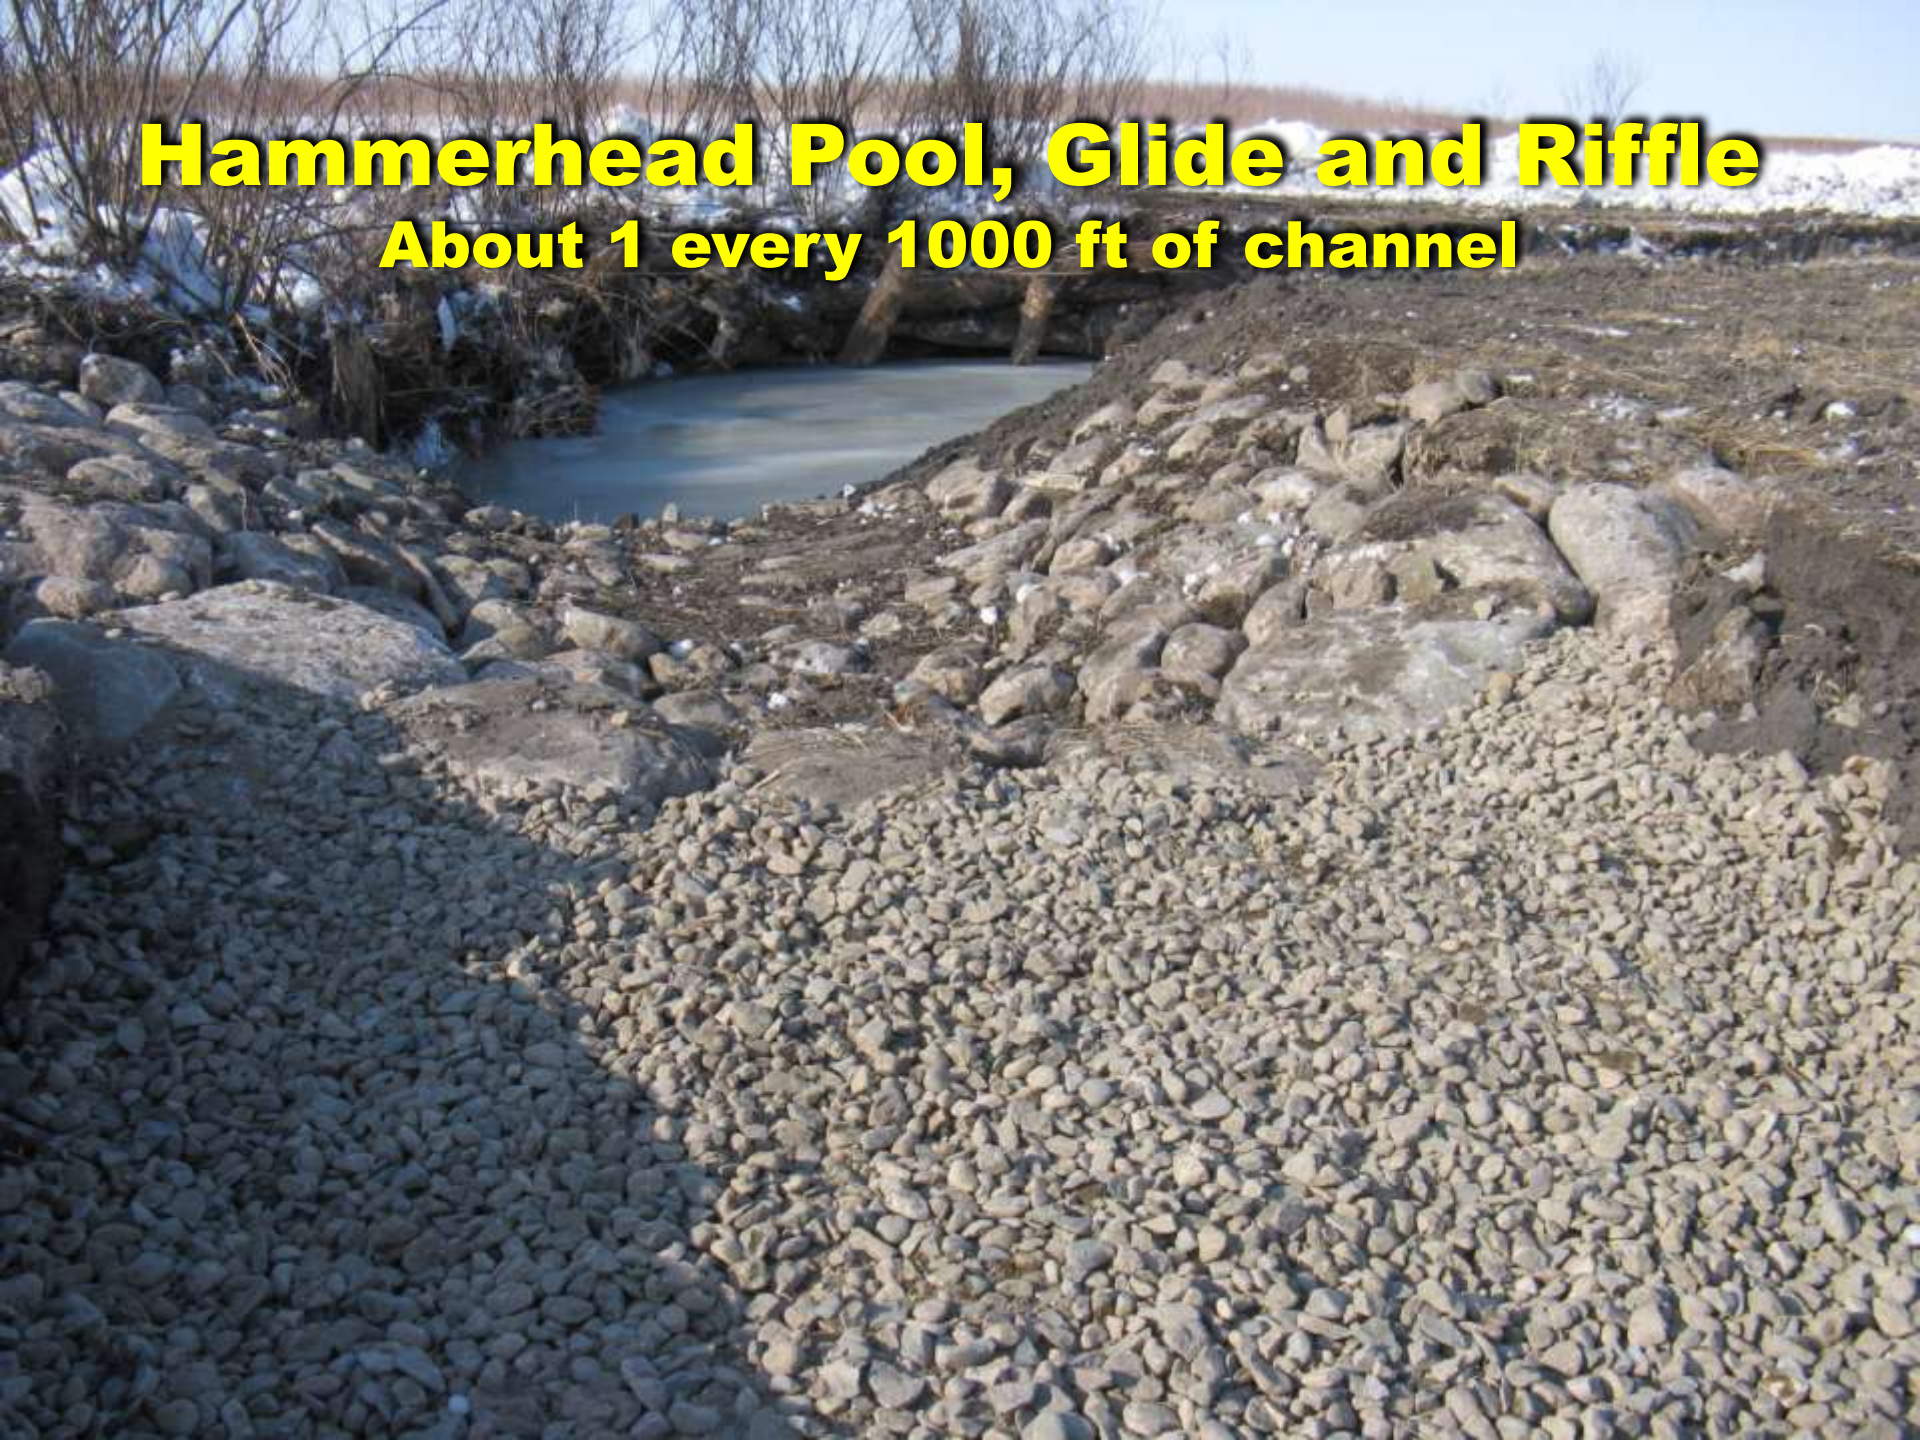
Hammerhead Pool, Glide and Riffle

About 1 every 1000 ft of channel

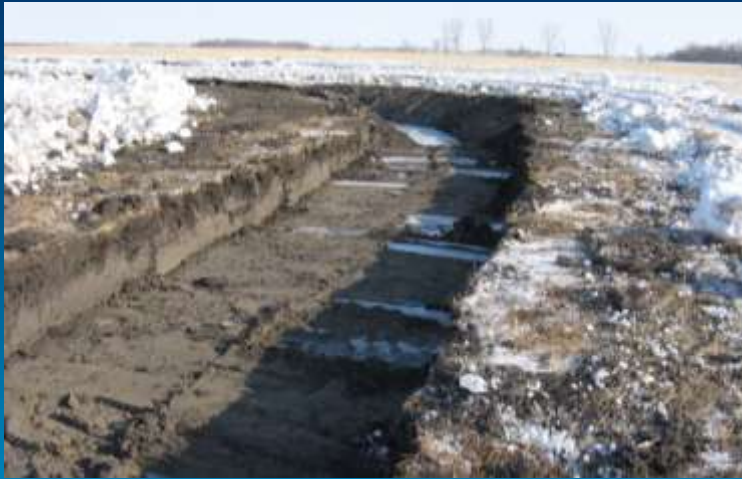
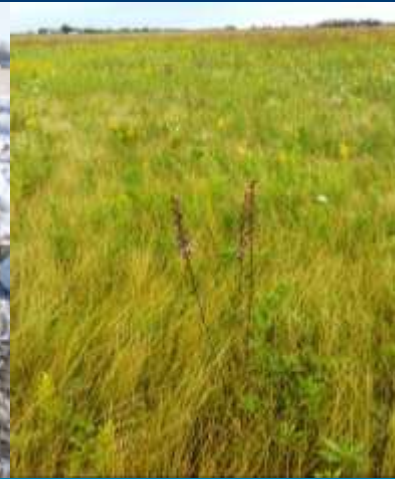
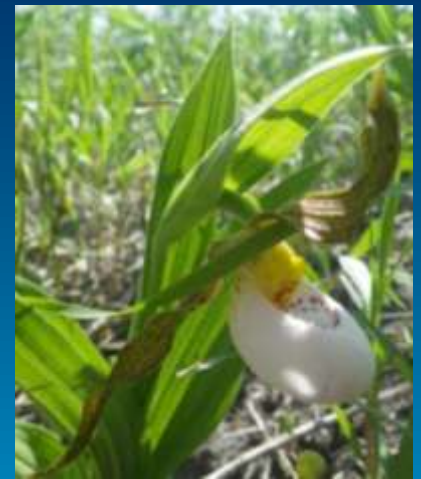
Segments with Diverse Prairie

Fill hauled to ditch plugs, minimum impact

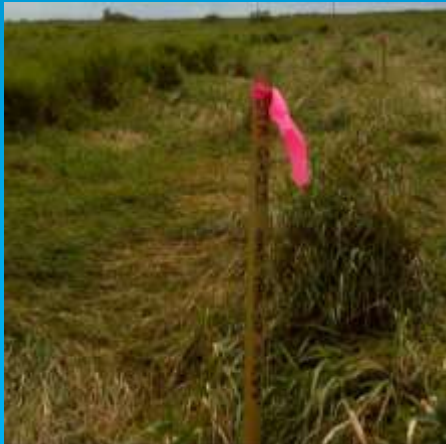
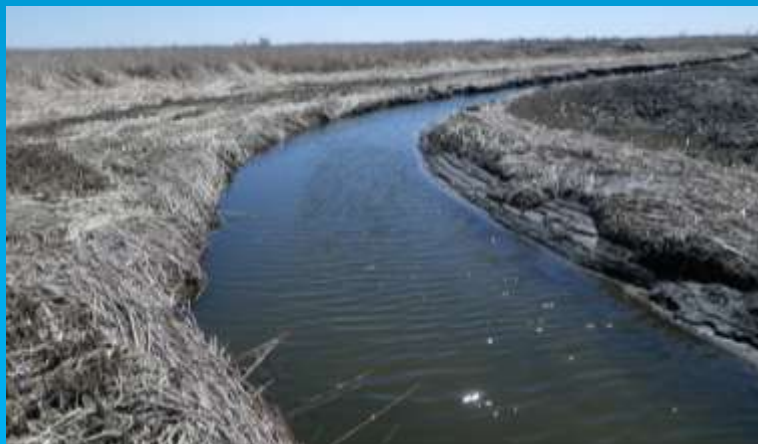
Segments with Invasive Species Monocultures

(reed canary grass, narrow leaf cattail)

Fill sidecast and seeded with native grasses and wildflowers

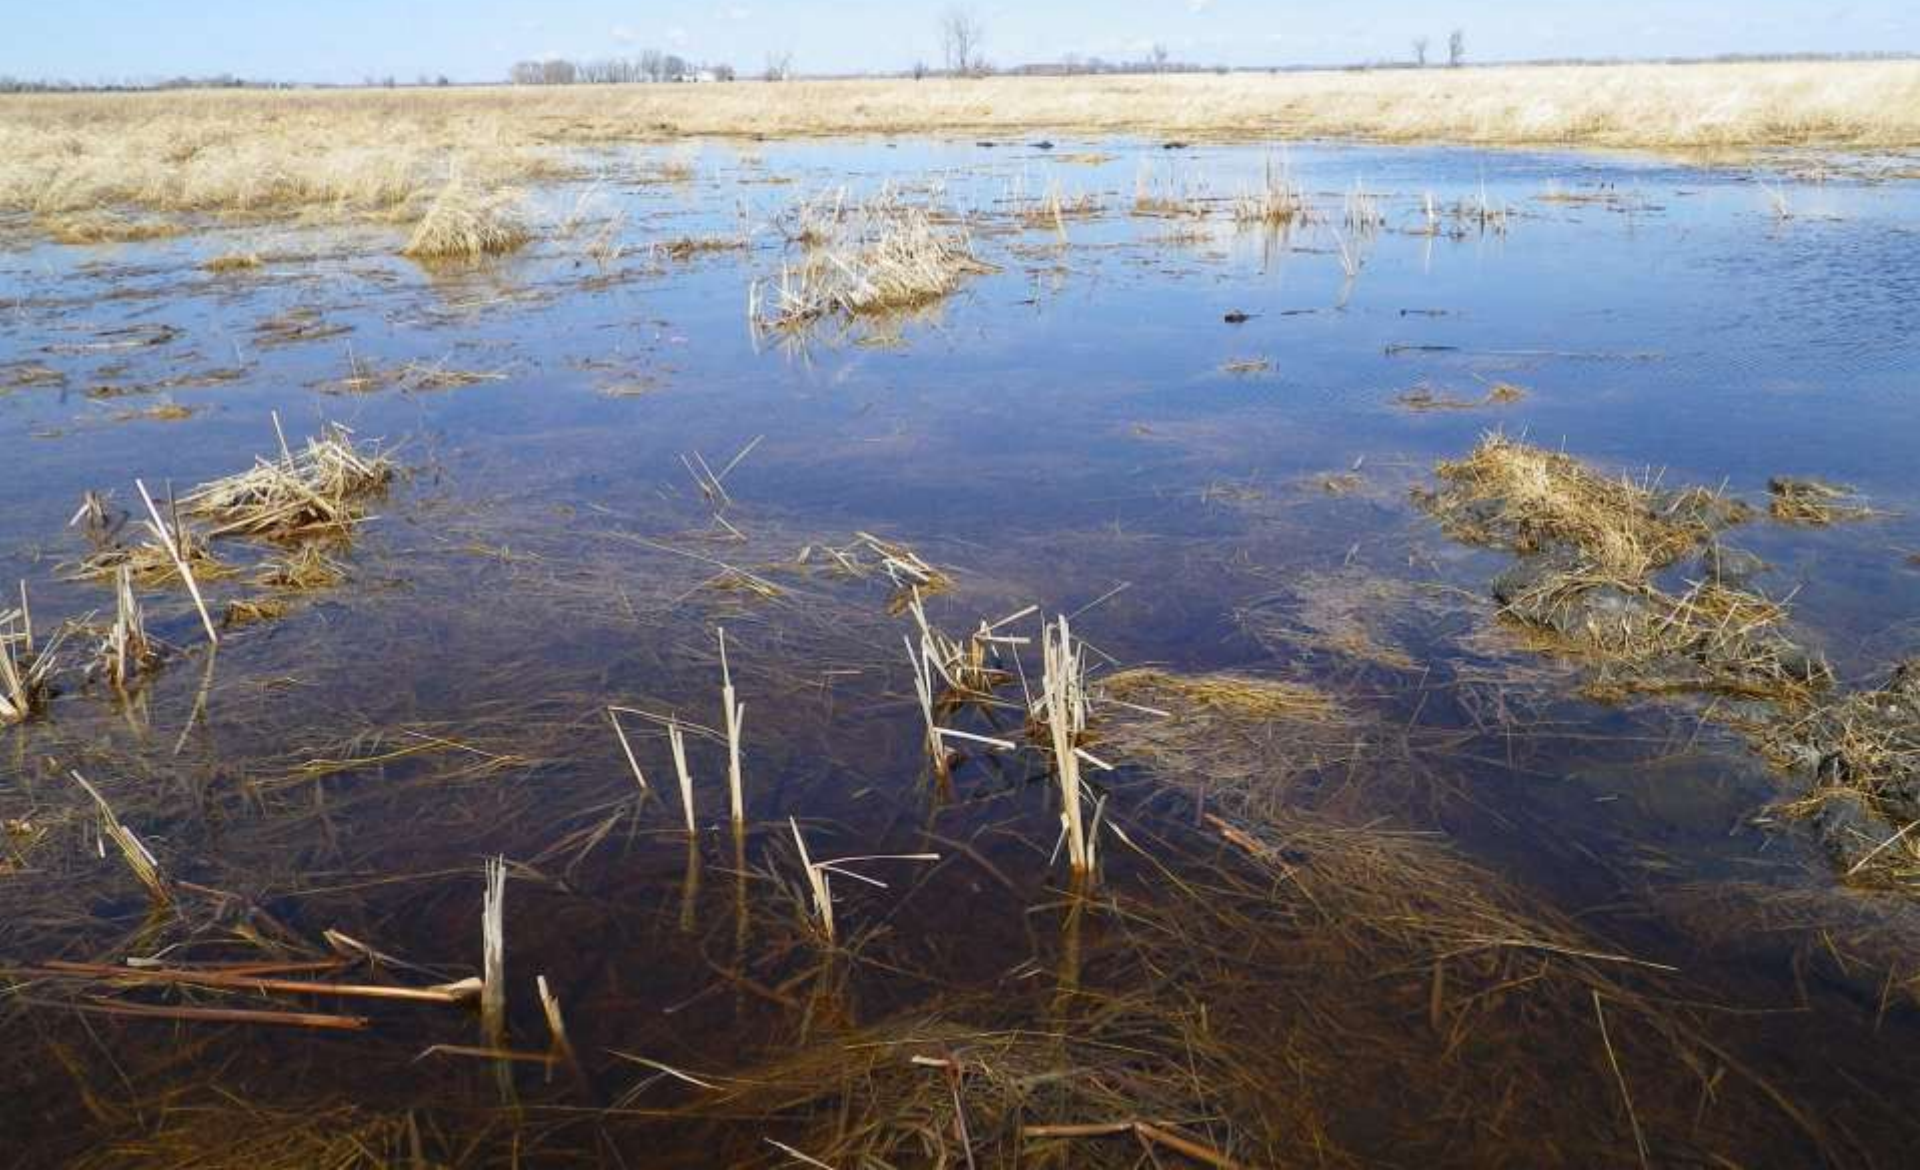
Ditch Plugs

Side-Cast Fill
(invasive species)

Fill hauled to plugs
(diverse prairie)

Wetland restored by plugging State Ditch 40

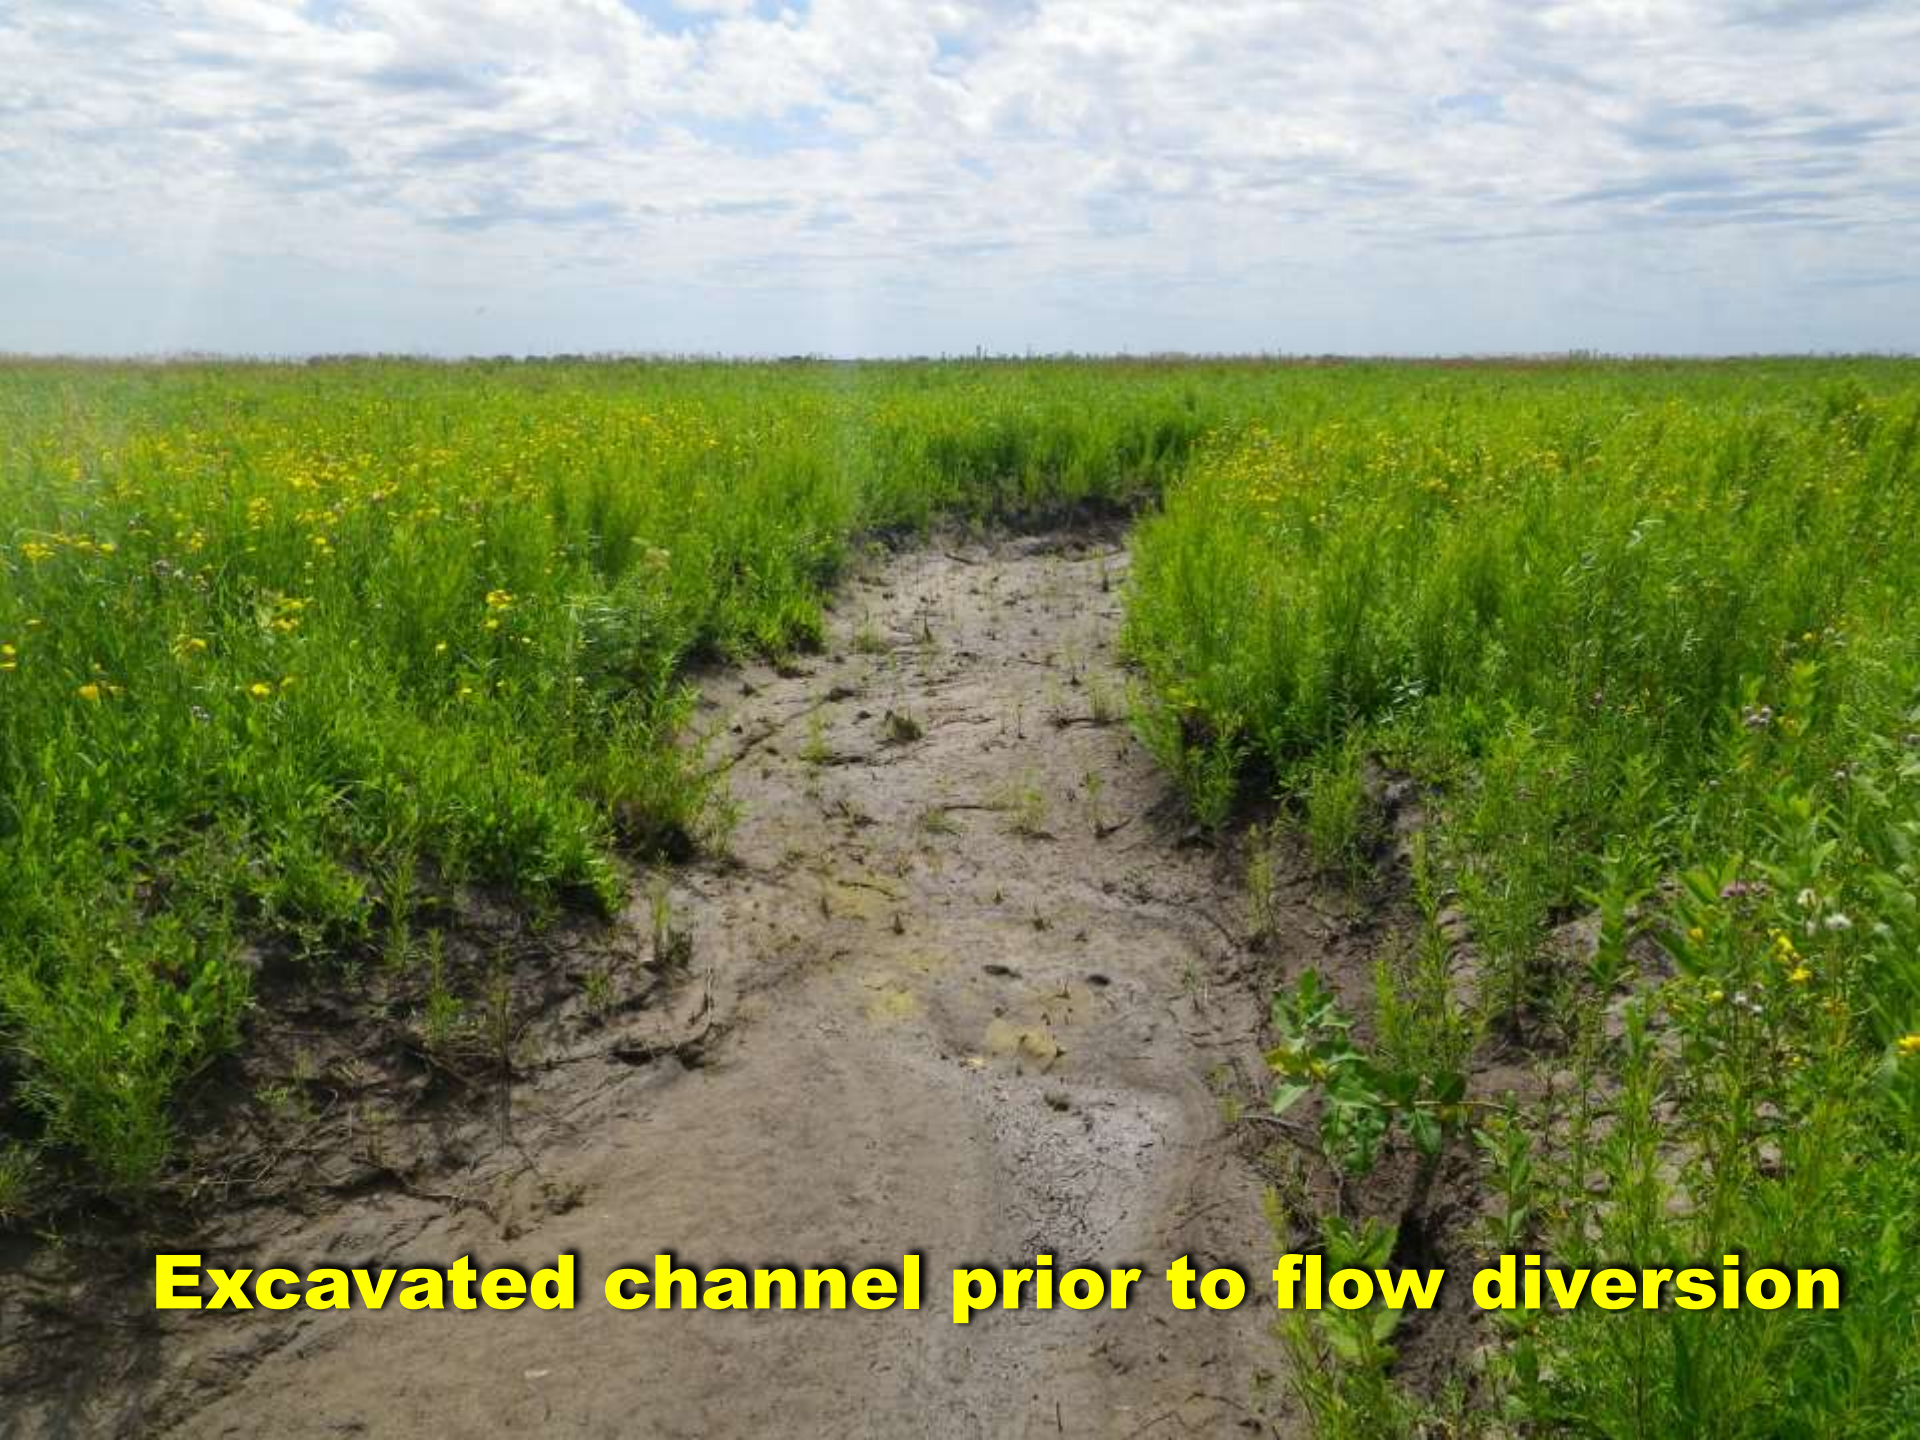
Excavated channel prior to flow diversion

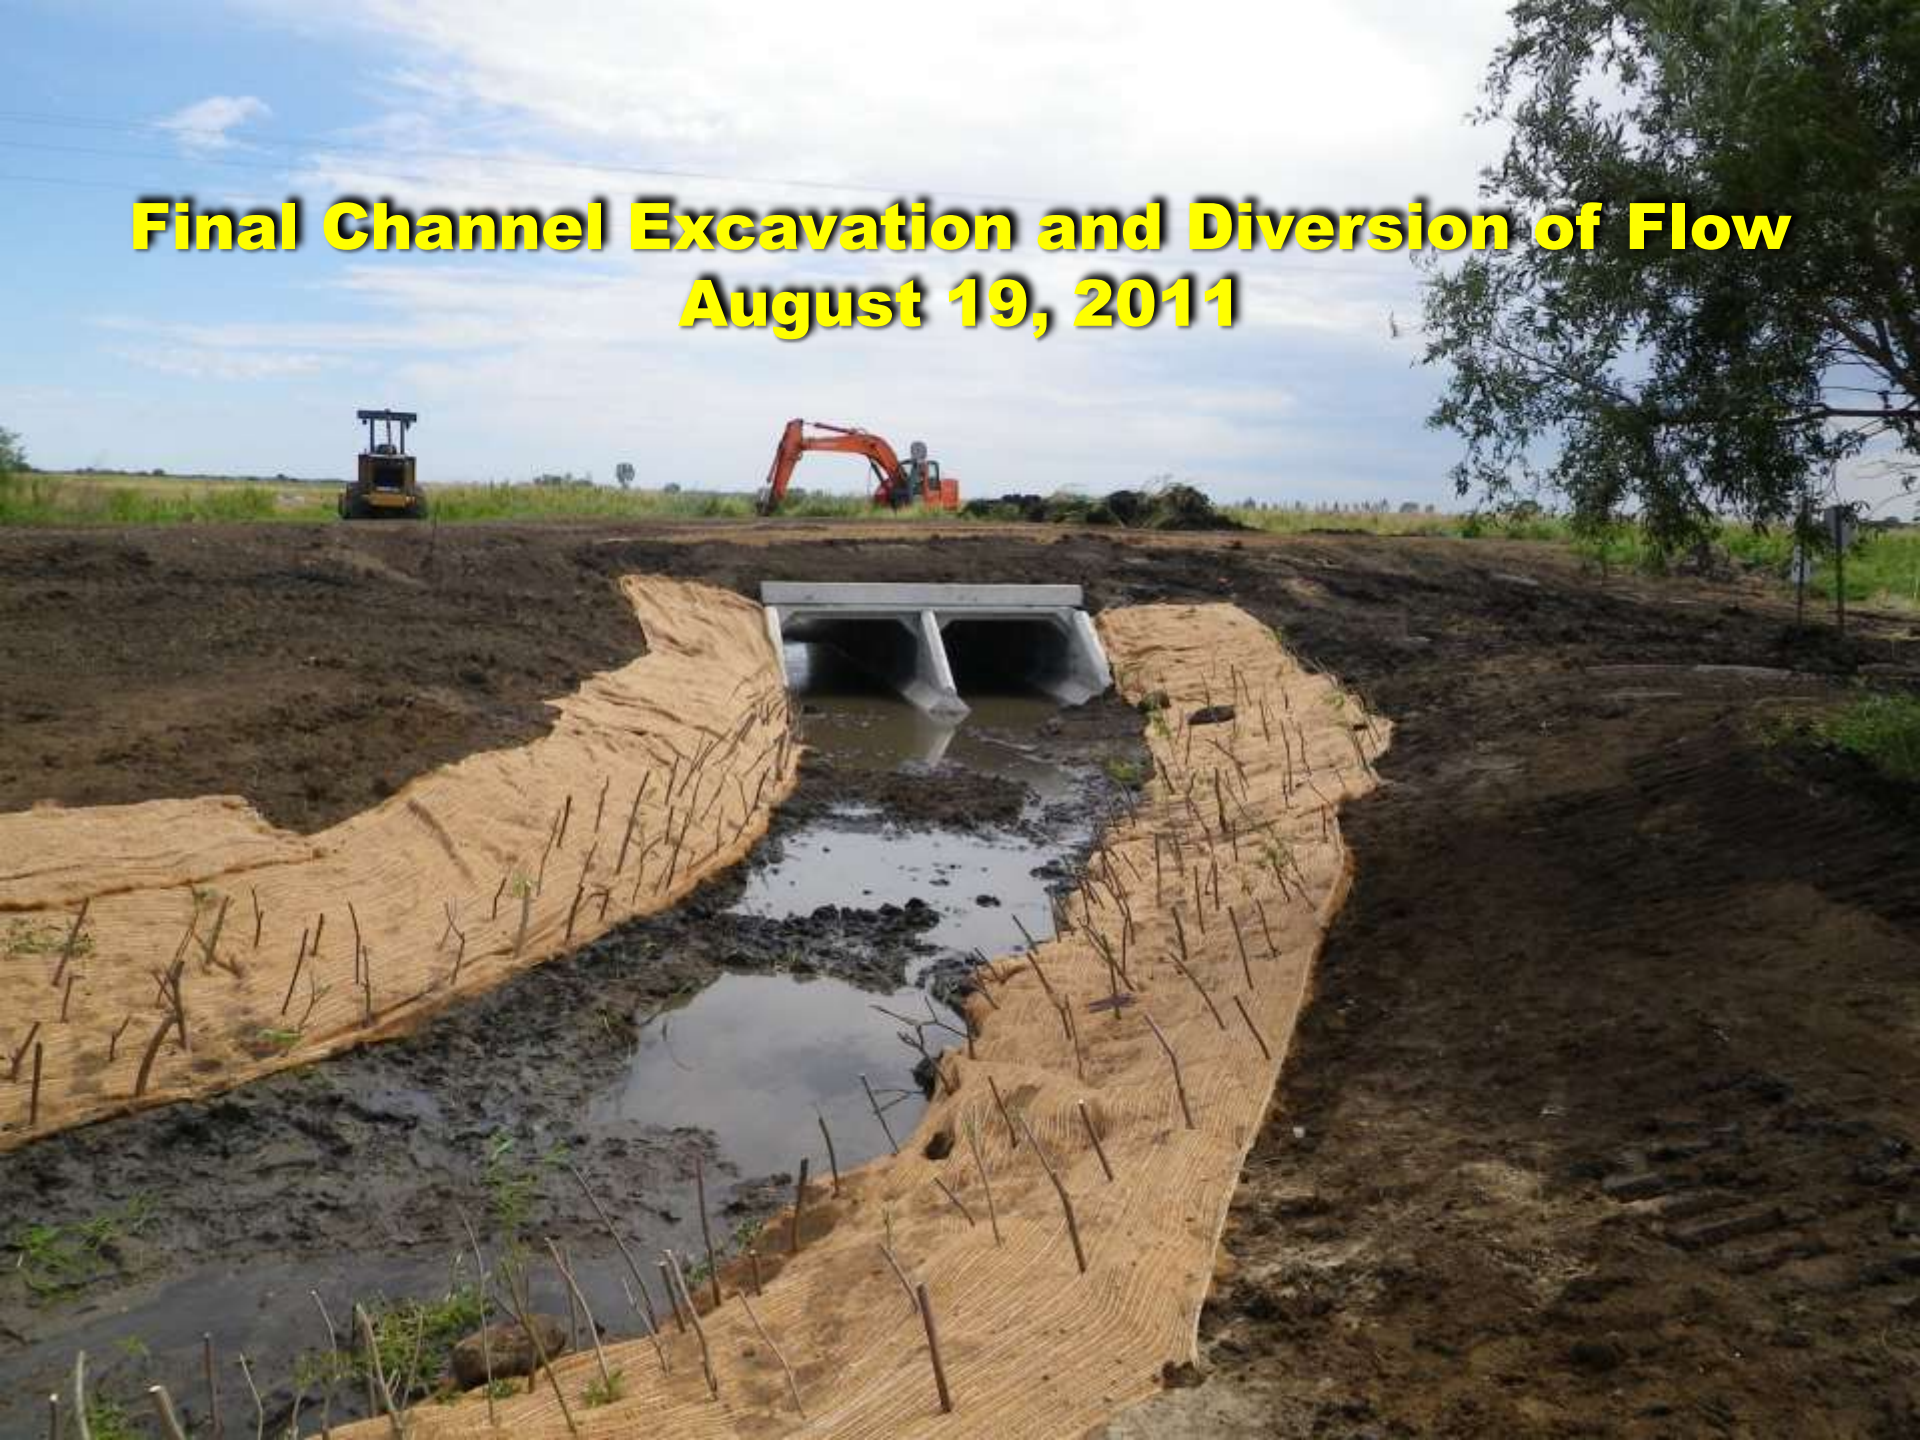
Final Channel Excavation and Diversion of Flow August 19, 2011

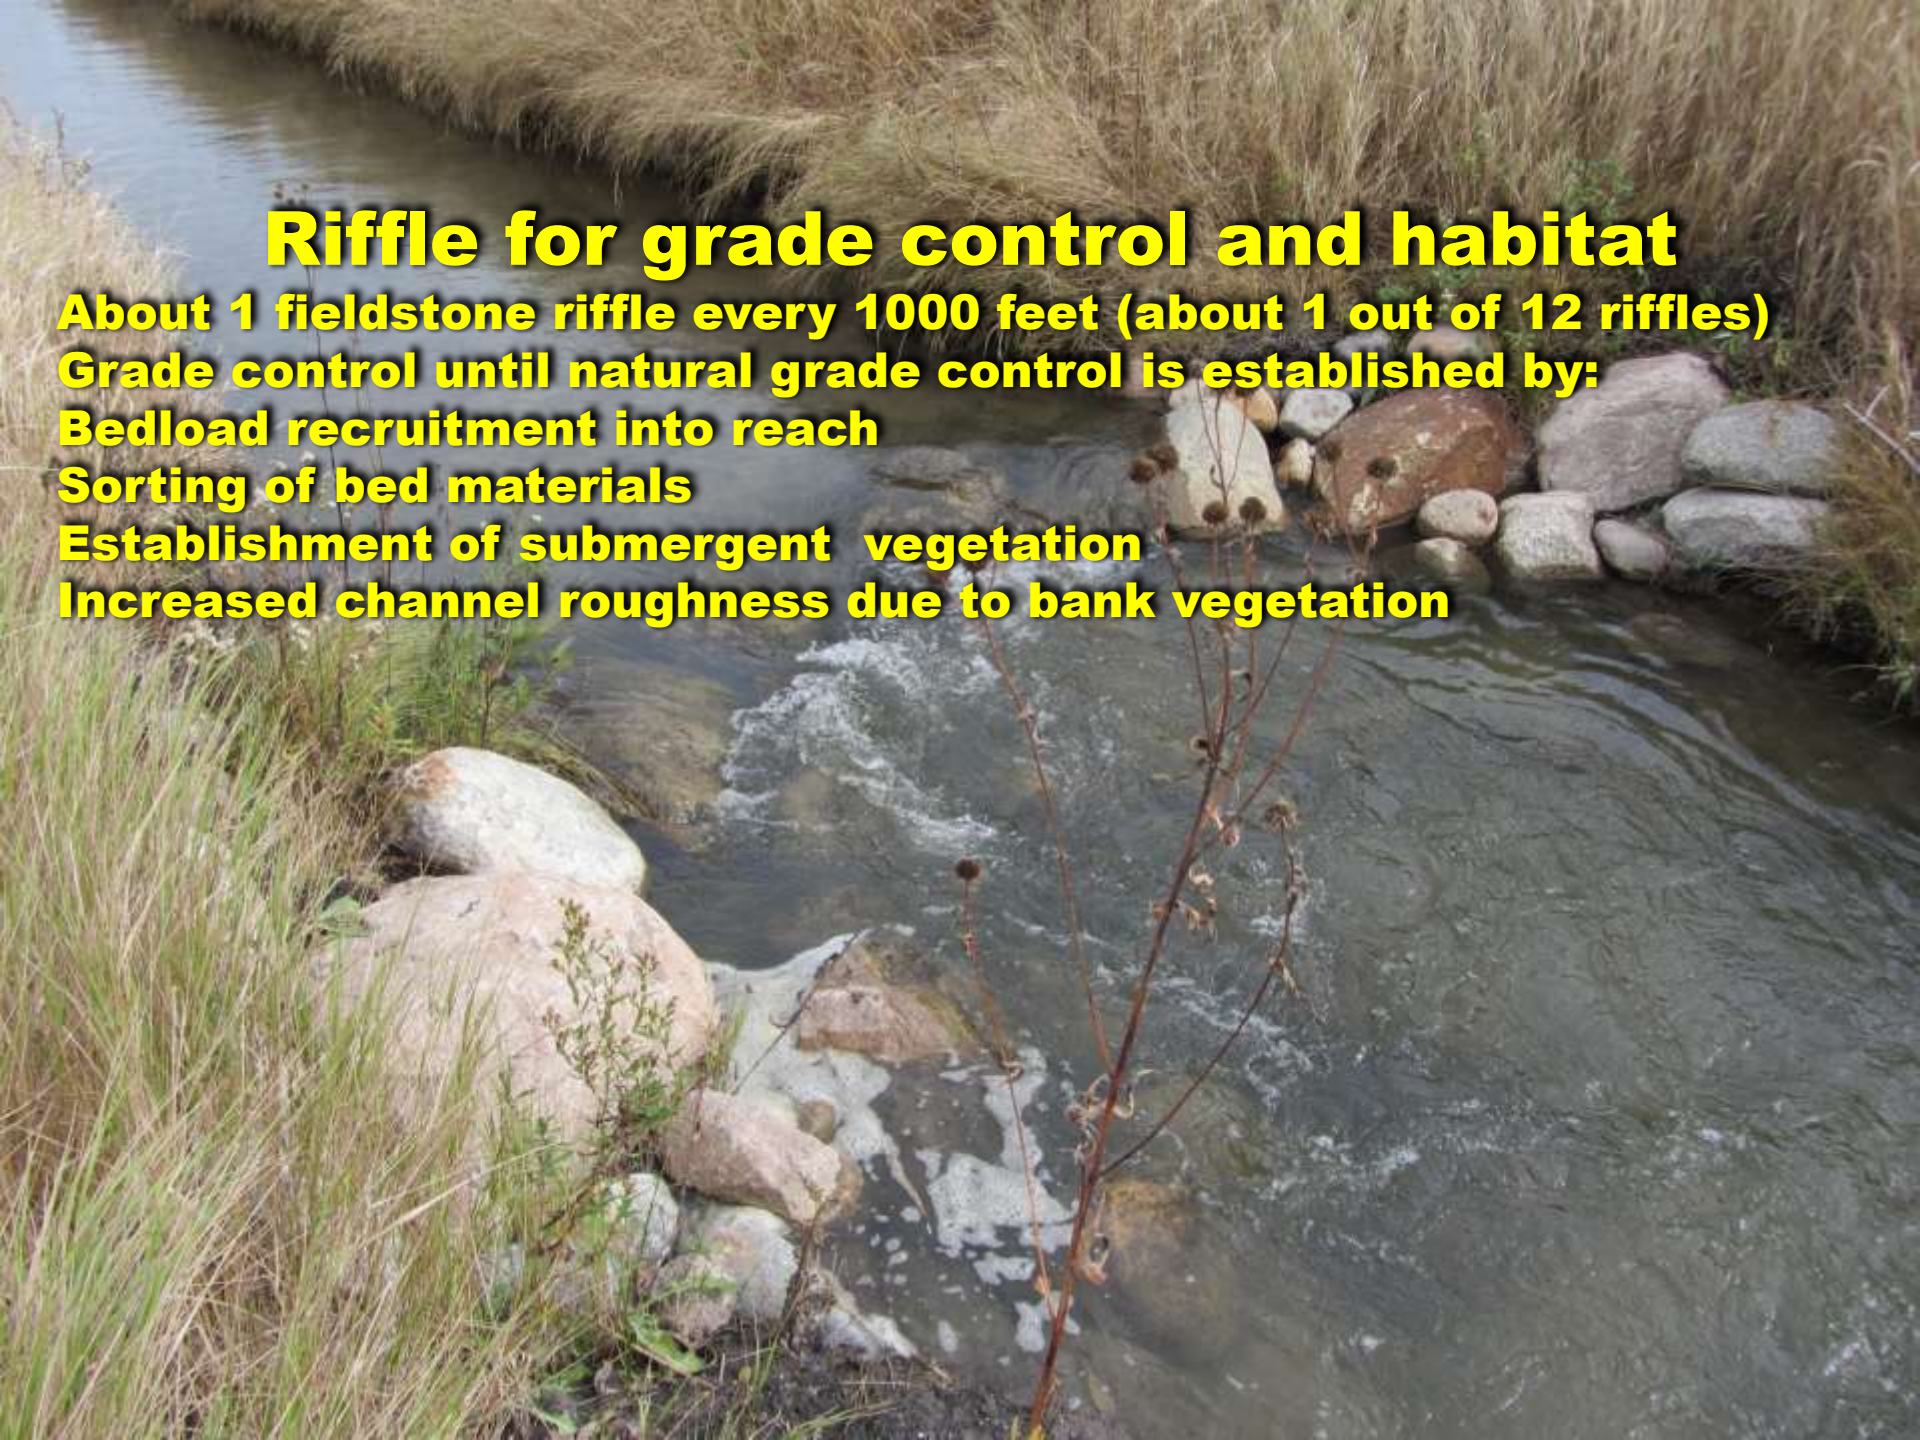
Riffle for grade control and habitat

About 1 fieldstone riffle every 1000 feet (about 1 out of 12 riffles)

Grade control until natural grade control is established by:

Bedload recruitment into reach

Sorting of bed materials

Establishment of submergent vegetation

Increased channel roughness due to bank vegetation
