Bluff Erosion in the LeSueur River Basin

Stephanie S Day

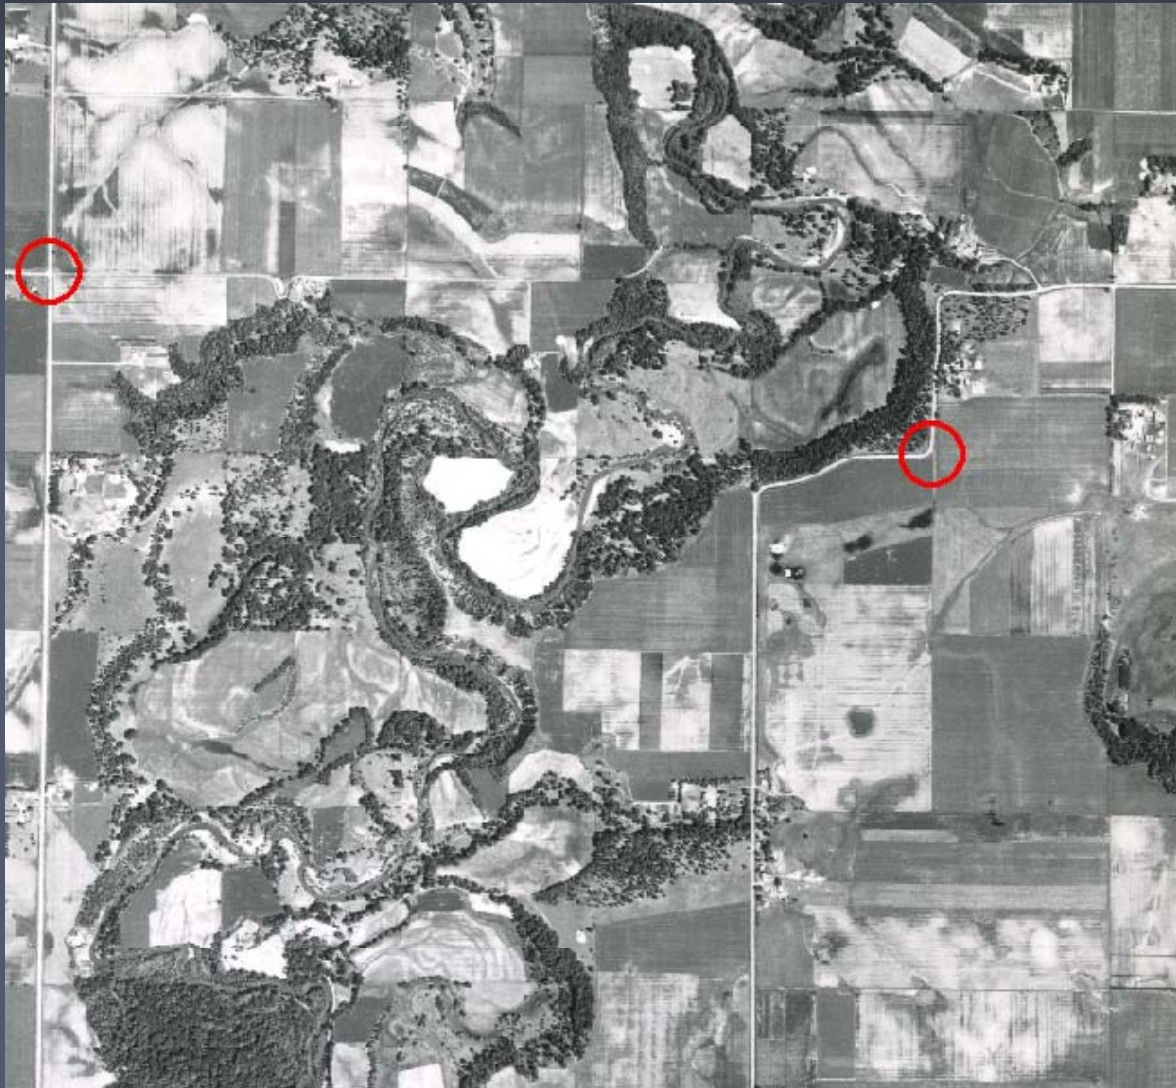
Aerial Photographs

1938

1971

2005

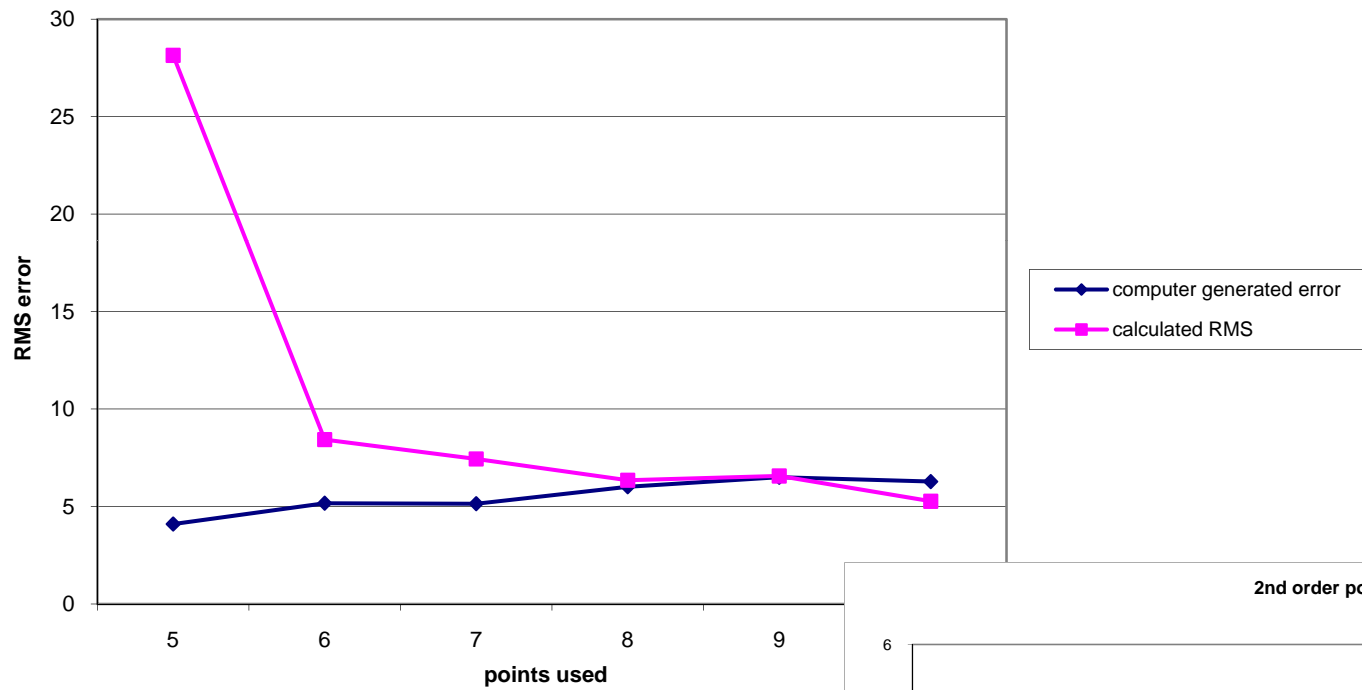
RMS error

1st order polynomial

- Arc GIS was used to georeference photos
- First order polynomial (affine) transformation used to reduce warp
- Eight or more stable points used to georeference aerial photos
- RMS error calculated by georeferencing error

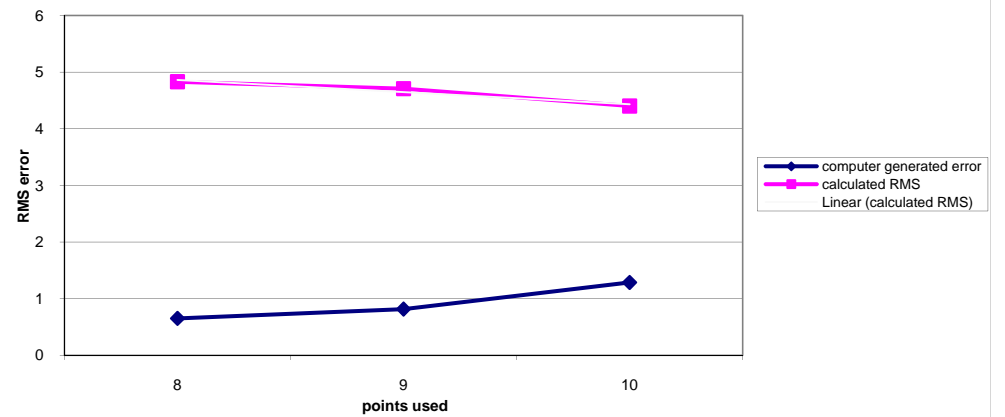
2nd order polynomial

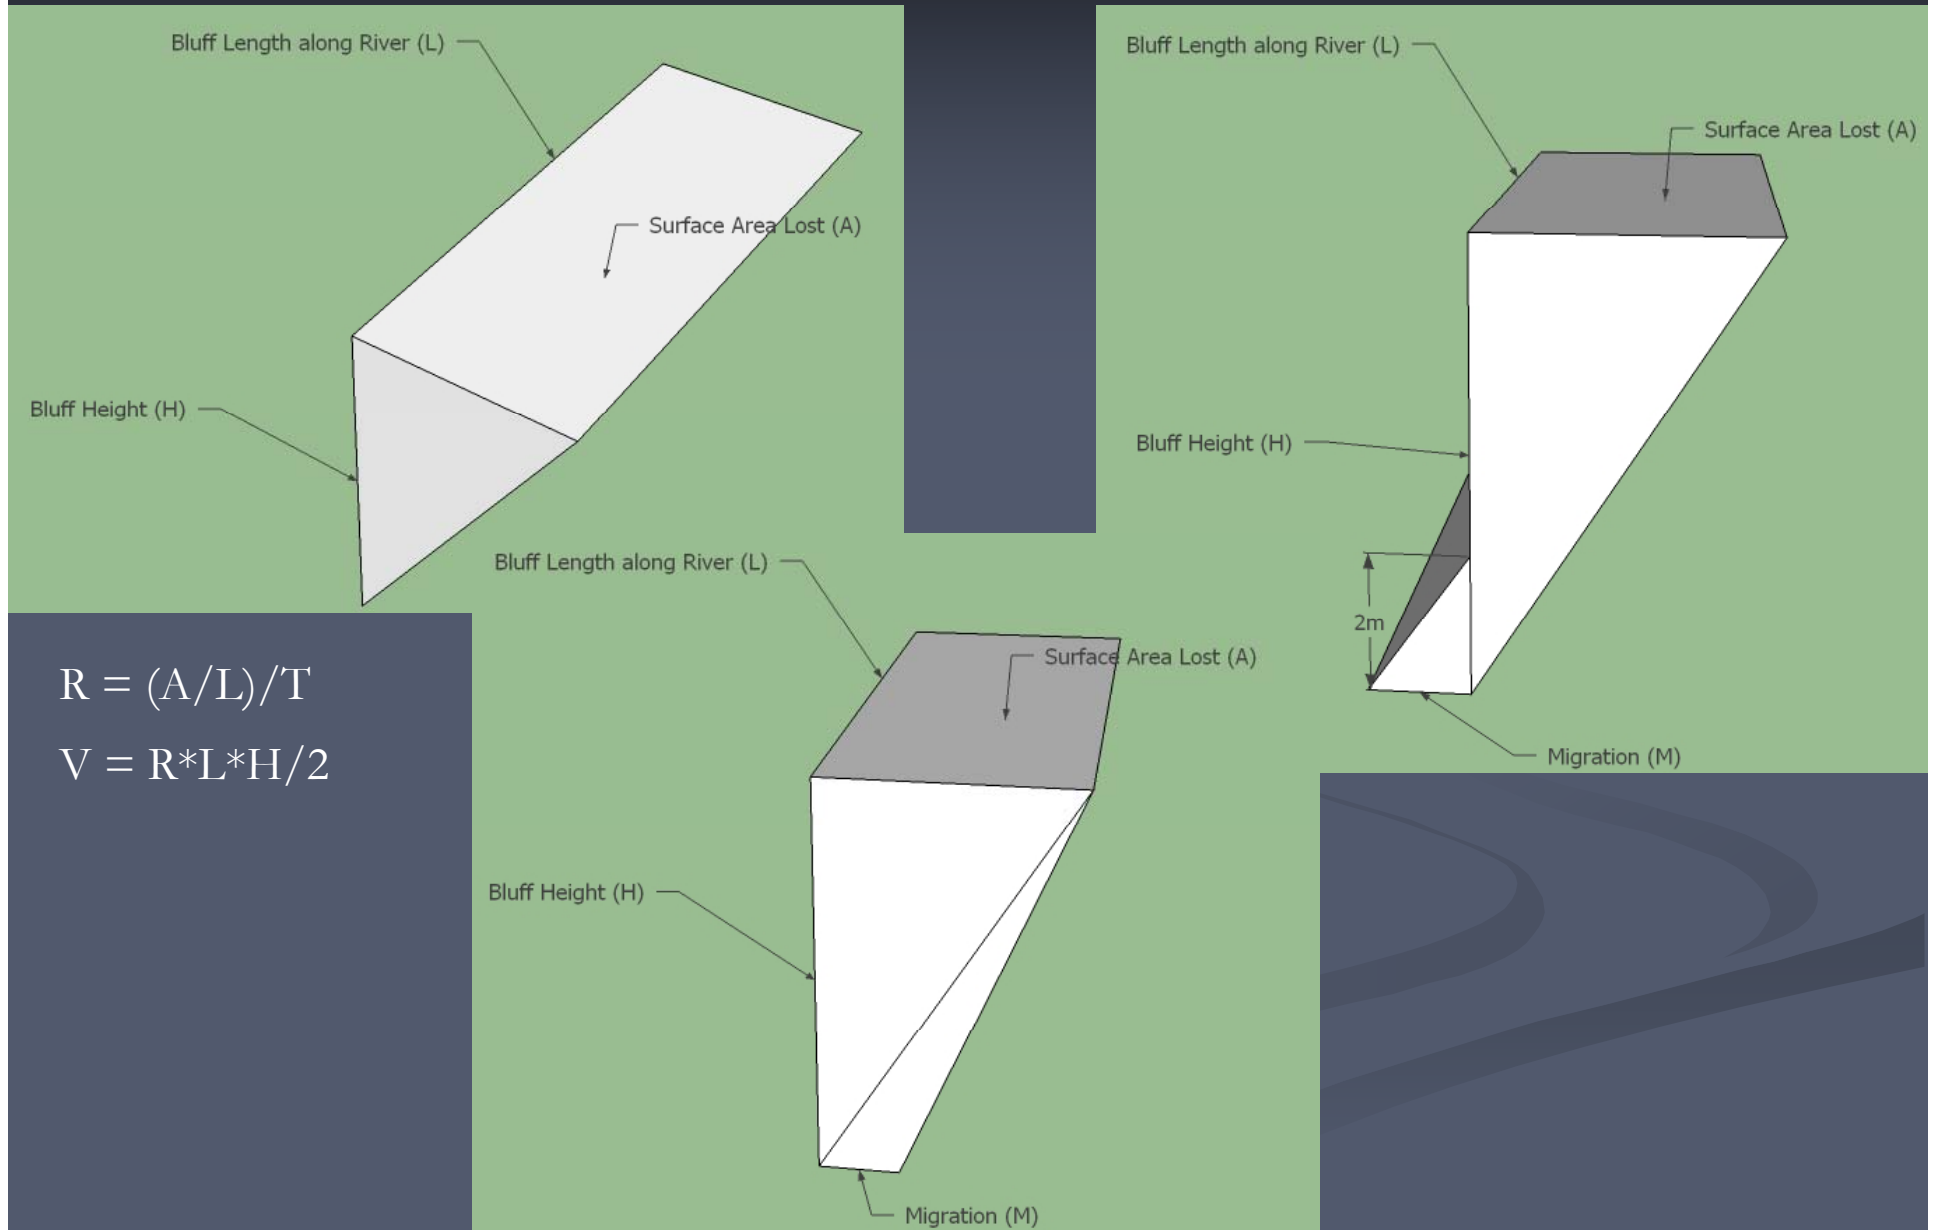
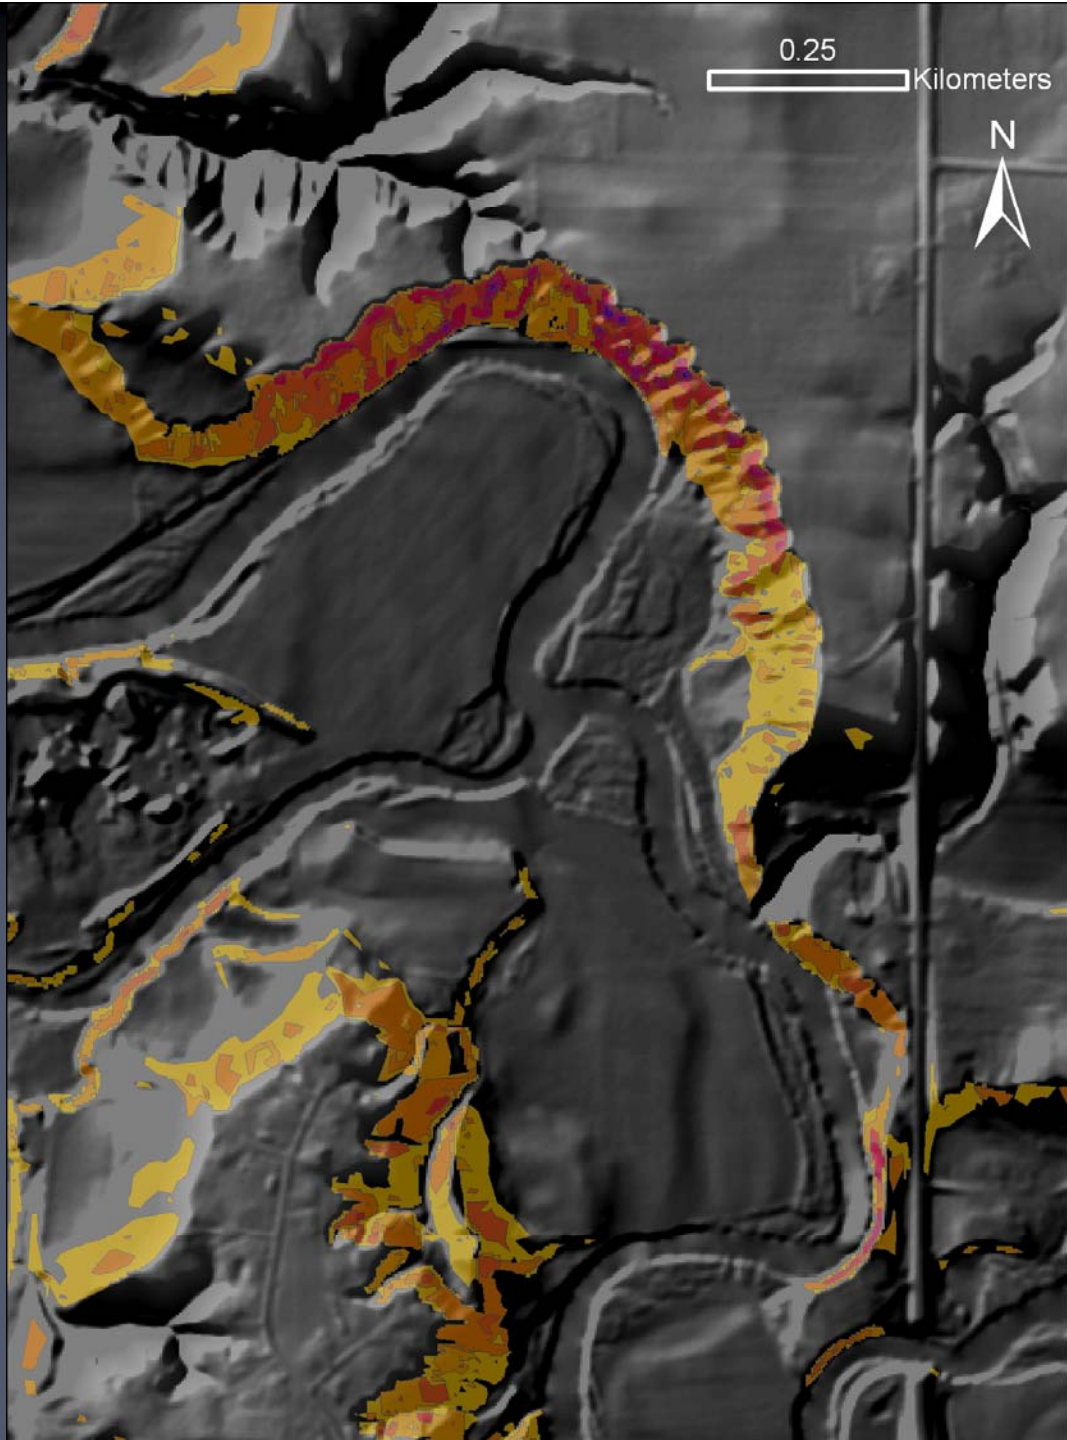
- Erosion at the base of the bluff causes failures near the crest of the bluff
- Material that slumps down and forms a toe is removed quickly by the river
- Minimum estimate of bluff erosion assumes a wedge of material being removed where greatest amount of sediment is removed near the crest of the bluff

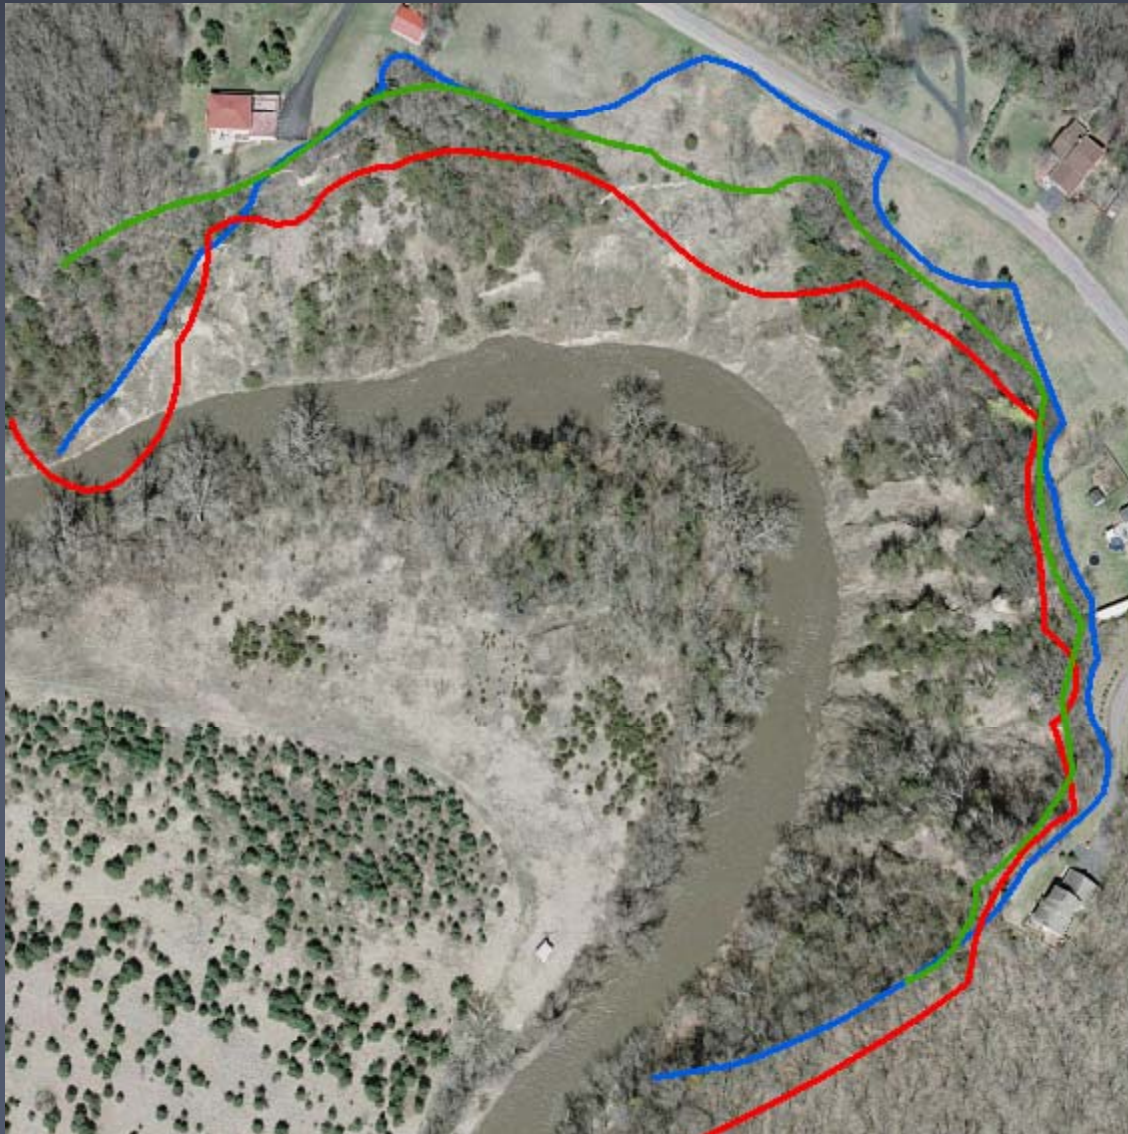
1938

1971

2005

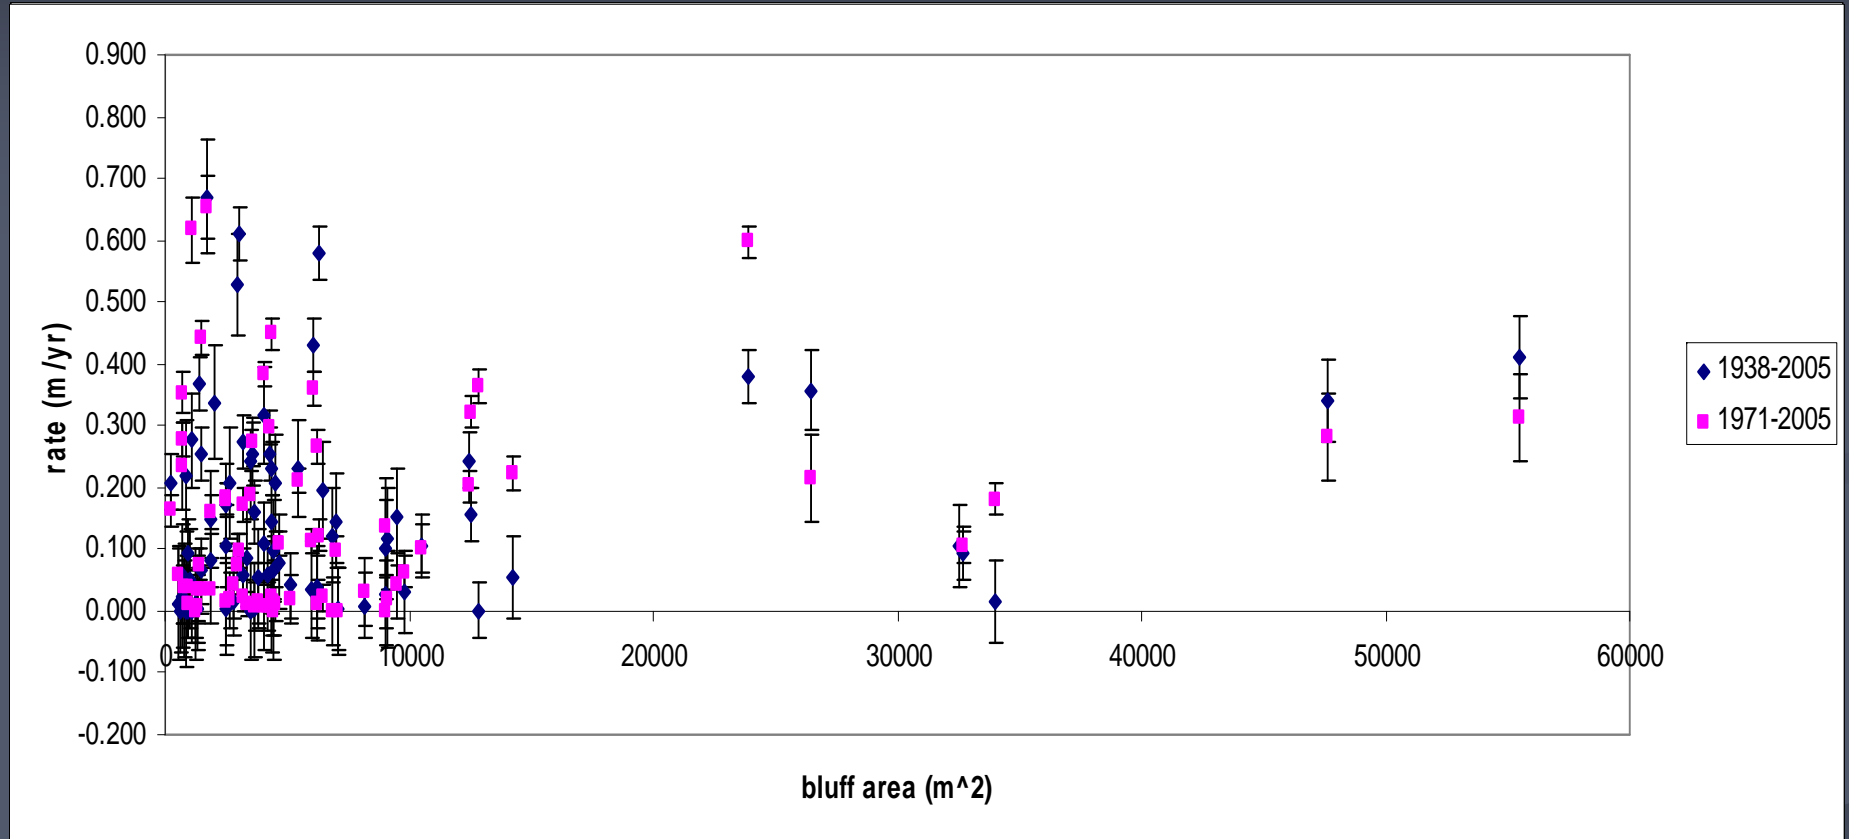
Average erosion 1938-2005: 0.15 m/yr \pm 0.06

1971-2005: 0.14 m/yr \pm 0.04

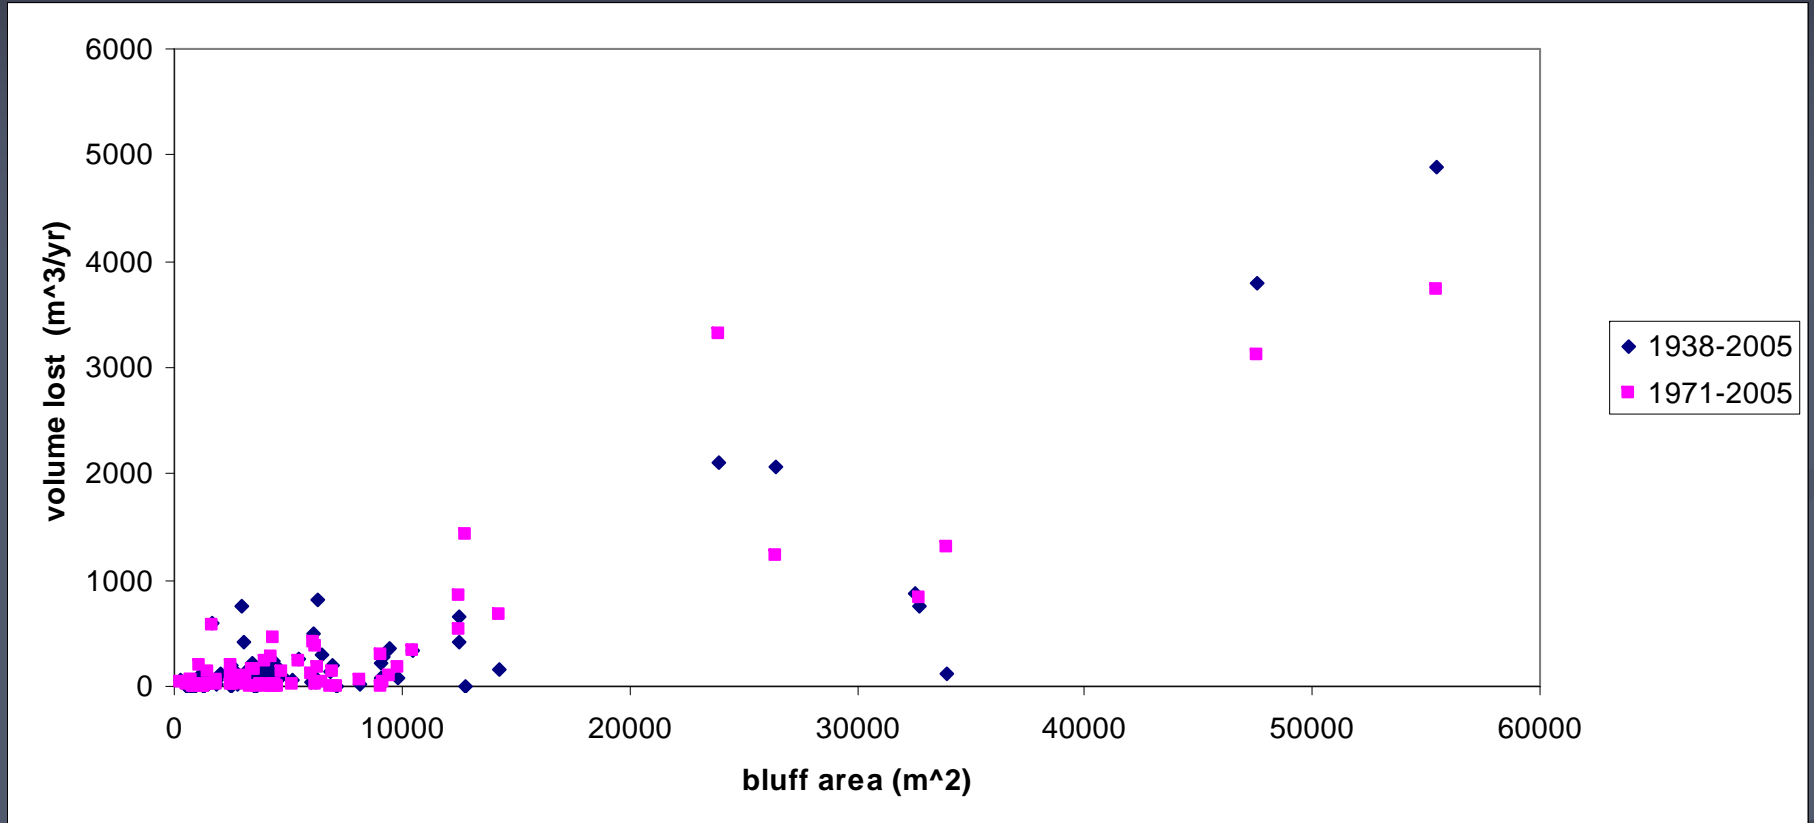
Total Volume lost assuming top wedge only 1938-2005: 25000 m³/yr
1971-2005: 23000 m³/yr

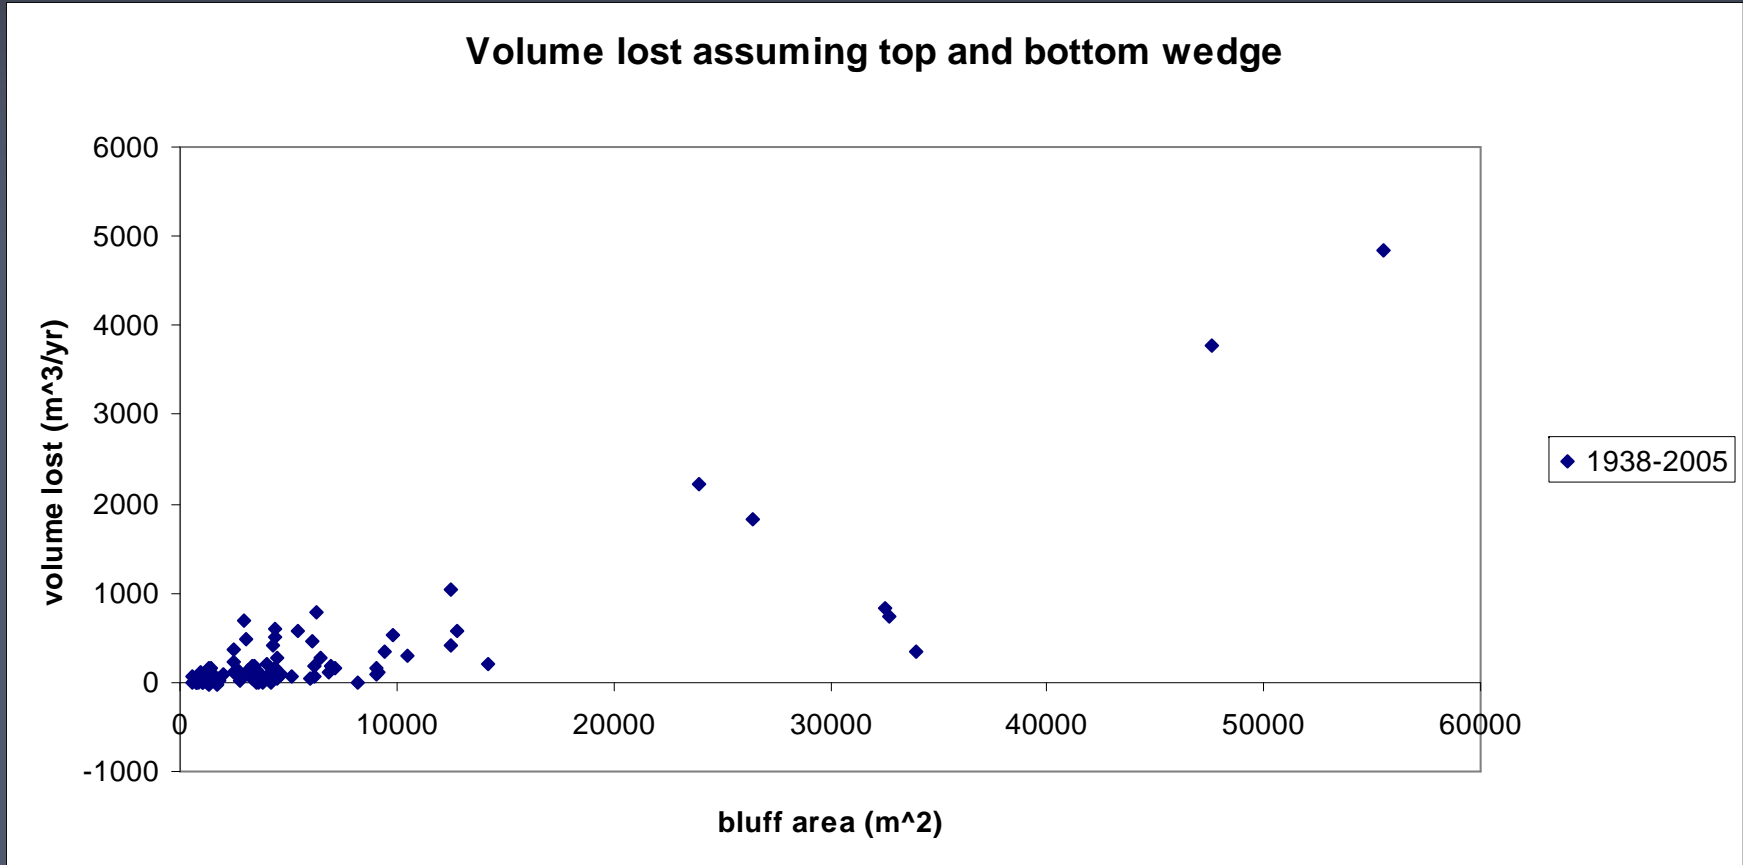
Volume lost for top and bottom wedge 1938-2005: 28000 m³/yr

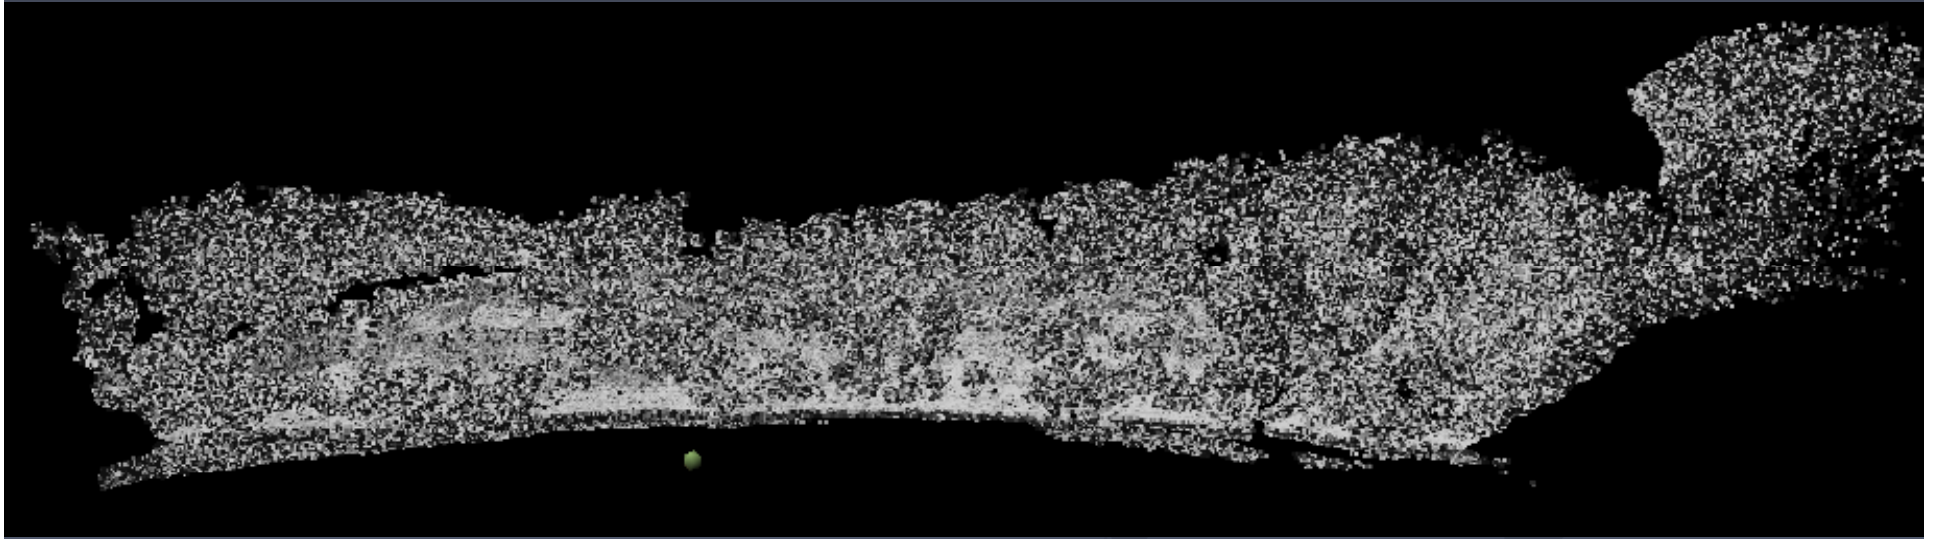
Before Vegetation is removed

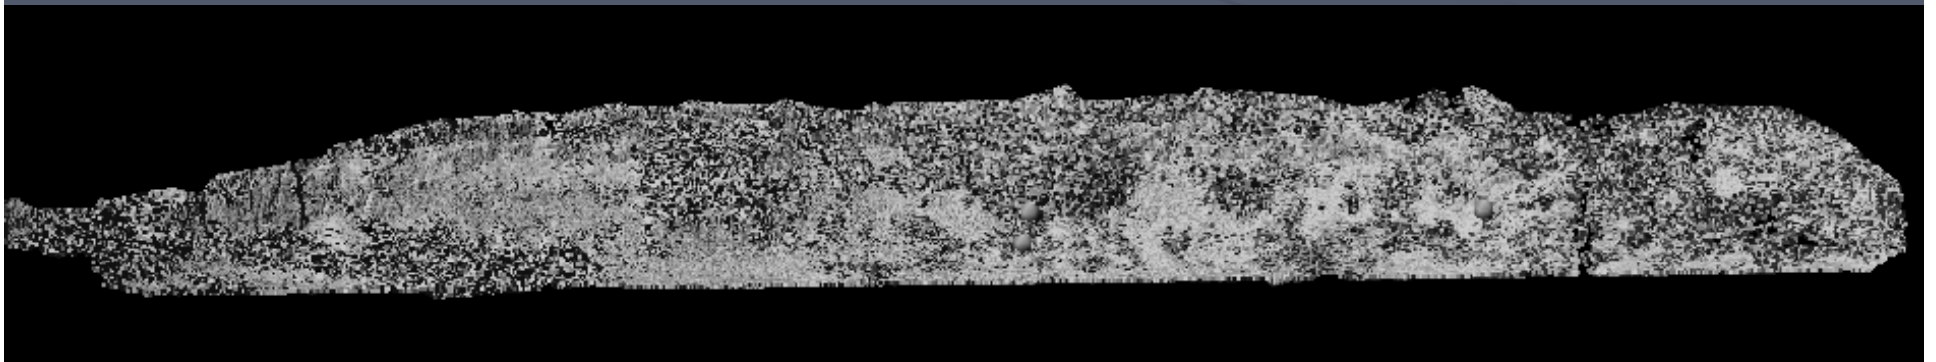
After Vegetation is removed

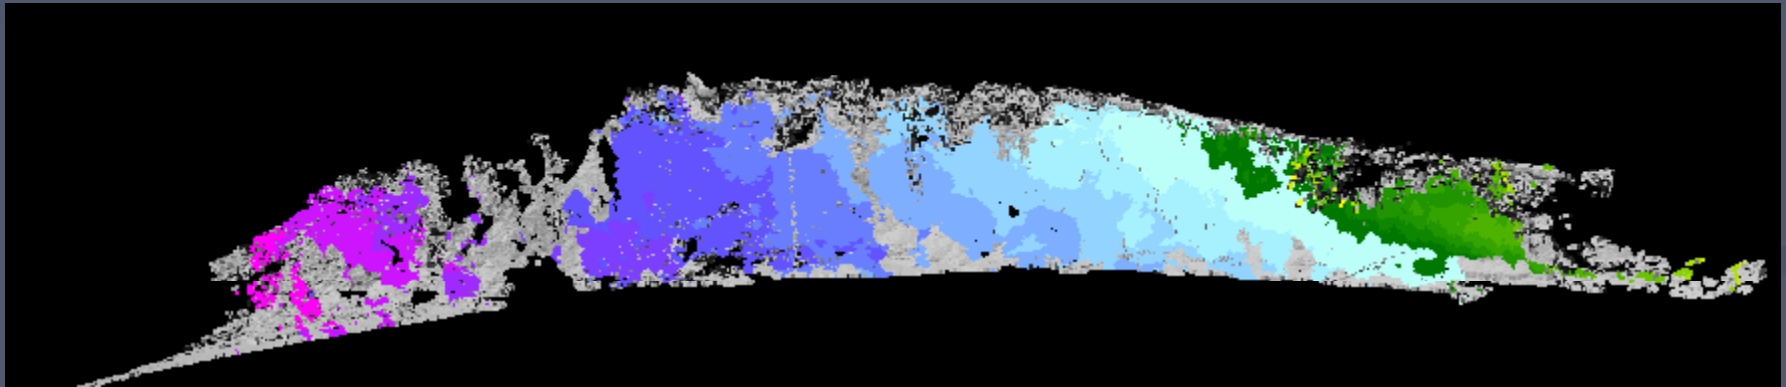
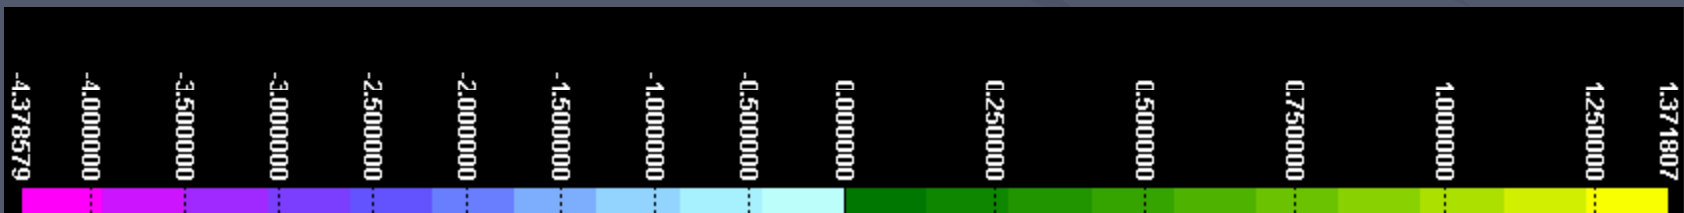
This is an example of bad alignment.

- The colors indicate the magnitude of change between two scans

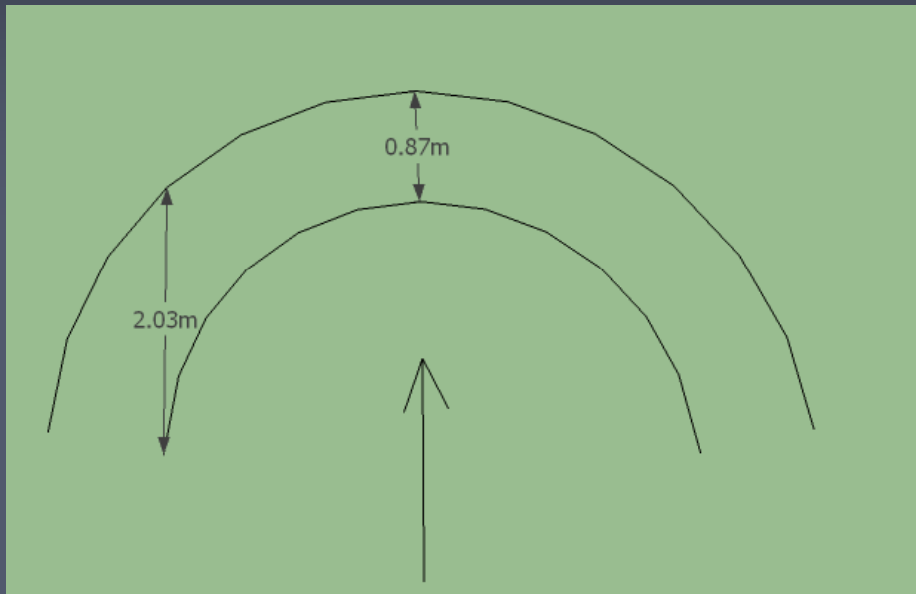
Result of looking at change in only one direction where bluff is curved

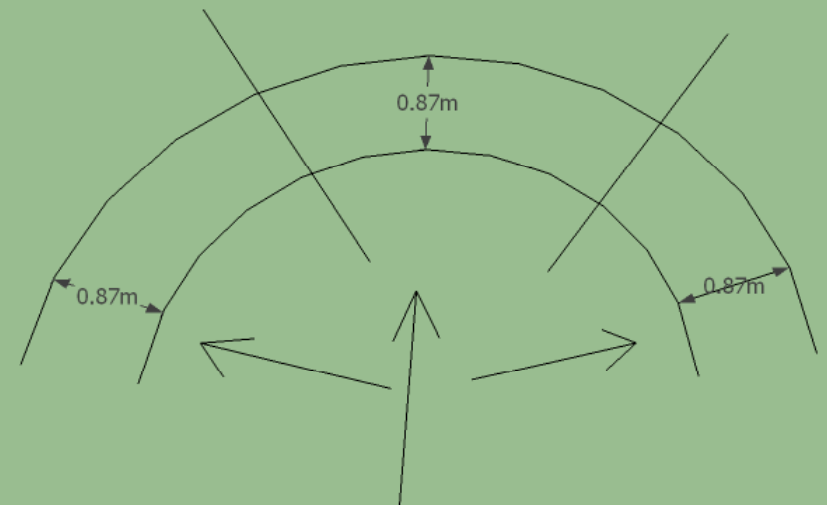
When using multiple vectors normal to the average surface, a more accurate estimation of the retreat is found

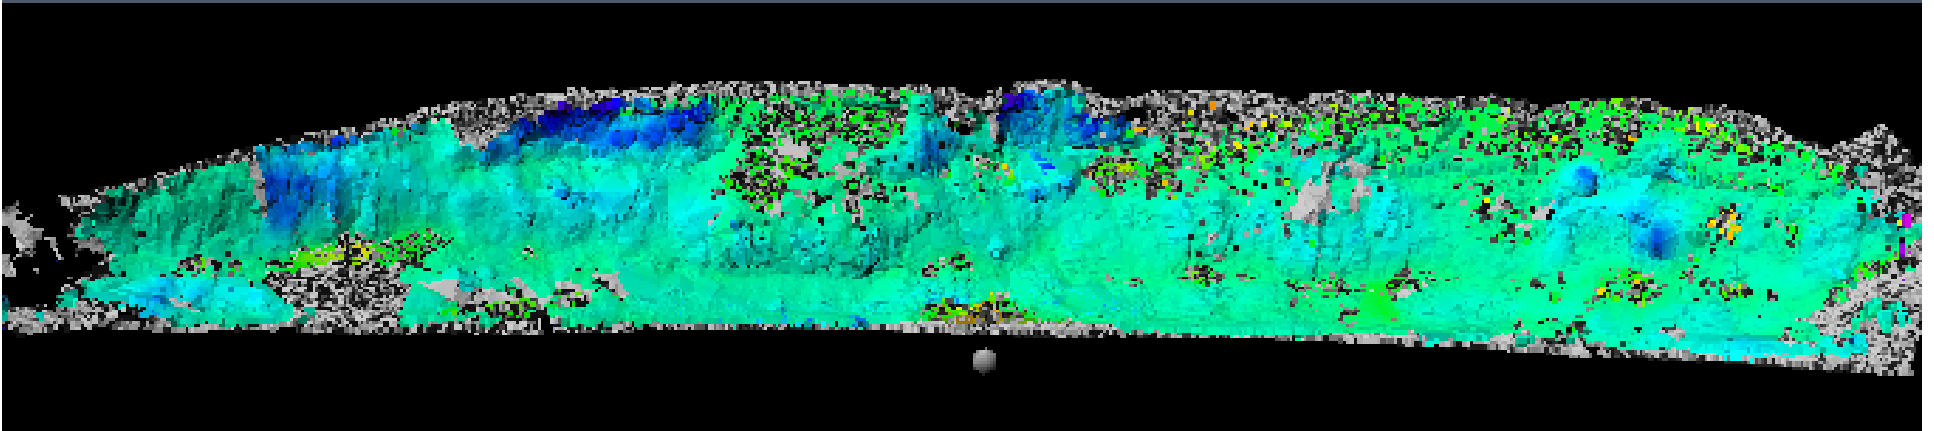
erosion

2007-2008

deposition

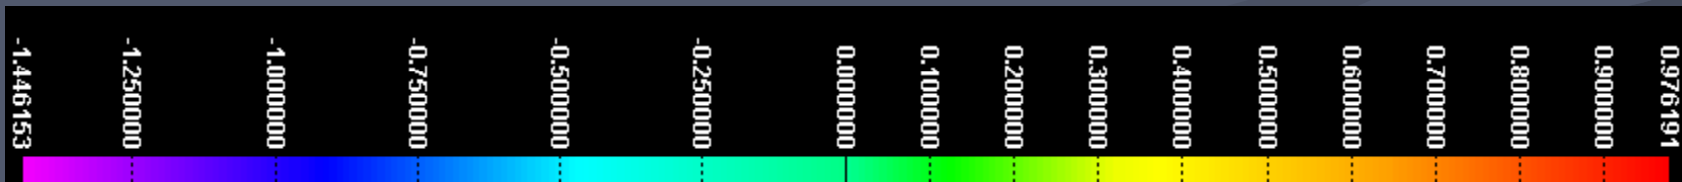
erosion

2007-2008

deposition

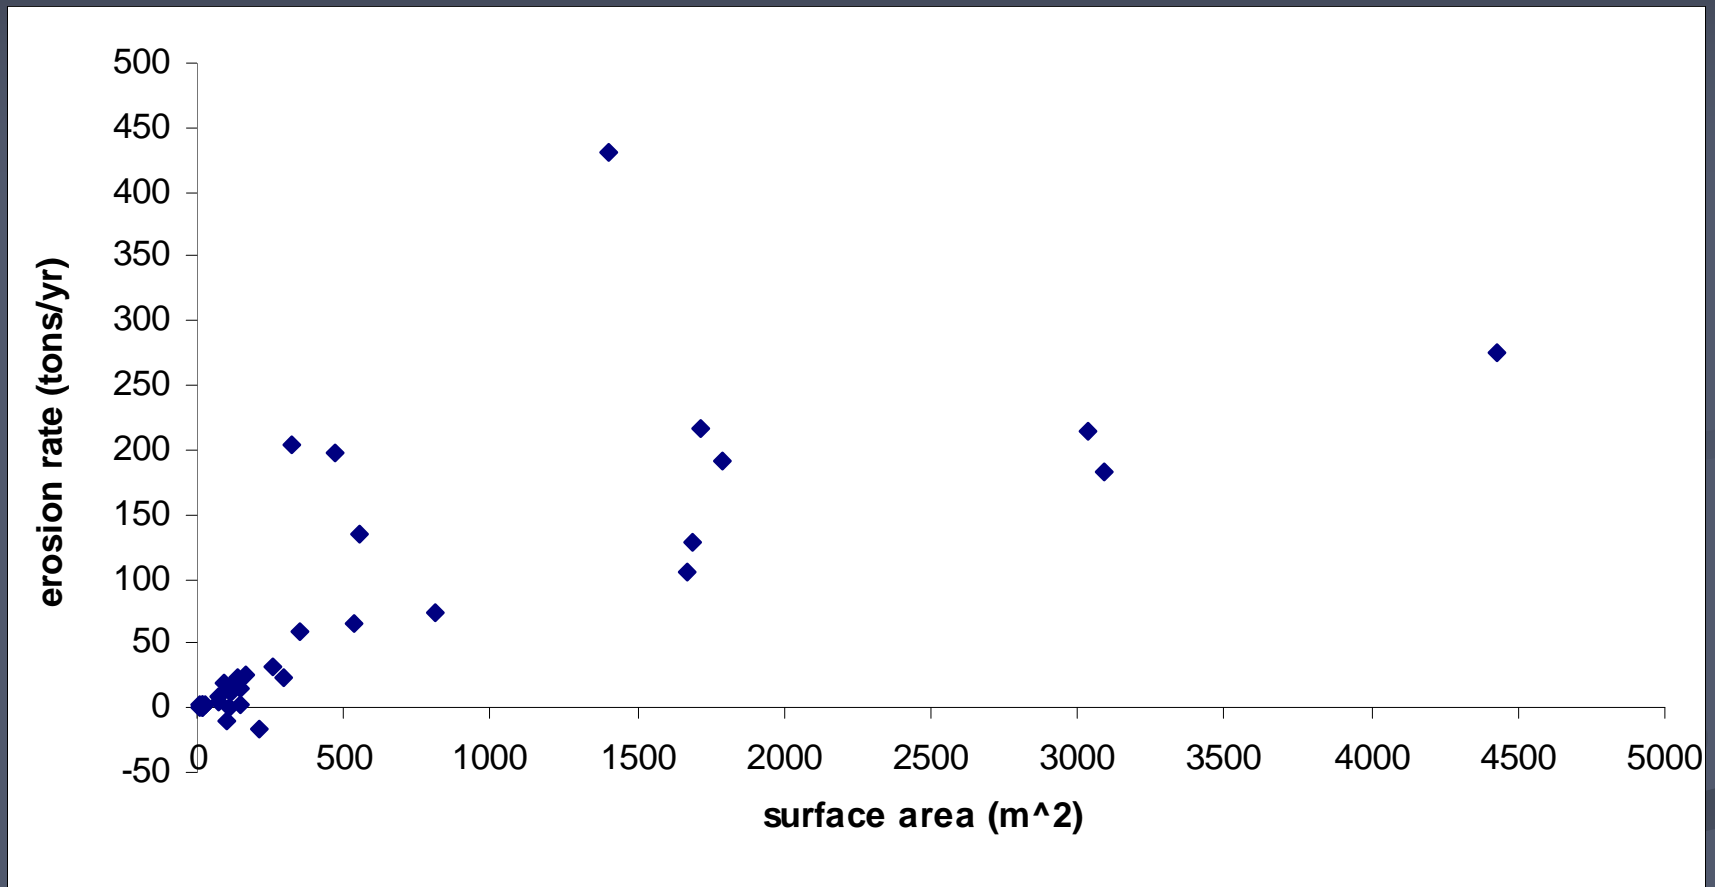
Average erosion rate 0.10 m/yr
Average volume lost 50 m³/yr
