Minnesota Falls Dam, Minnesota River

Dam Removal

Montevideo Dam, Chippewa River

Dam Removal & Modification with a Rock-Arch-Rapids

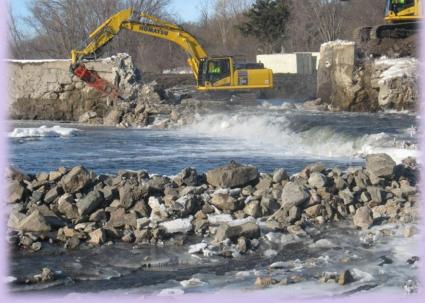
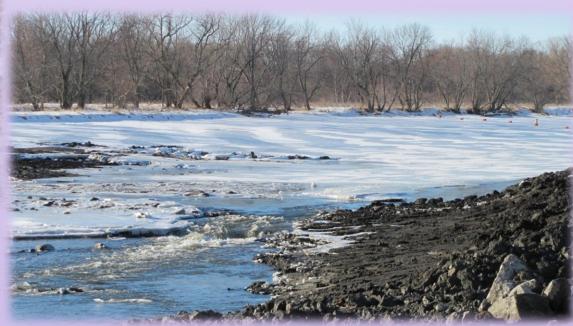
- ♠ Removal of the dam drained the almost 3 mile long reservoir which exposed natural waterfalls and rock outcrops and restored significant riffle spawning habitat crucial to many native fish species including: paddlefish, lake sturgeon, shovelnose sturgeon, American eel, blue sucker, flathead catfish, and quillback.
- ♦ Removal reconnected 3 miles of the Minnesota River allowing upstream migration of fish and mussel species.
- Recreational opportunities such as canoeing, kayaking, and fishing have been greatly improved in this reach of the Minnesota River, which is a designated Wild and Scenic River.

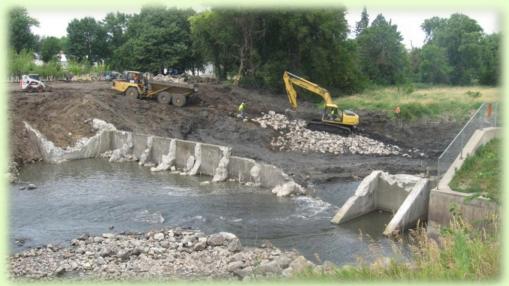
Details: The dam was notched to let the reservoir drain for several days, then the dam was completely removed, including the abutments. A diversion 12 miles upstream was used to divert flow during construction. A rockarch-rapids was constructed just upstream of the dam site for grade control and to prevent head cutting. The river carved a new channel through the reservoir sediment. Some work was done upstream, j-hooks and a rock riffle,

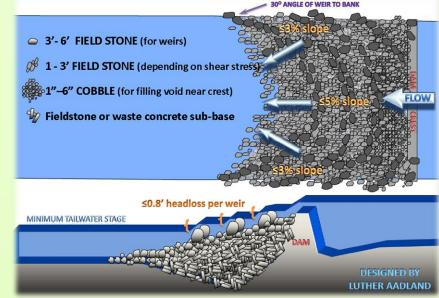
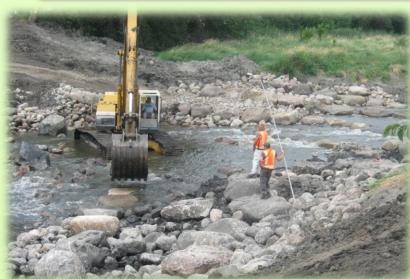
- ♠ Removal of the dam reconnected 12 miles upstream on the Chippewa River. The river upstream of the dam is largely a natural channel with high habitat diversity including riffle and gravel habitat.
- Removal reconnected the main-stem Minnesota River to very valuable upstream habitat for the fish and mussel community.
- ♦ This site is in the city of Montevideo along a city park so is a popular fishing and recreation area.
- ♦ This reach of the Chippewa River is also a popular canoe route and has received rave reviews from canoe and kayak enthusiasts.

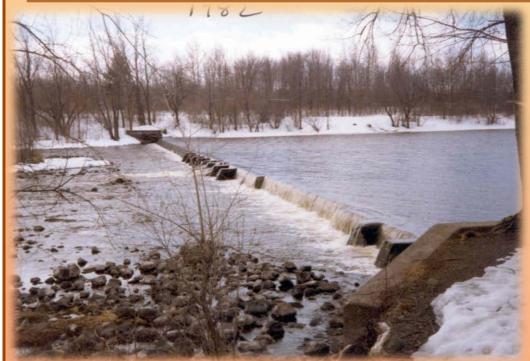
Details: A ramp or wedge of base rock was constructed below the dam. Over 400 4-6' boulders were placed strategically in a honeycomb design. This design, which incorporates round cells into the rock-archrapids design, emulates a natural rapids with a variety of pools, eddies, and cascades. This creates spawning habitat for sturgeon and other fish species.

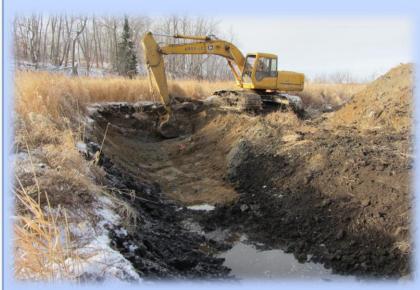
Details: The stop logs were removed, starting in 2008, to slowly lower the reservoir water level to let the sediment consolidate and to allow the stream to create a river channel. The channel restoration was designed from an upstream reference site and the historic channel. In fall 2012, a 500' meandering channel was excavated. Bank stabilization techniques including, toe wood-sod mats, root wads, and willow plantings, were used to protect some of the outside banks.

Future: A rock-arch-rapids will replace the dam and will be built when the bridge is replaced. The rapids will maintain water slope and prevent erosion of the nine feet of accumulated reservoir sediment. Due to the volume of accumulated sediment and high arsenic levels, it would have been too costly to haul offsite.
