Presentation to the

Upper Midwest Stream Restoration Symposium

Habitat Improvement on Valley Creek

Tom MacDonald, Barr Engineering Co. Feb. 22, 2010

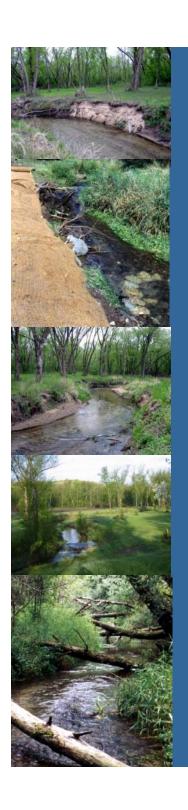
Option 4 Selected

Floodplain grading and grade control

- Excavate floodplain terraces
- Boulder riffles for grade control

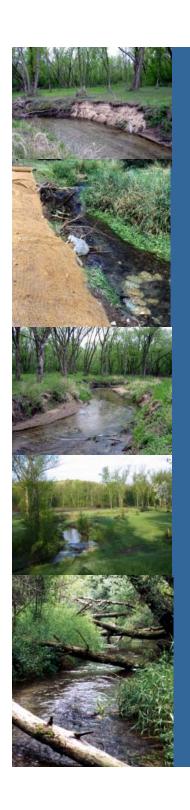
Final Design

- Excavate floodplain terraces
- Eight Boulder riffles for grade control
- 45 root wads installed
- 7,000 feet of biolog
- Native grass, willow stakes and shrubs

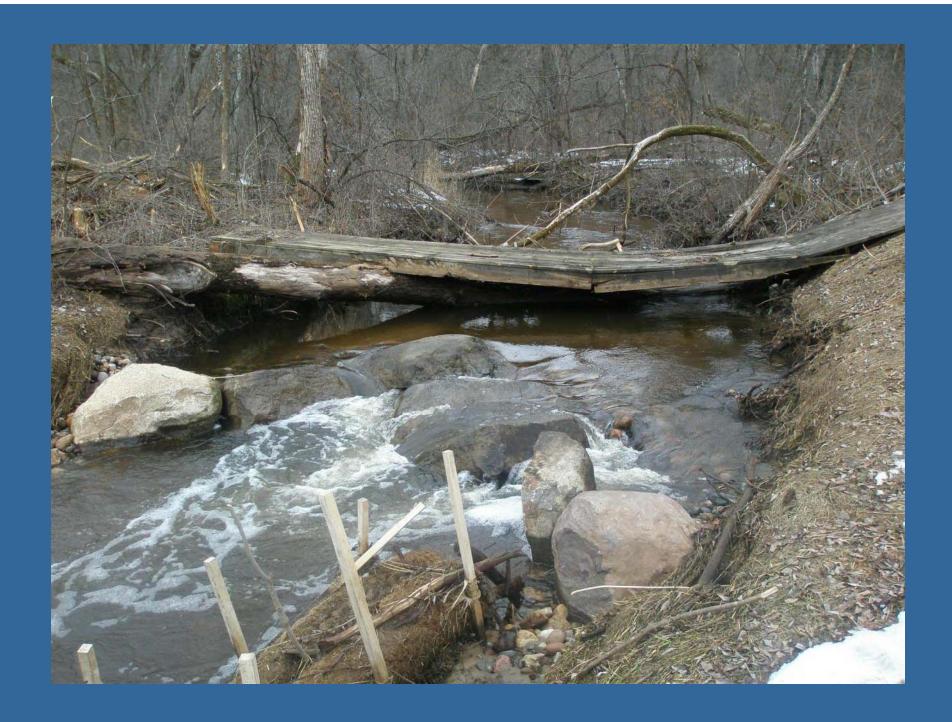
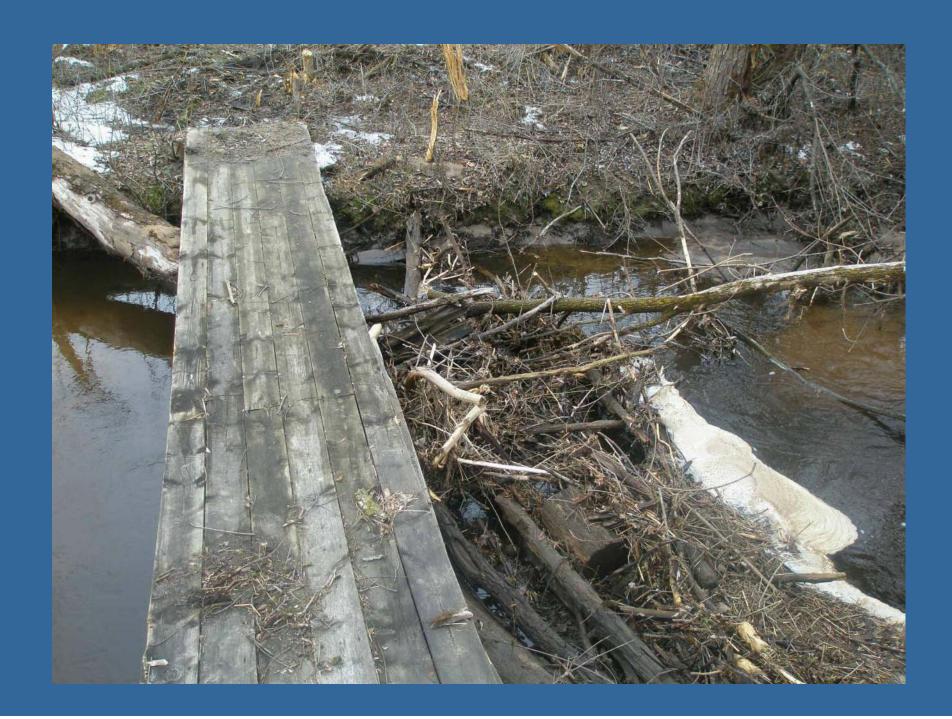
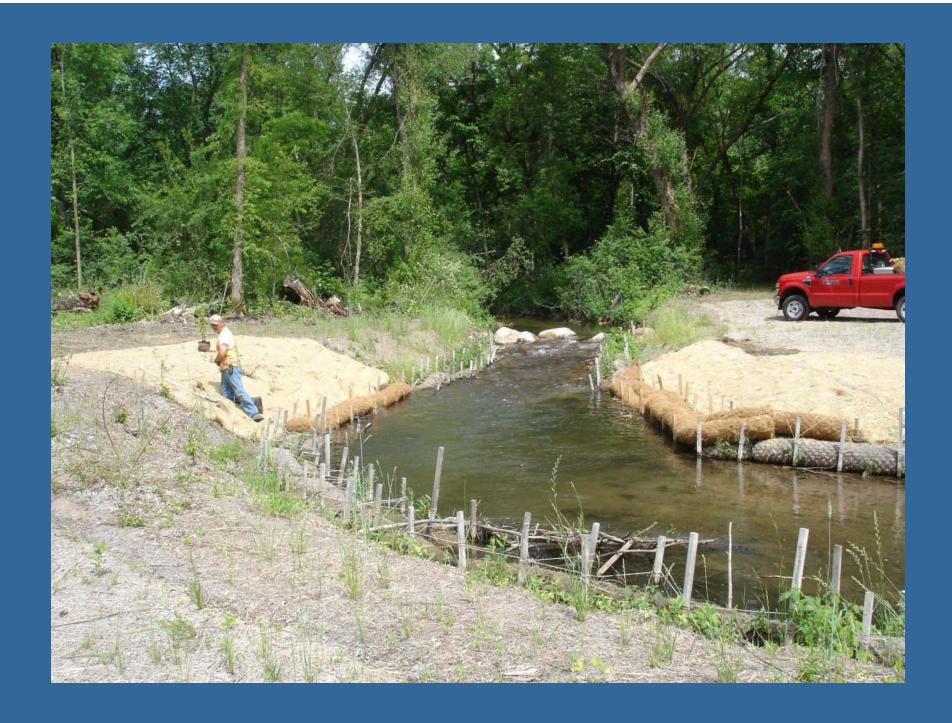
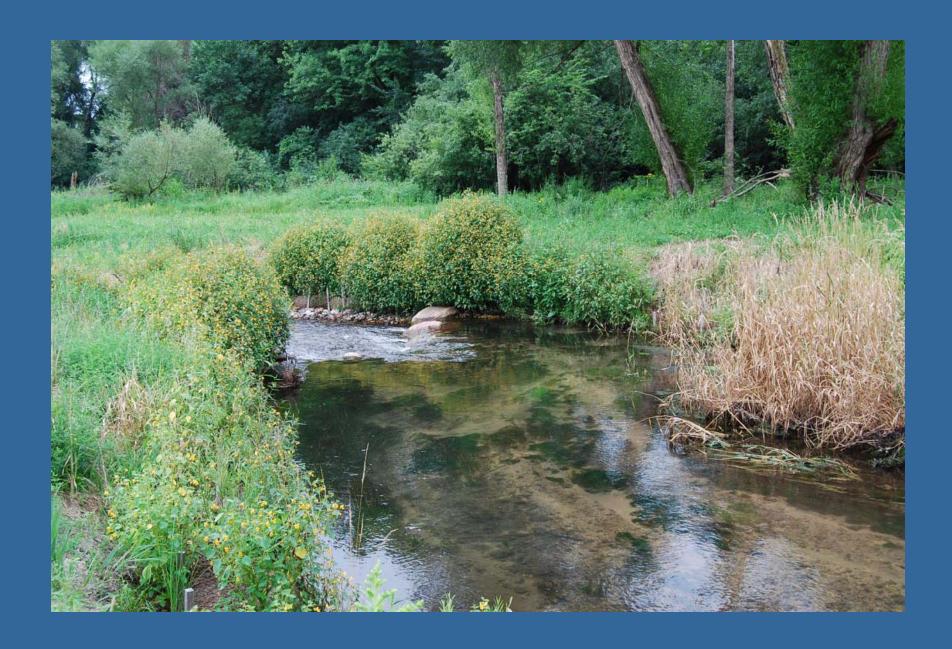
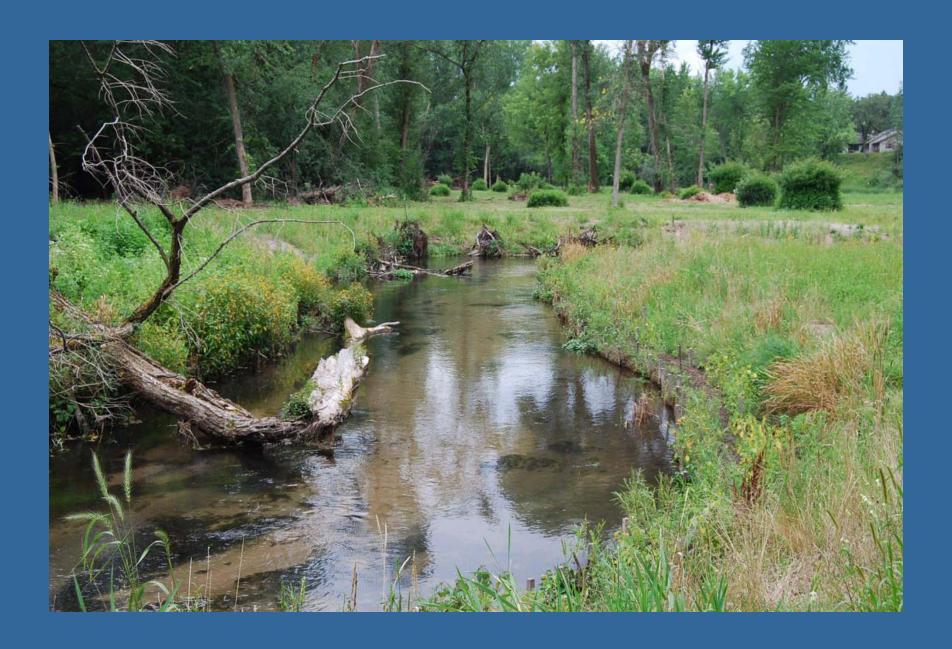
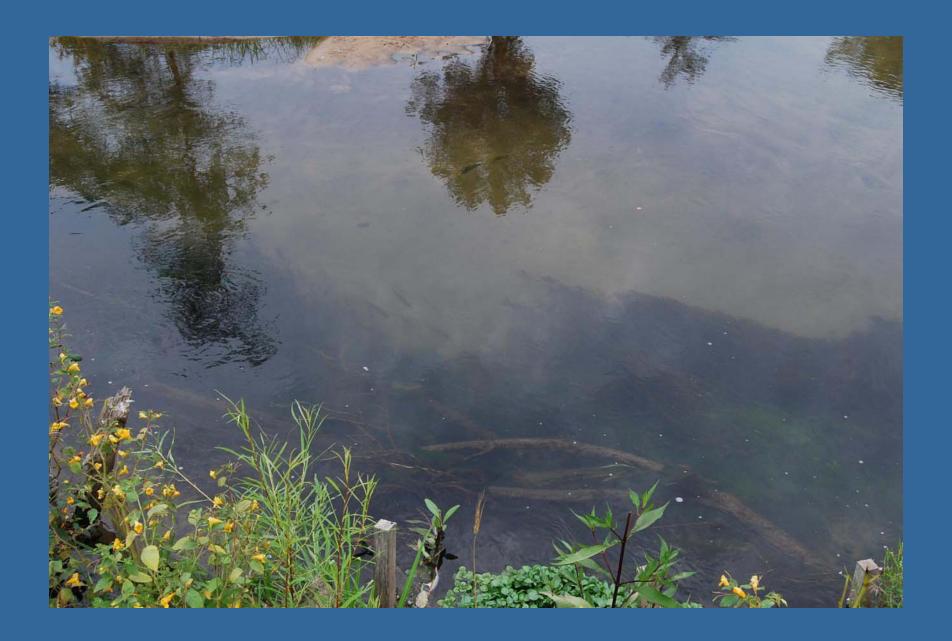
Snowmelt Event Feb. 2009

Bank vegetation not yet established....

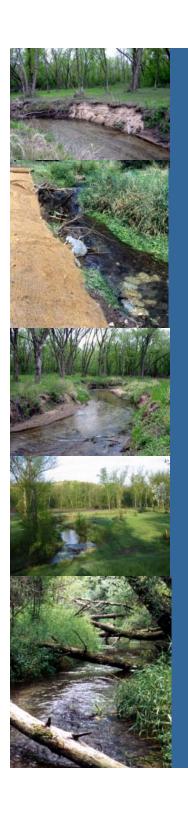
CSAH 18 Bridge Replacement

- MnDNR Habitat improvement project to mitigate wetland loss
- Narrowed channel width beneath bridge using lunker structures
- Root wads provide for stable banks and fish habitat
- Boulder riffle grade control

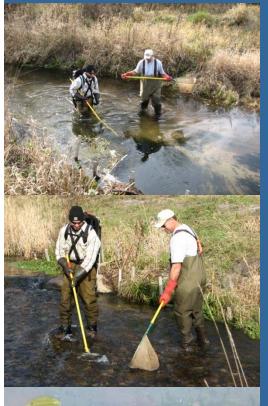
- Site I located upstream of CSAH 18 bridge, downstream of VBWD project
- Site II (control site) located upstream at Stagecoach Road
- Both sites also sampled by MnDNR in 2006

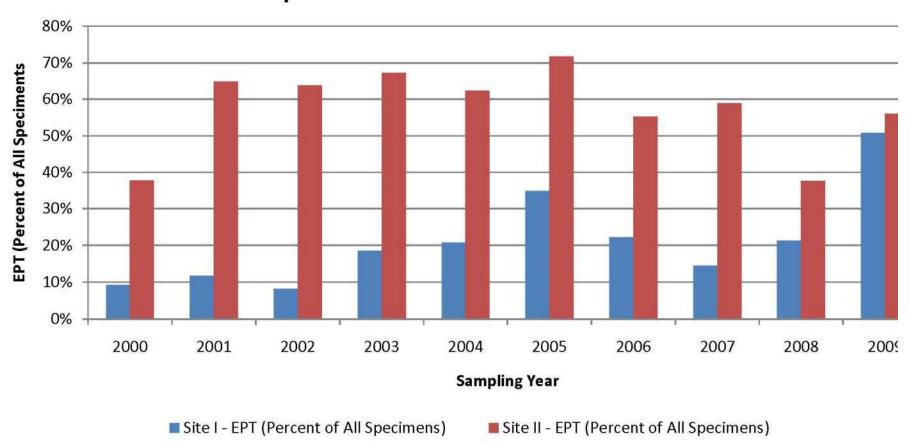
Valley Creek Aquatic Macroinvertebrate - Percent EPT
