Stream Restoration at Road Crossings in Northern Wisconsin

Dale Higgins, USDA Forest Service

Stream Restoration at Road Crossings in N WI

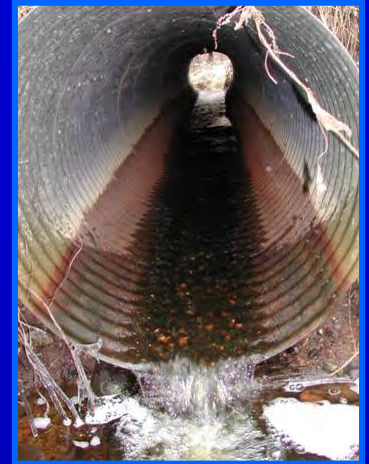
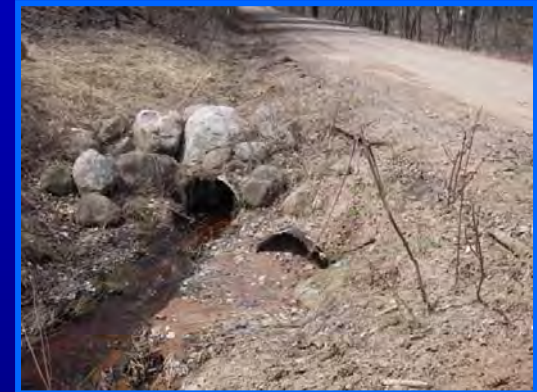
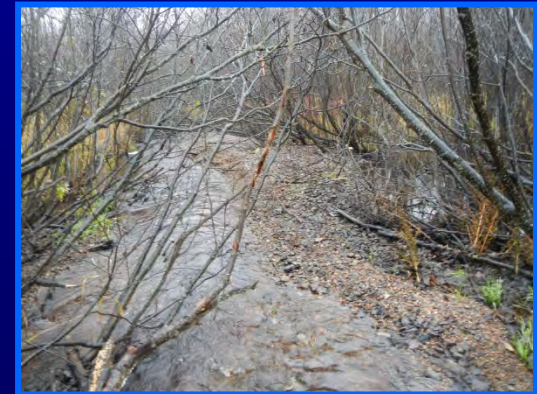
Stream Crossing Impacts

- Restrict aquatic organism passage
- Degrade water quality (sediment, water temperature)
- Alter channel morphology (aggradation and scour)

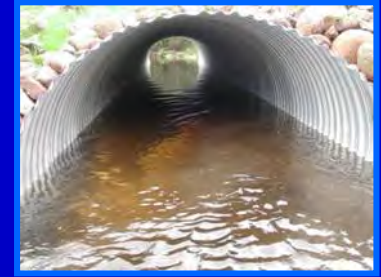
Low Gradient (<0.5%): BFW-TWC

- **Bankfull width (BFW) - tailwater control (TWC).**
- **Tailwater provides sufficient depth and velocity to allow AOP**
- **Sized to match BFW and pass the 100-yr flood (Q_{100}) with a headwater to depth ratio (HW/D) <1 (i.e., below top of culvert)**
- **Invert elevations are based on analysis of the stream profile**
- **Invert elevation restores or maintains channel morphology and the natural transport of sediment and organic matter**
- **Generally no material is placed in the culvert, with exceptions**

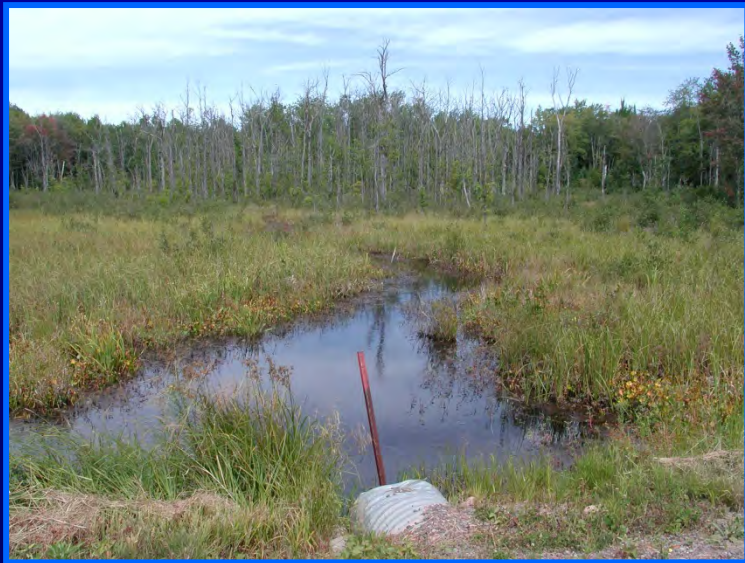
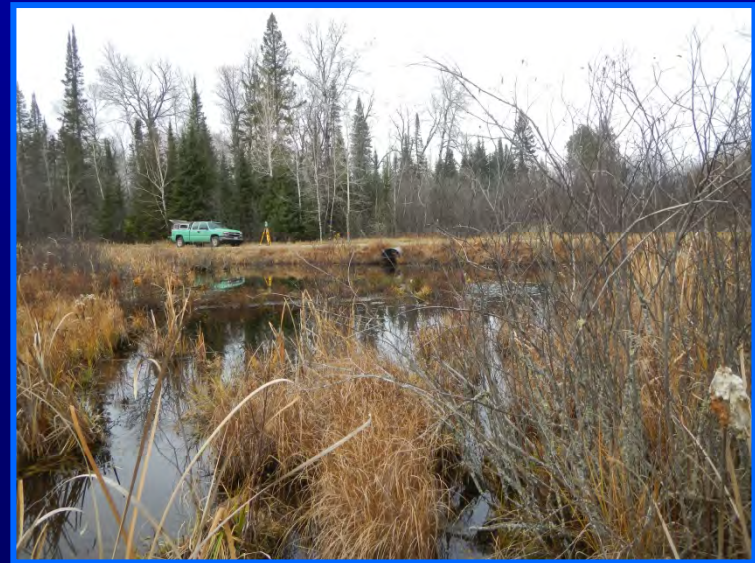
Low Gradient: Inlet Set High

- Many low gradient streams have slopes of just 0.1-0.2%
- Culverts set just 1.0 ft high can cause water to pond several hundred feet upstream
- Channel aggrades with sand and muck

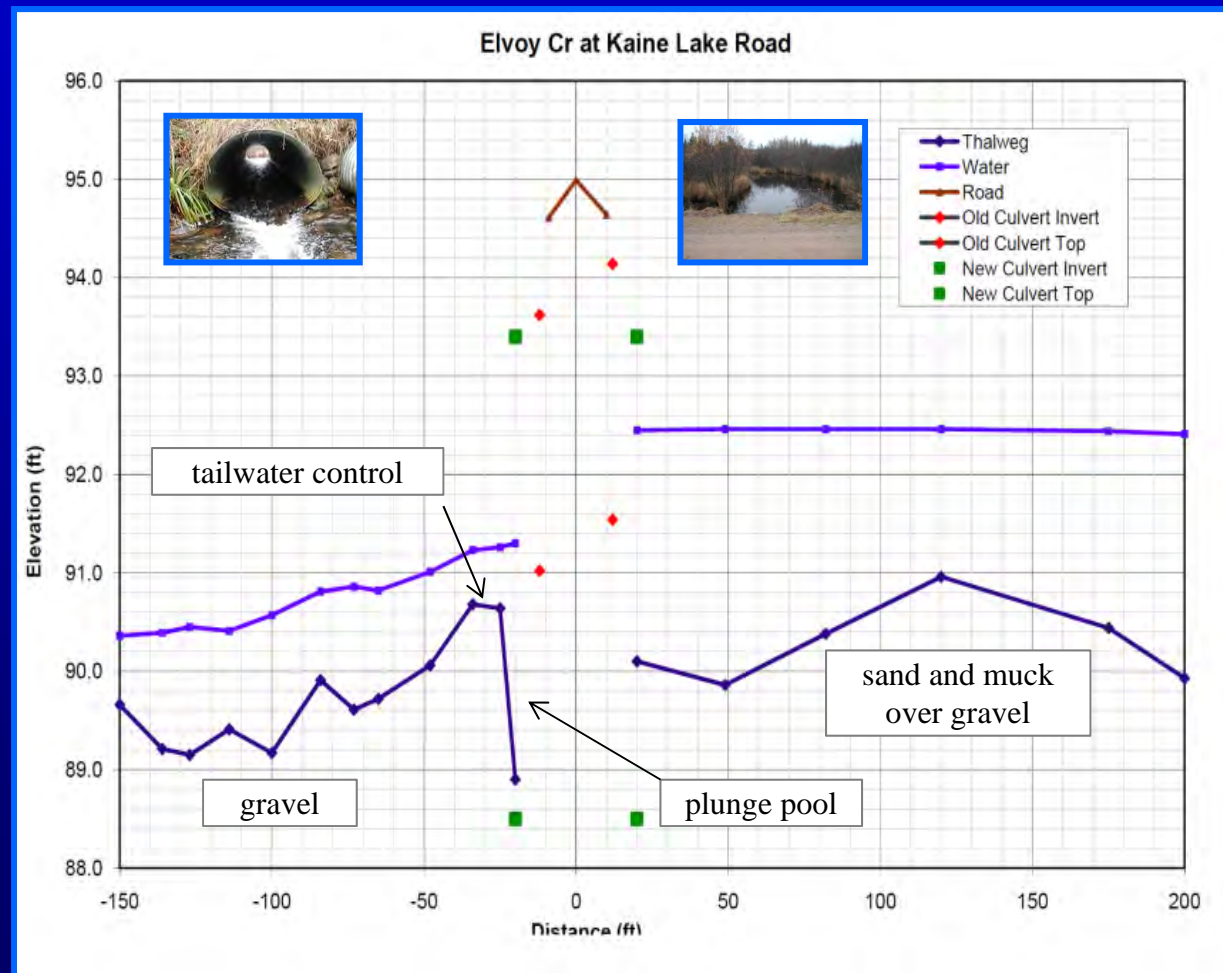
Upstream Ponding and Aggradation

- **Culvert replacement can expose gravel buried upstream**
- **Consider the affect of the tailwater control on upstream aggradation**
- **Tailwater control may degrade over time or may need to be lowered**

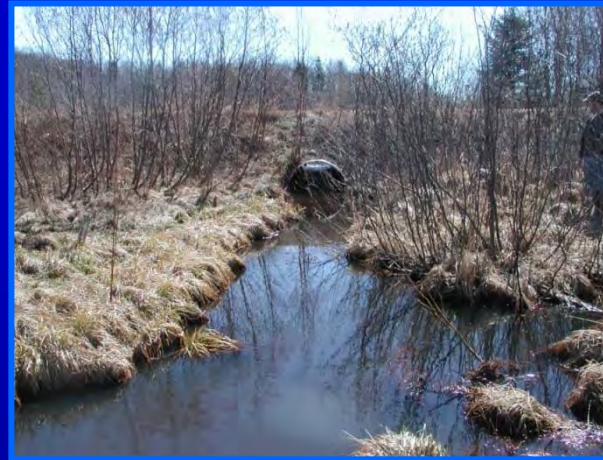
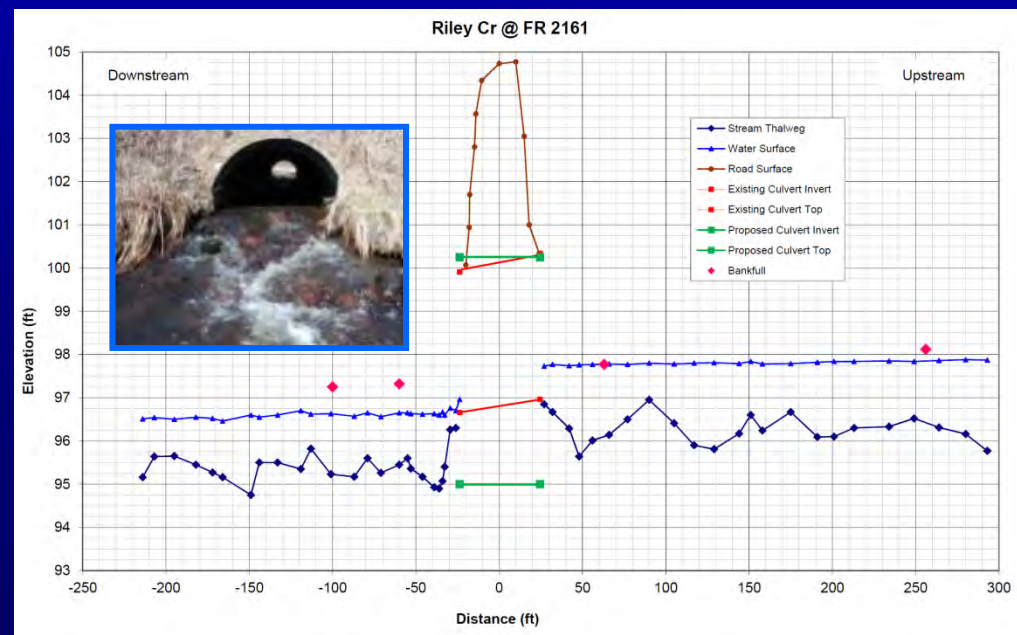
Low Gradient Example: Riley Cr at Forest Road 2161

- **Bankfull Width (BFW)**
 - Min = 7.0 feet
 - Mean = 9.2 feet
 - Range = 7.0-11.5 feet, n=6
 - Drainage Area = 2.25 sq mi
 - BFW (E-Reg Eq) = 8.2 ft

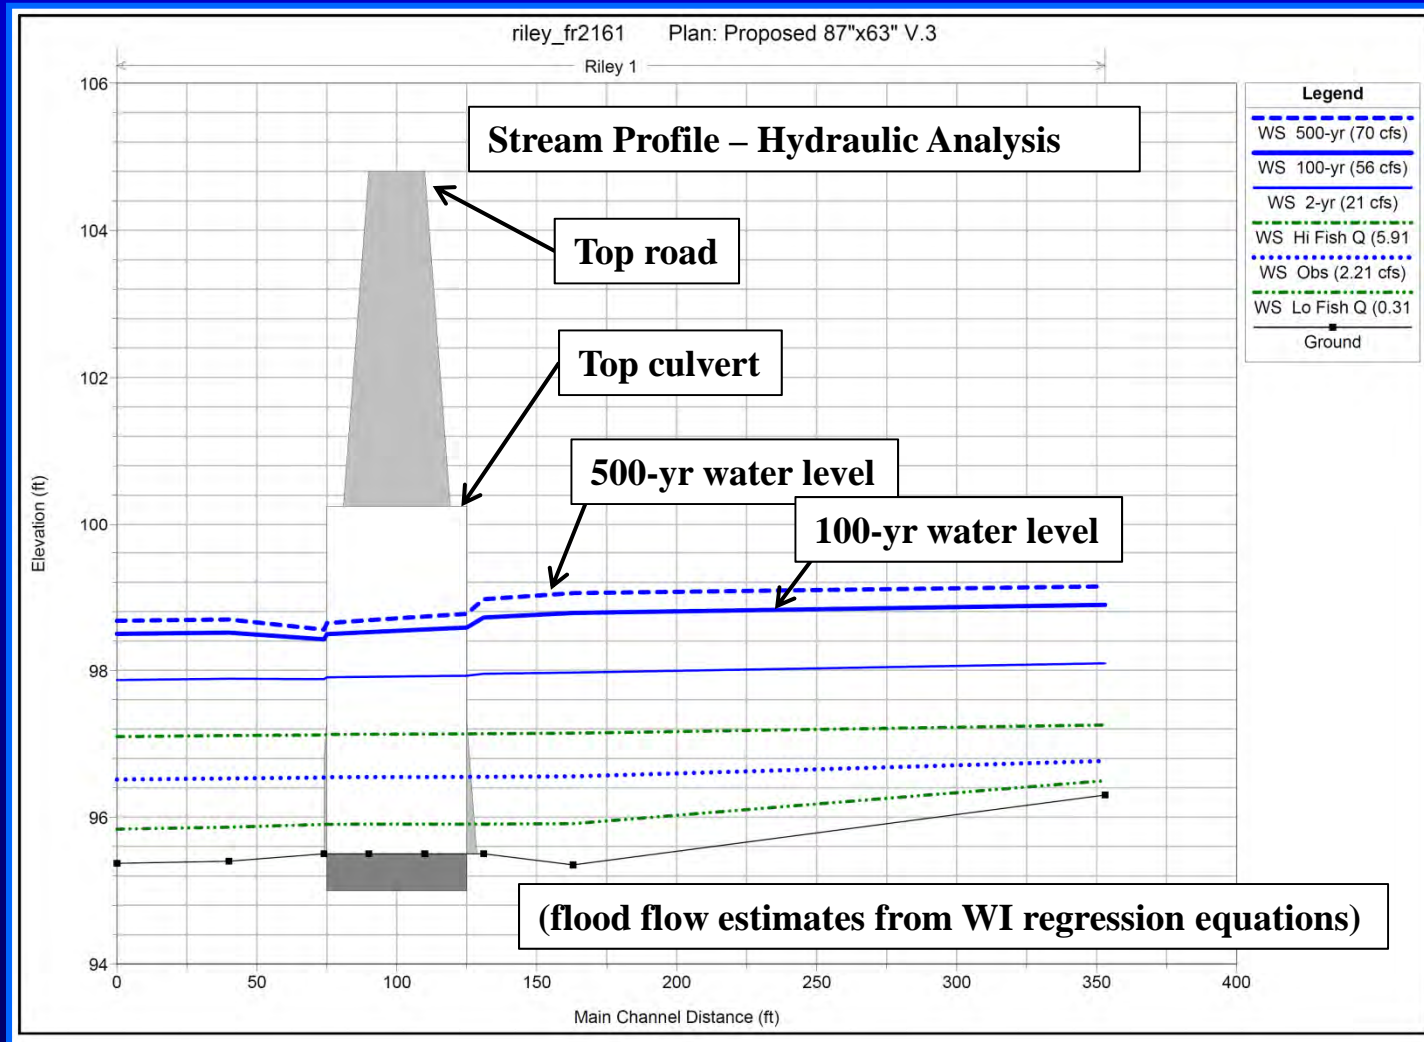
Low Gradient: BFW Culvert Passes Q_{100} With $HW/D < 1$

In N WI watersheds with low flood flows, BFW culverts typically pass the 100-yr discharge with a minor head increase and headwater below the top of culvert.

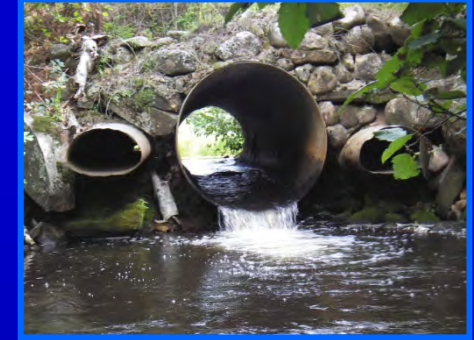
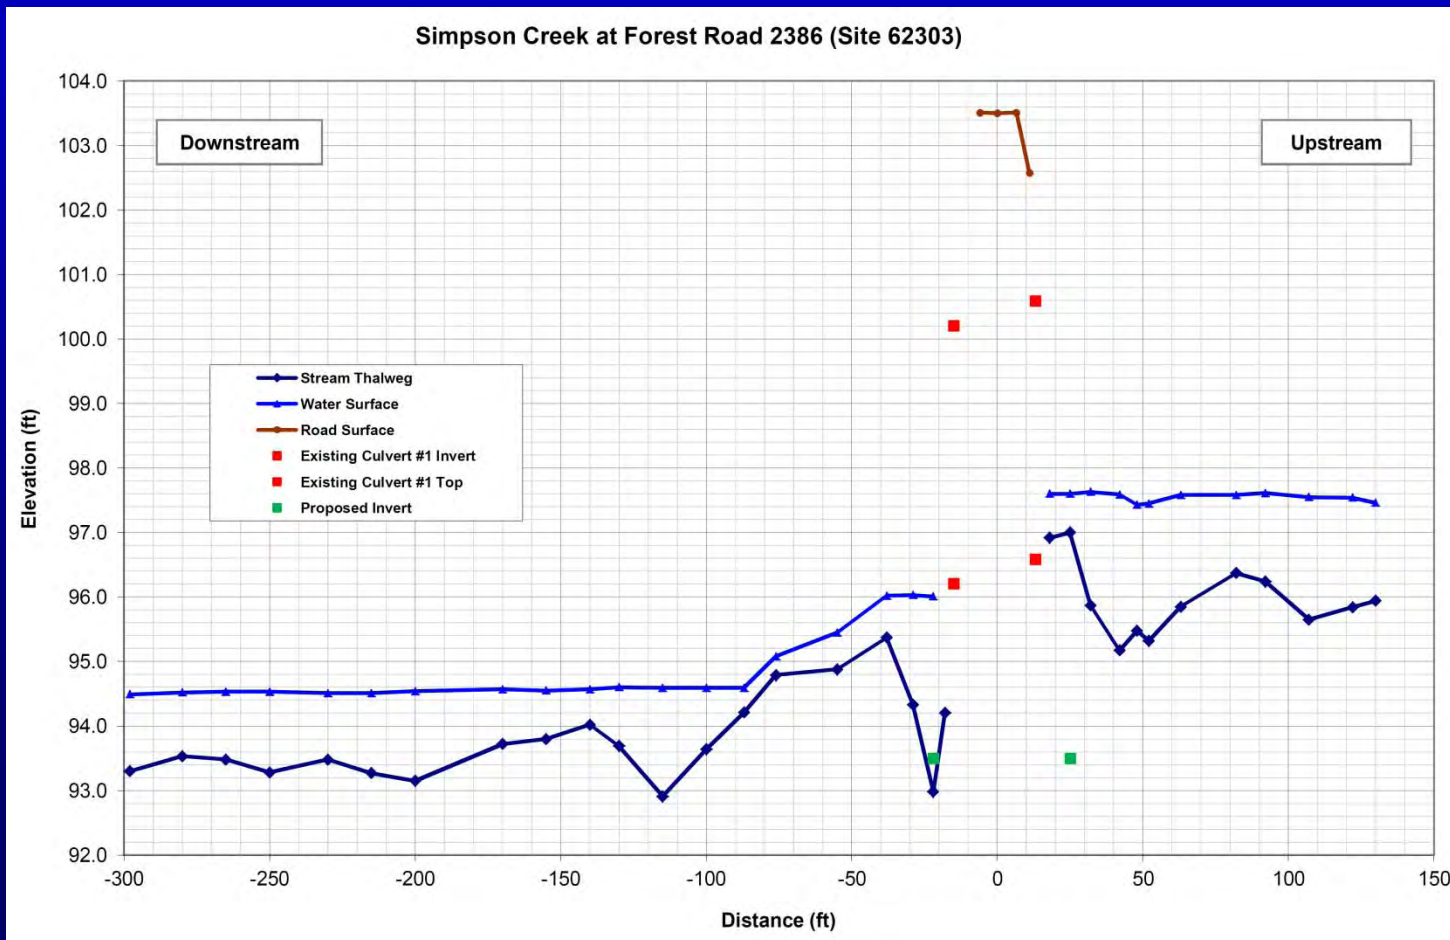
Low Gradient: Undersized Culvert Set Too High Water Temp & other Impacts Stream Restoration at Road Crossings in N WI

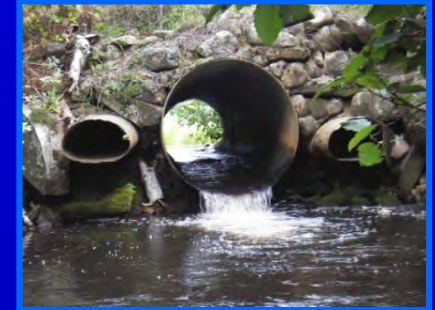
Low Gradient: Undersized Culvert Set Too High Water Temp & other Impacts Stream Restoration at Road Crossings

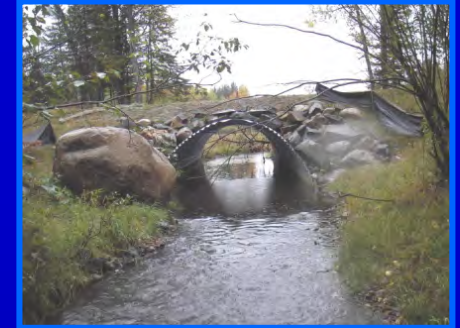
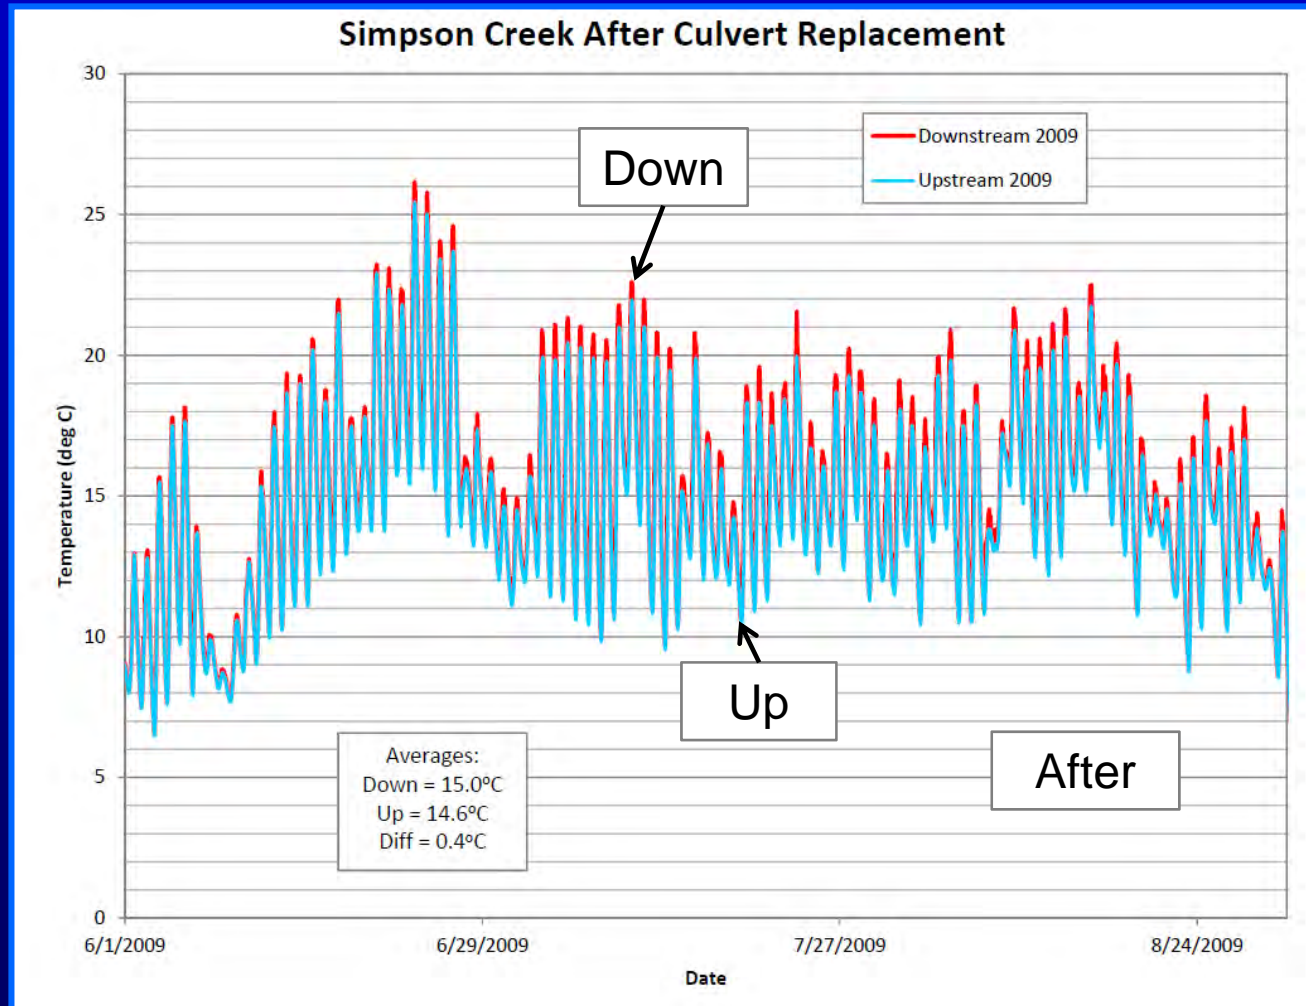
Low Gradient: Undersized Culvert Set Too High Water Temp & other Impacts Stream Restoration at Road Crossings

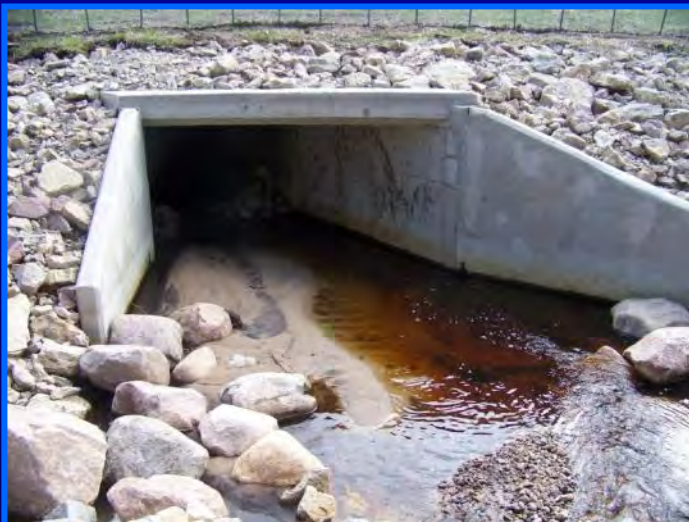
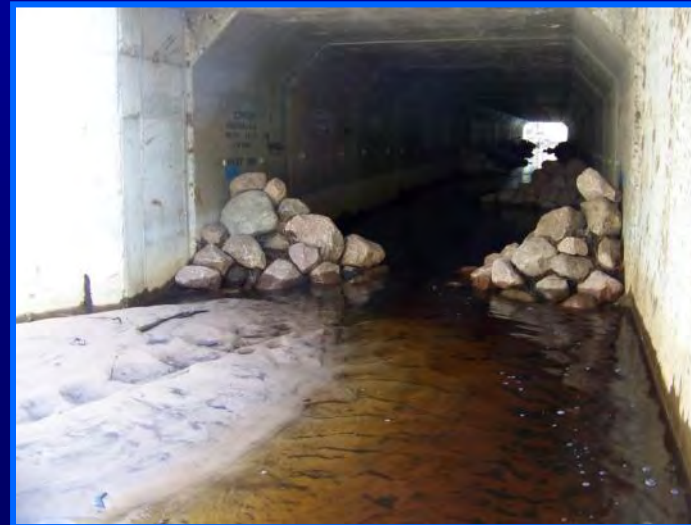
Rock bars for thalweg development: NB Oconto Trib at Hwy 64

- Culvert width = 8.0 ft
- BFW = 8 ft (ave)
- Culvert width/BFW = 100%
- Culvert length = 135 ft
- CL/BFW = 16.9
- 1 wavelength = $8' \times 10 = 80$ ft
- 5 bars/wavelength
- Bar spacing = $80/5 = 16$ ft
- Total bars = $135'/16 = 8$ bars
- Bar spacing adjusted slightly to fit culvert

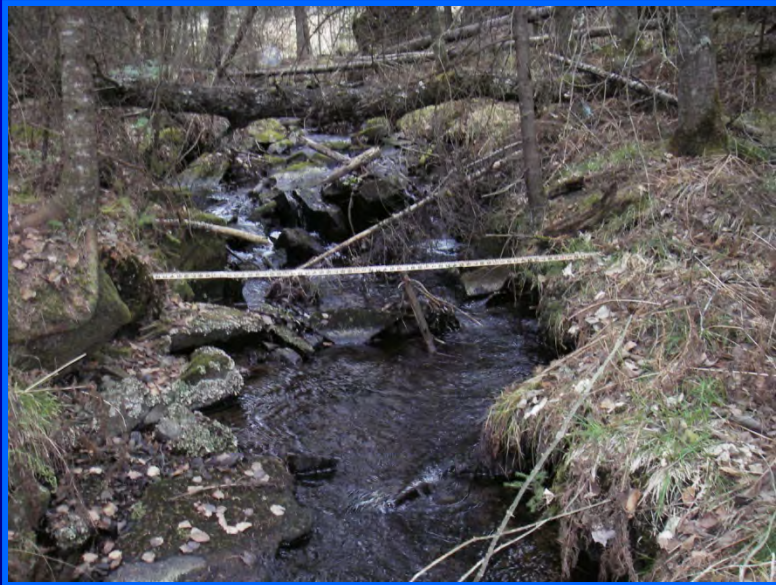
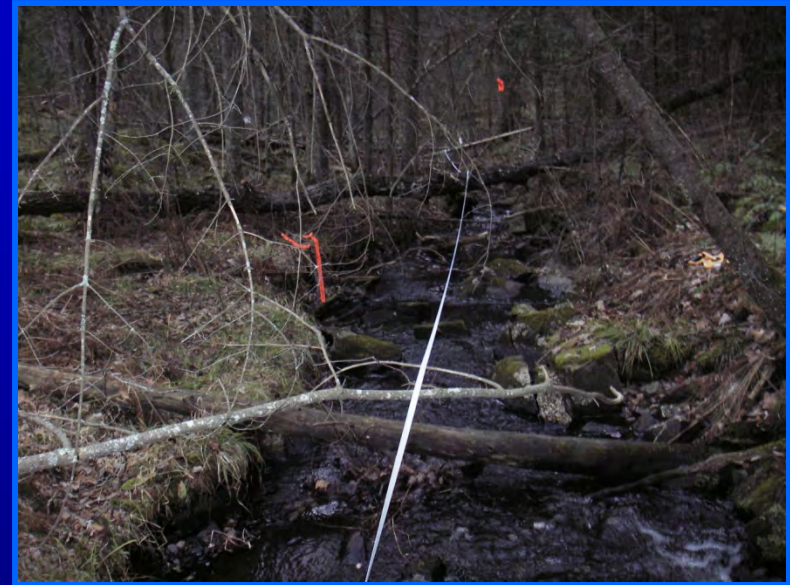
Reference Reach: Duck Cr at Hwy 139

Mean Bankfull Width = 7.2 ft

Range of BFWs = 5.7-9.9 ft

Key pieces 18-24 inches

Gradient = 3.4%

D50 = 105 mm (small cobble)

Range from sand to boulders

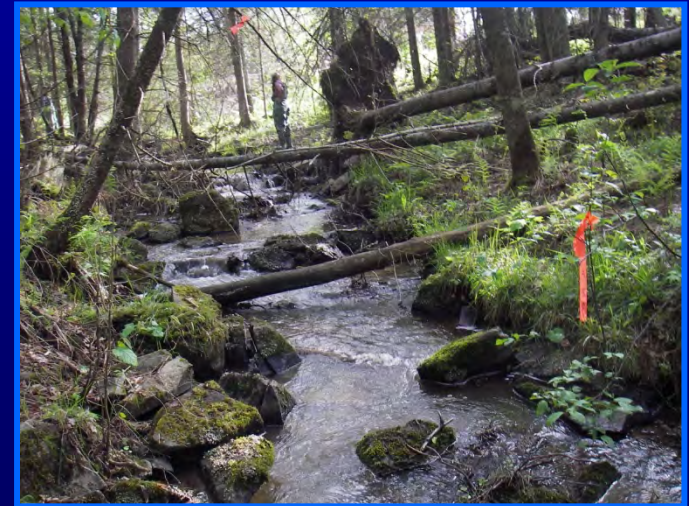
Channel Materials: Duck Cr at Hwy 139 Stream Restoration at Road Crossings in N WI

Streambed Mix for Duck Cr Culverts at Highway 139

Size (inches)	% Passing	% by Volume	Size Range	Volume Needed (cu yds)		
				Lower Xing	Upper Xing	Both
20	100	15	12-20"	15	11	25
12	87	15	8-12"	15	11	25
8	70	25	4-8"	25	18	42
4	45	10	2-4"	10	7	17
2	37	15	3/4-2"	15	11	25
<3/4	22	20	sand-3/4"	20	14	34
Total		100		100	70	170

Note: volume assumes 0.7 cu yd/ft of culvert length
Note: also need 410 rocks 18-24", 320 for banks and 90 for bands

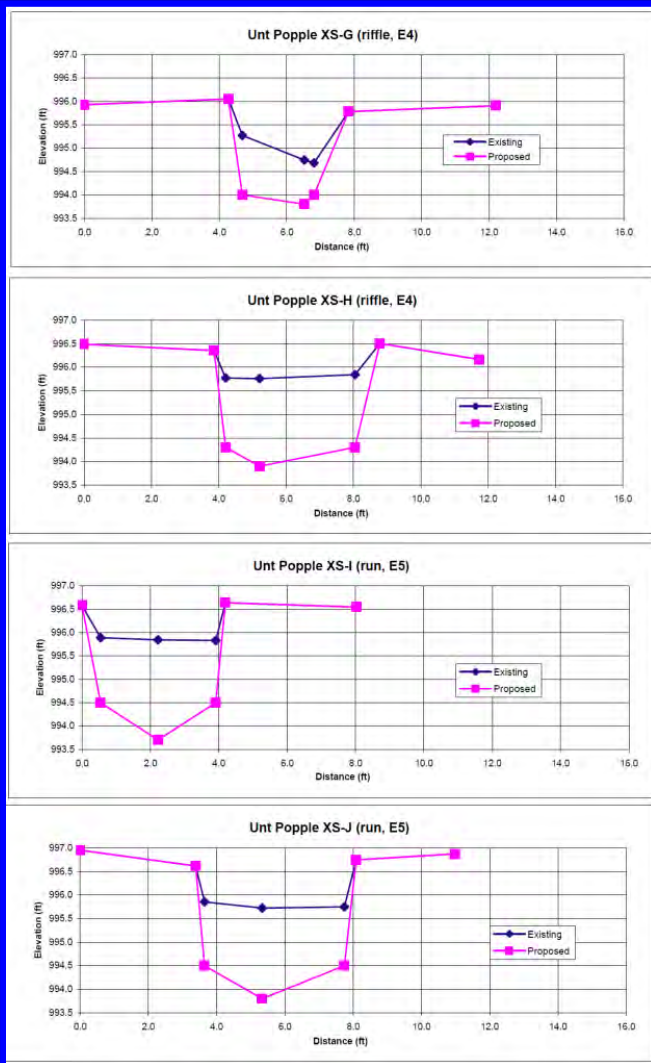
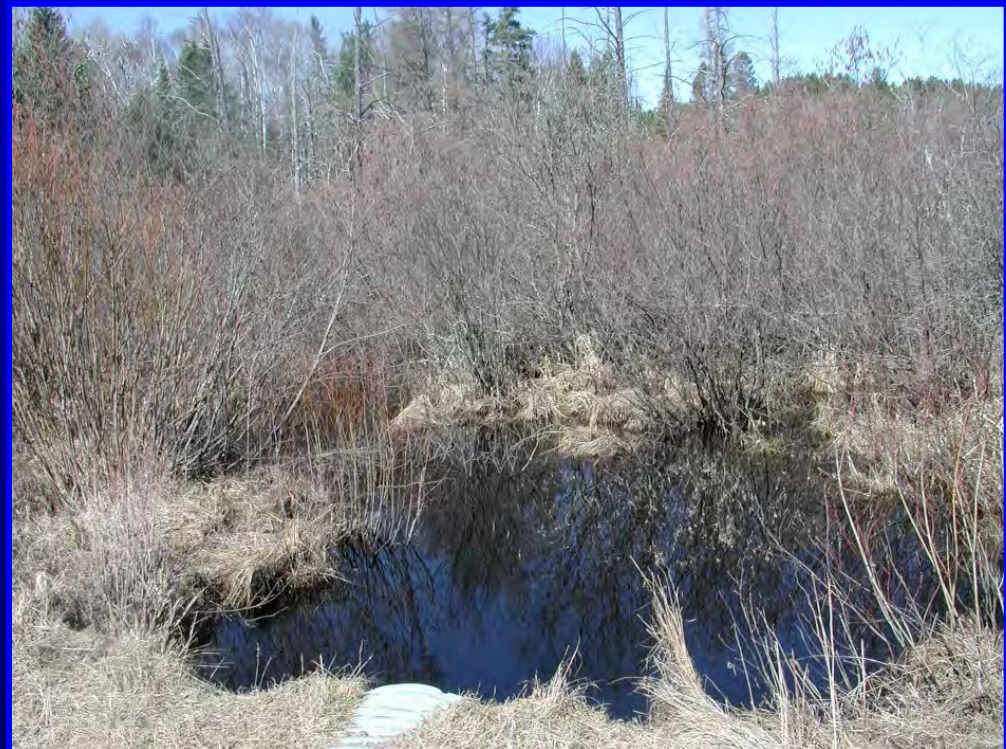
Aggradation from Frequent Failures

Downstream road sediment removal to restore stream profile and dimensions.
